ASSIGNMENT

SLQ 2769X

Mc E200d

RE: VEHICLE REPAIR QUOTATION

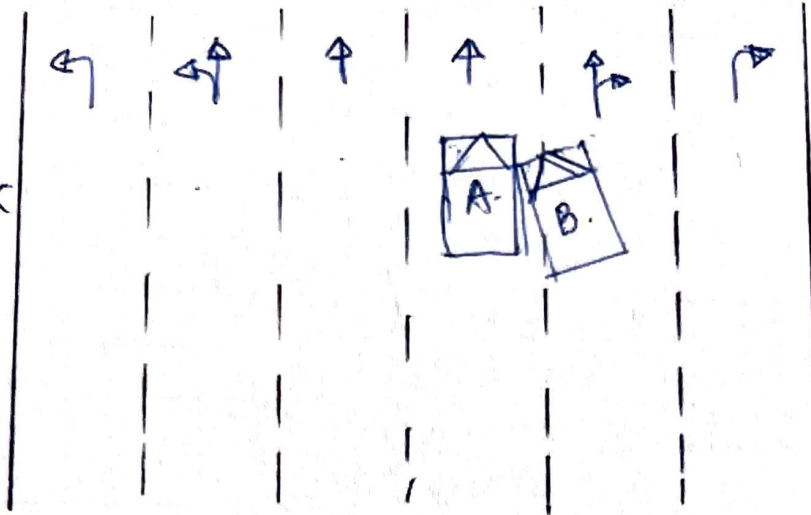
SKETCH PLAN

A: SLQ2769X
B:

On 27 Dec '22 at 17:40, I was driving shenton way on lane 3 (Vehicle A), and vehicle B on lane 2. try to change lane and hit my side. I was heading straight to reach Keppel road.

Vehicle B left-side mirror was folded inside due to this hit in. Crucial evidence. ~~Am~~ This side mirror made skid mark on my rear door. (right)
