ASSIGNMENT

Veh No: SMQ 94707 Yr Regn: 12.19

Make: Honda Civic C.C. 1597

REPAIR ESTIMATE

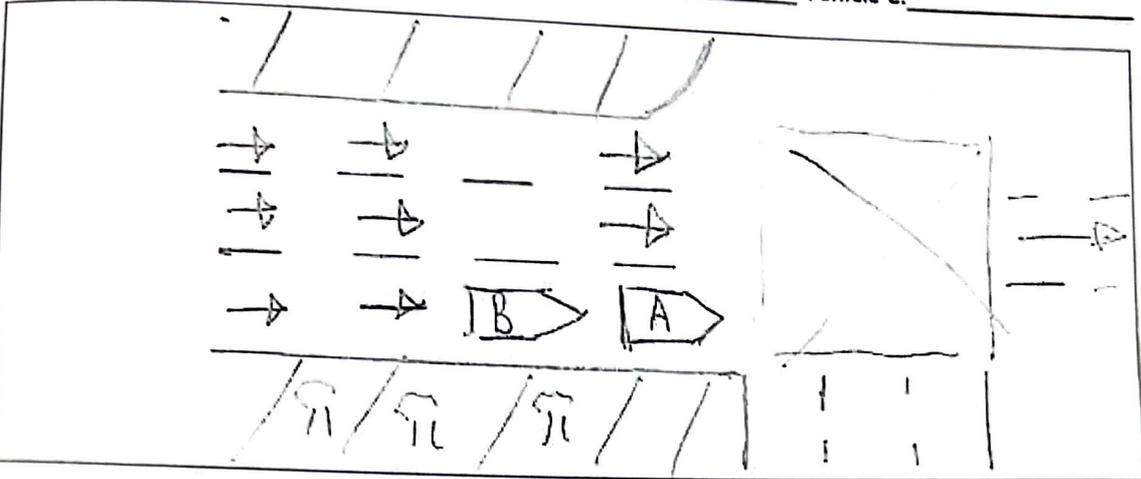
Date of accident: 22 Feb 2023 Time: 0647hrs Location: Sengkang East Ave
 My Vehicle A: SMQ 9470 Z Vehicle B: G8K 2185 E Vehicle C: -

On 22 Feb 2023 at about 0647hrs, I stopped my vehicle (SMQ9470Z) at the traffic light junction as the traffic light has turned red. Within seconds after my vehicle came to a halt, a min-van (G8K2185E) failed to apply his brake on time, resulting his vehicle to collide onto the rear of my vehicle. My vehicle back bumper was damage as a result of the collision.
