Report Reference : TP / 19024-10/MY / 2019
Date of Report : 7 Nov 2019

THIRD PARTY SURVEY
ACCIDENT HAPPENED ON 22 Oct 2019

As per your instruction dated **24 Oct 2019** with regard to the above matter. We have carried out a physical inspection on the said vehicle **SDZ 3099 L**. We enclosed herewith our report and findings as follows:

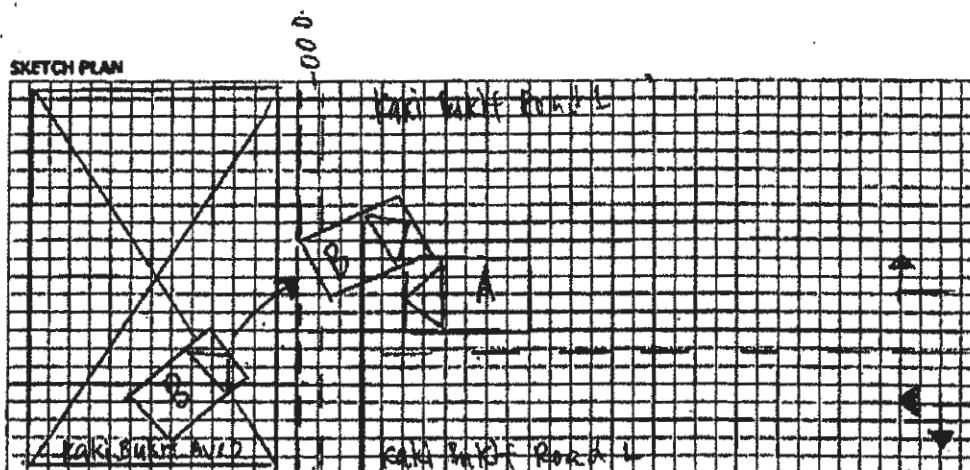
Sketch Plan #2 Pg. 1

On 22/10/19 at about 6.08pm, I was driving along Kaki Bukit Road 1 on the right lane. When I was coming to a stop, Car B which was turning into Kaki Bukit Road 1 from Kaki Bukit Ave 2, came into my lane and hit the front right portion of my car (A).

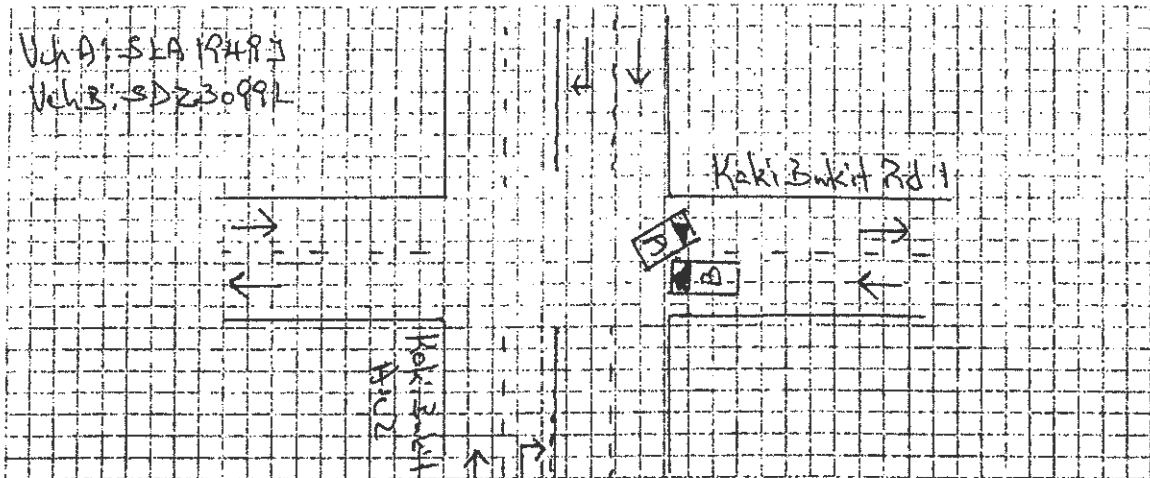
SKETCH PLAN

On the 22/10/2019 @ ord 1800hrs I was travelling along Kaki Bukit Ave 2 turning right into Kaki Bukit Rd One. When I was negotiate the turn, I misjudge and collided into vehicle B.

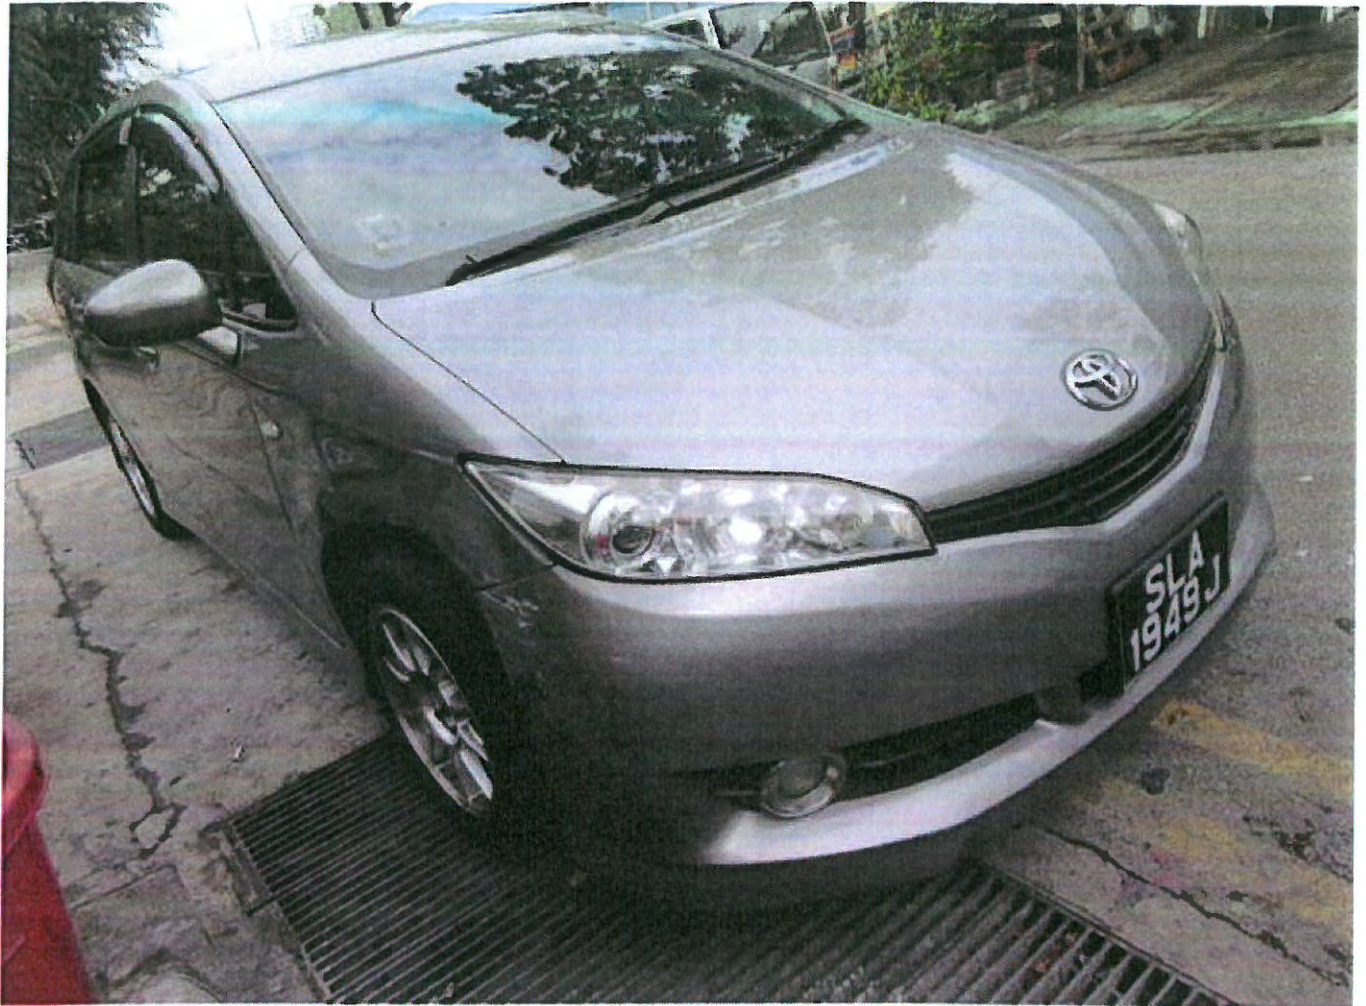
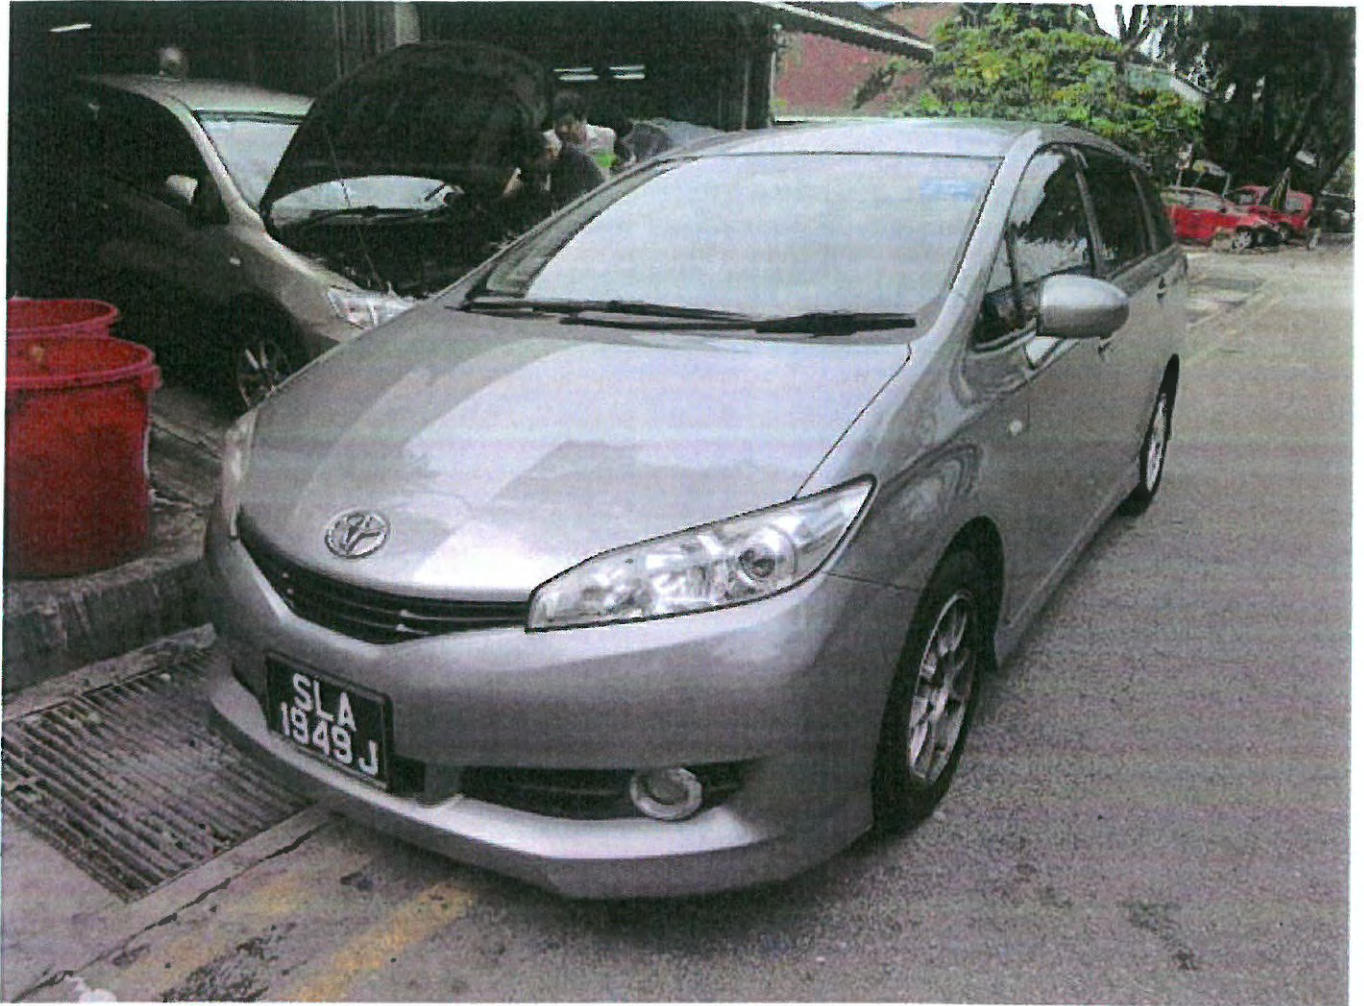
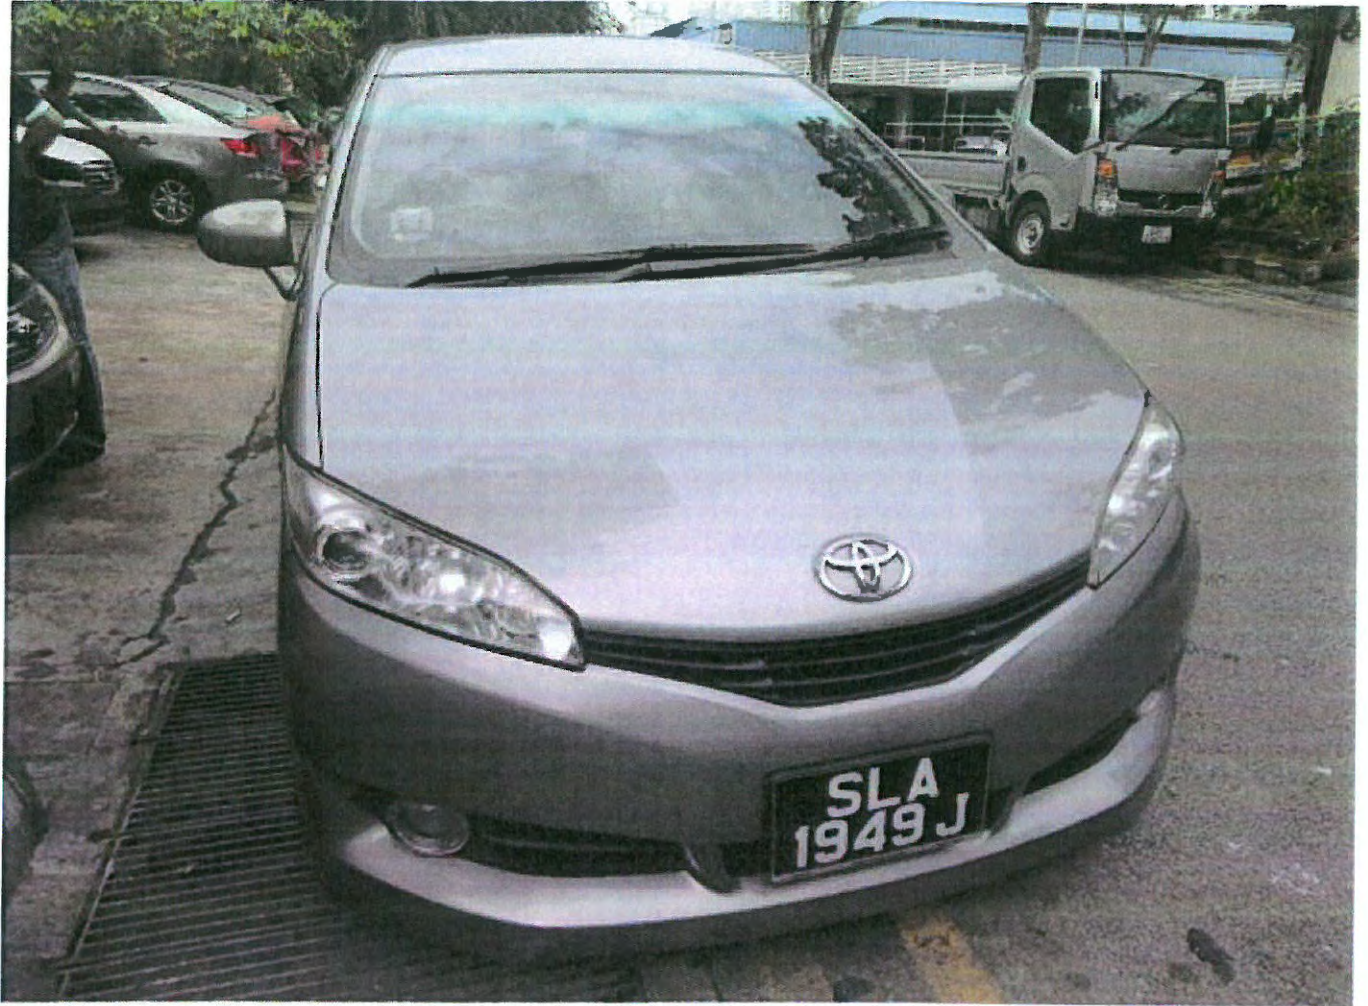
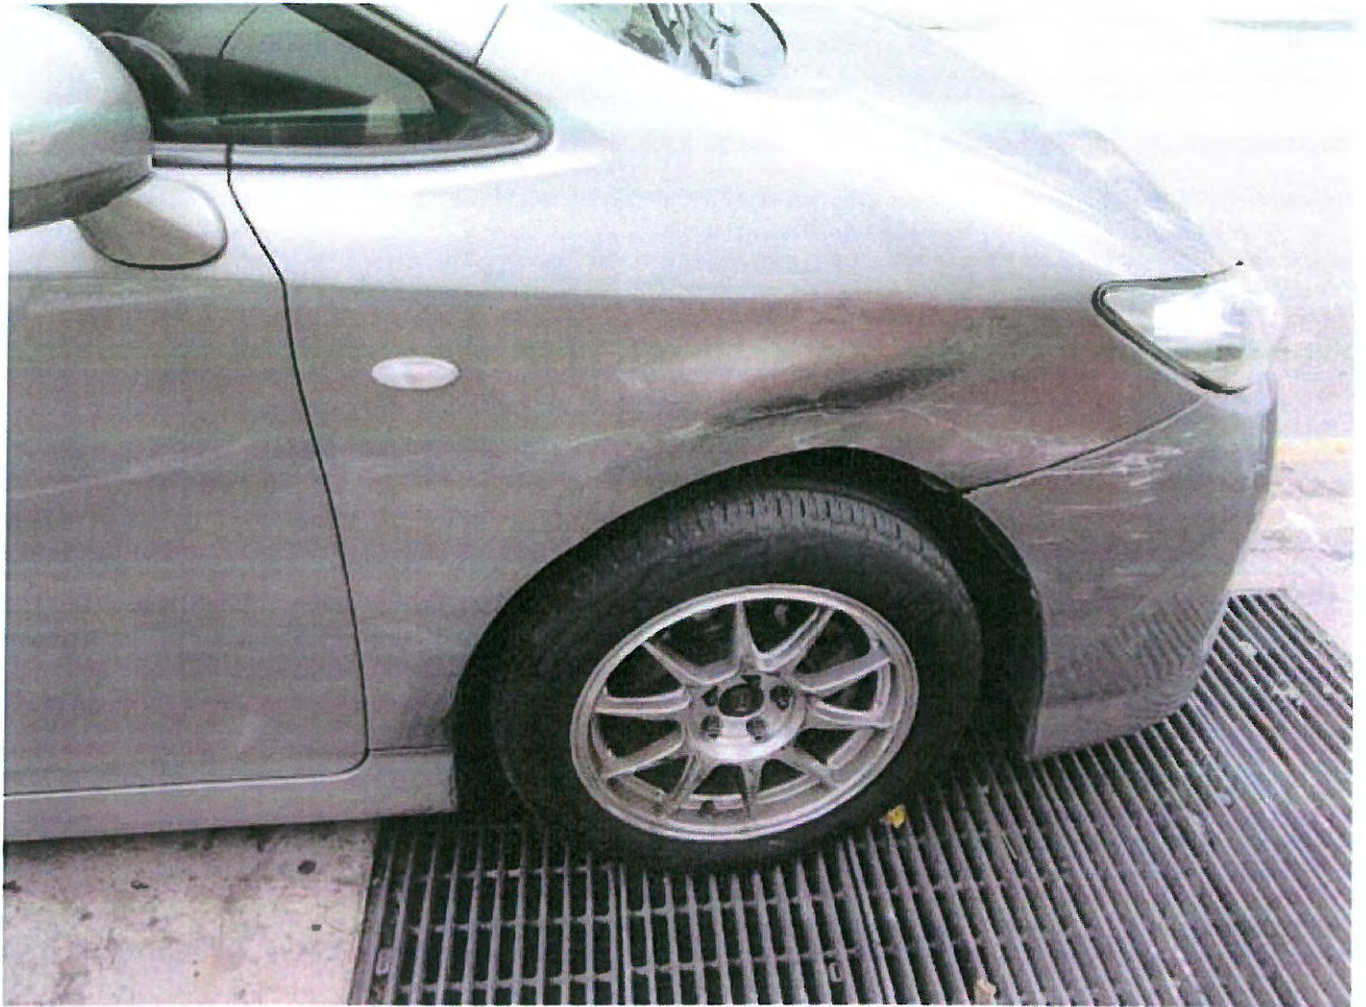
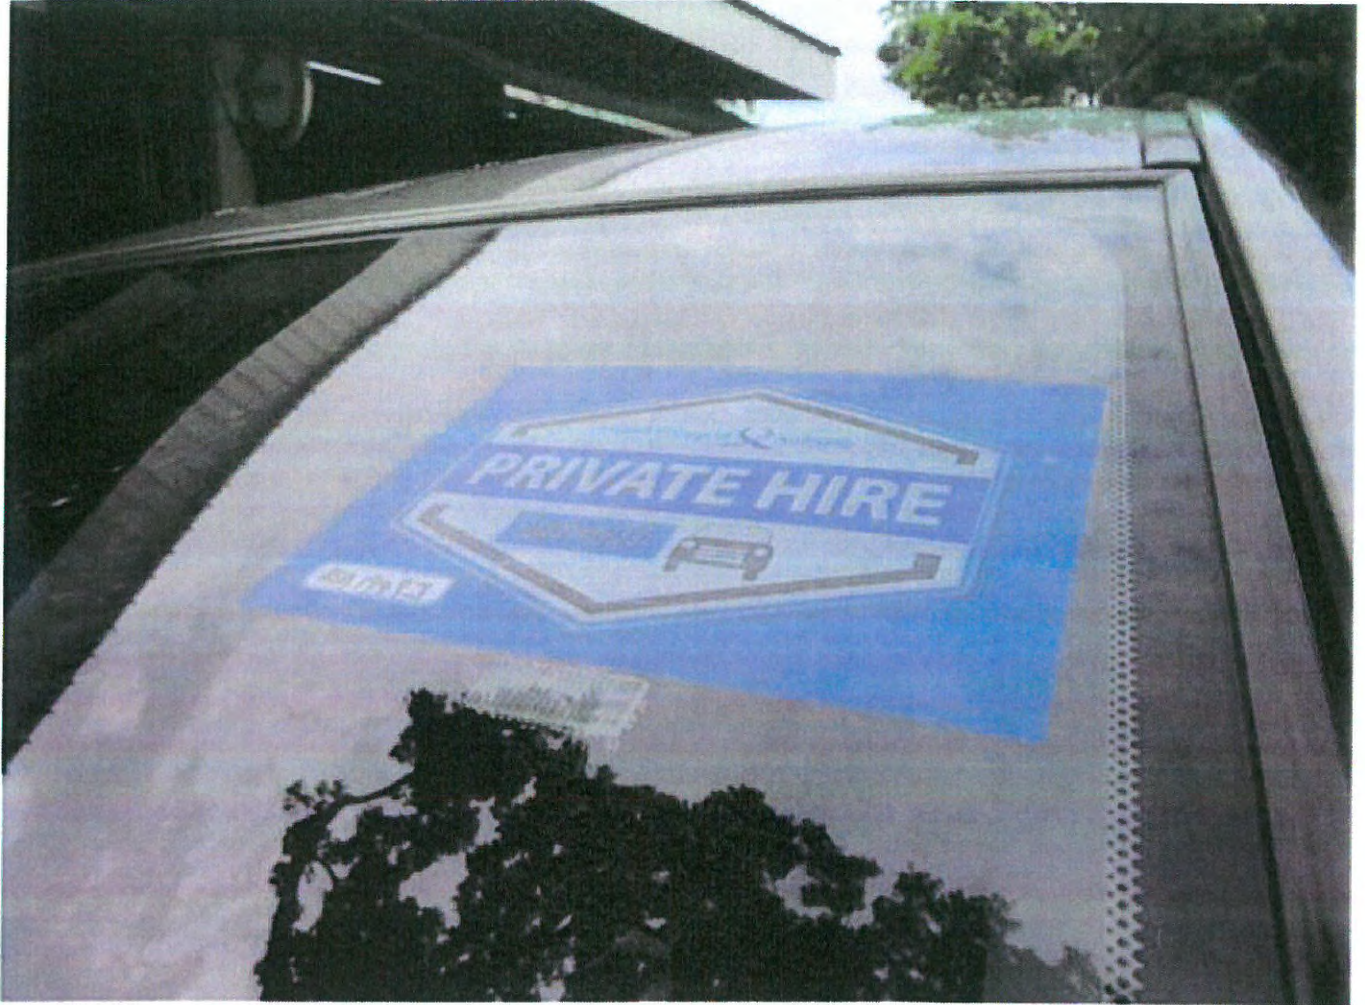
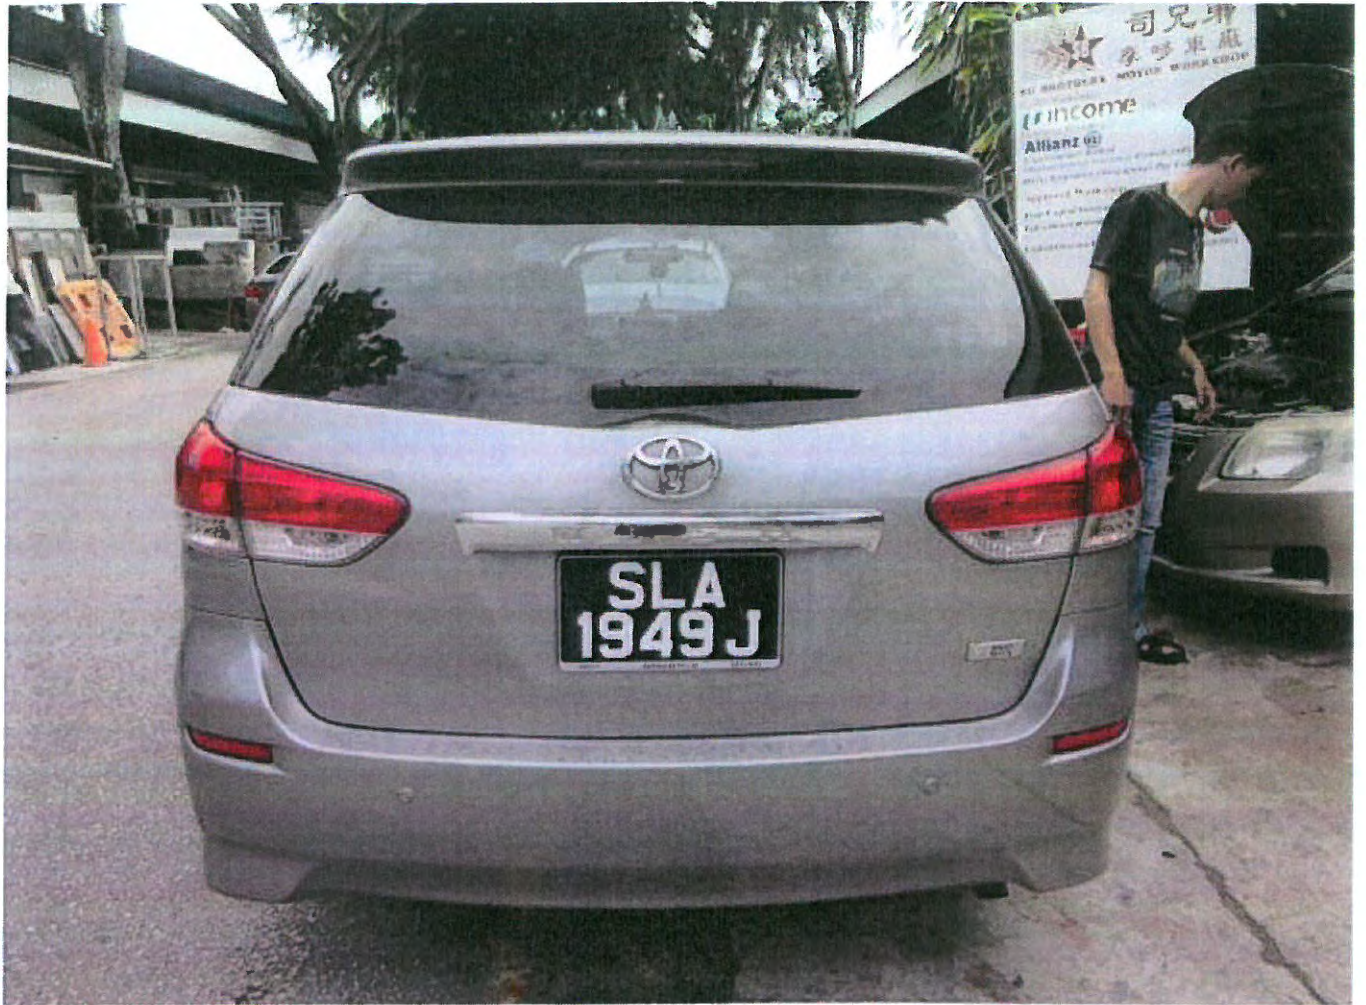
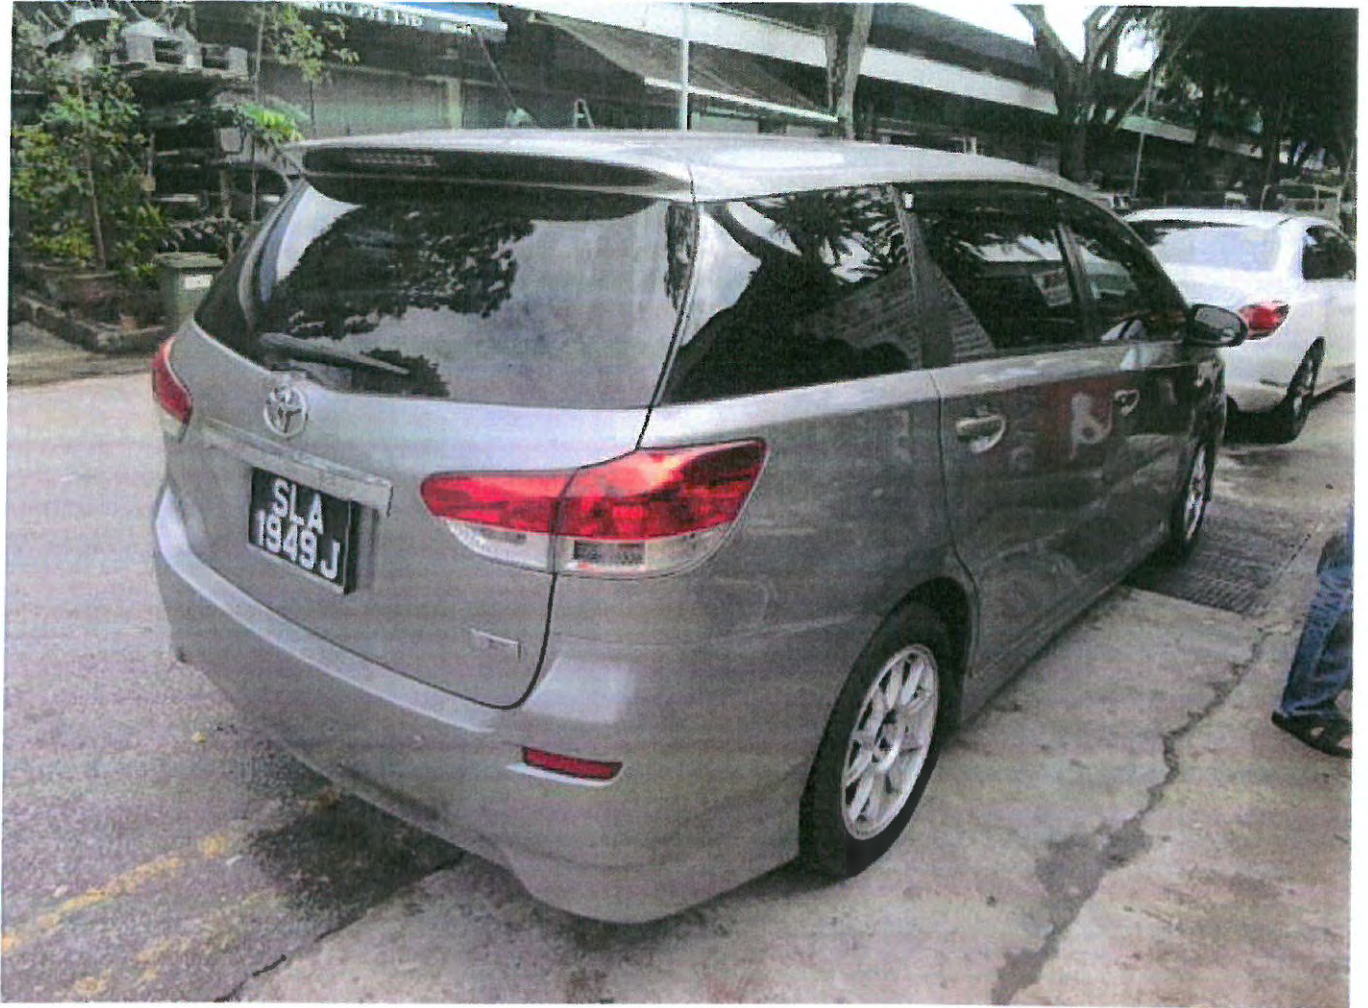
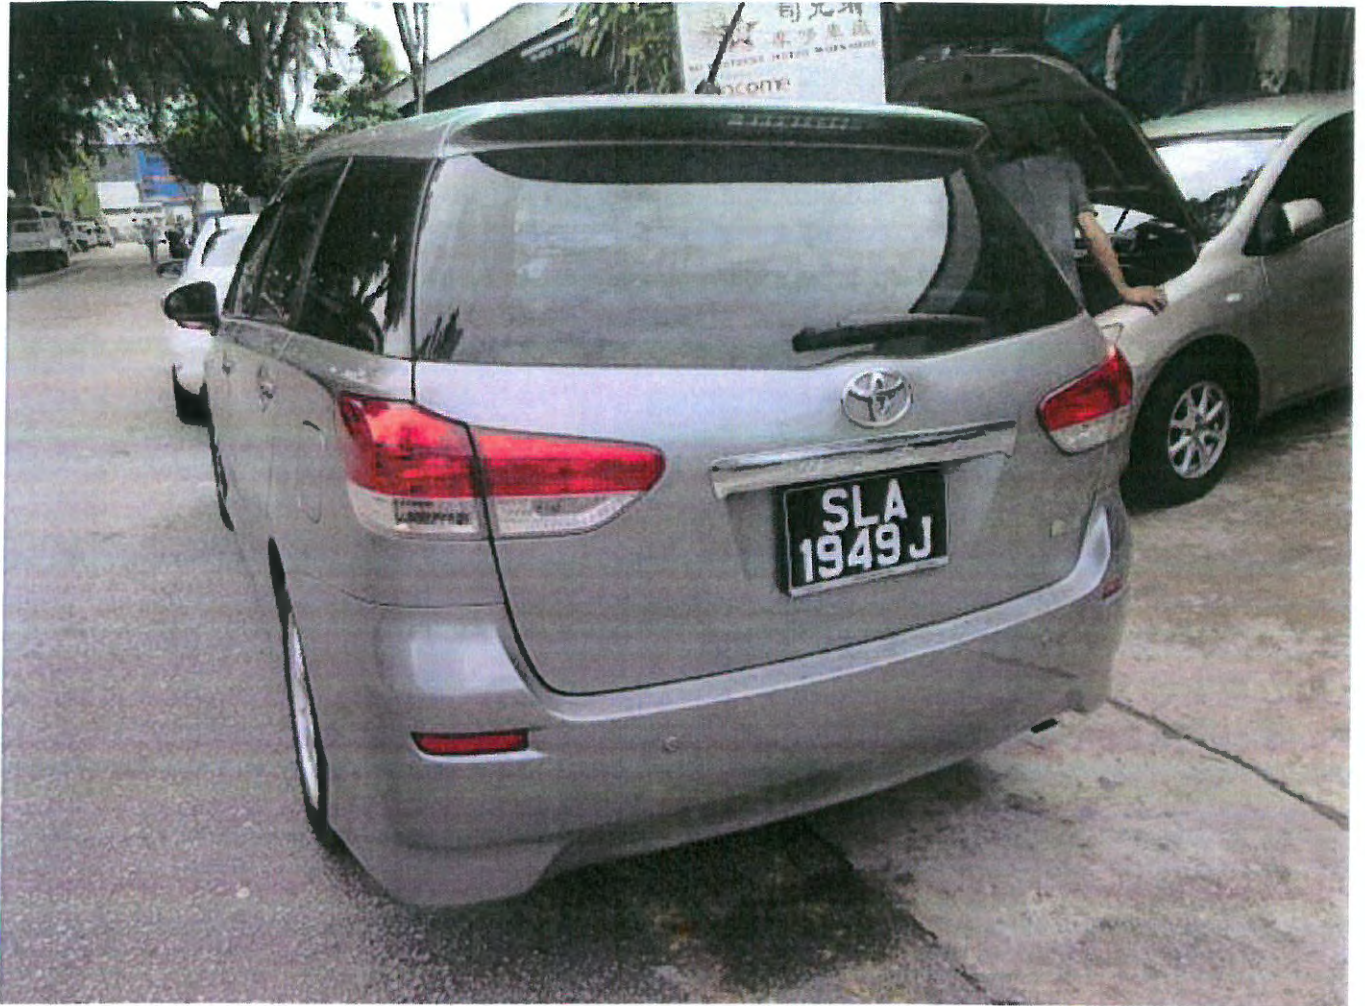
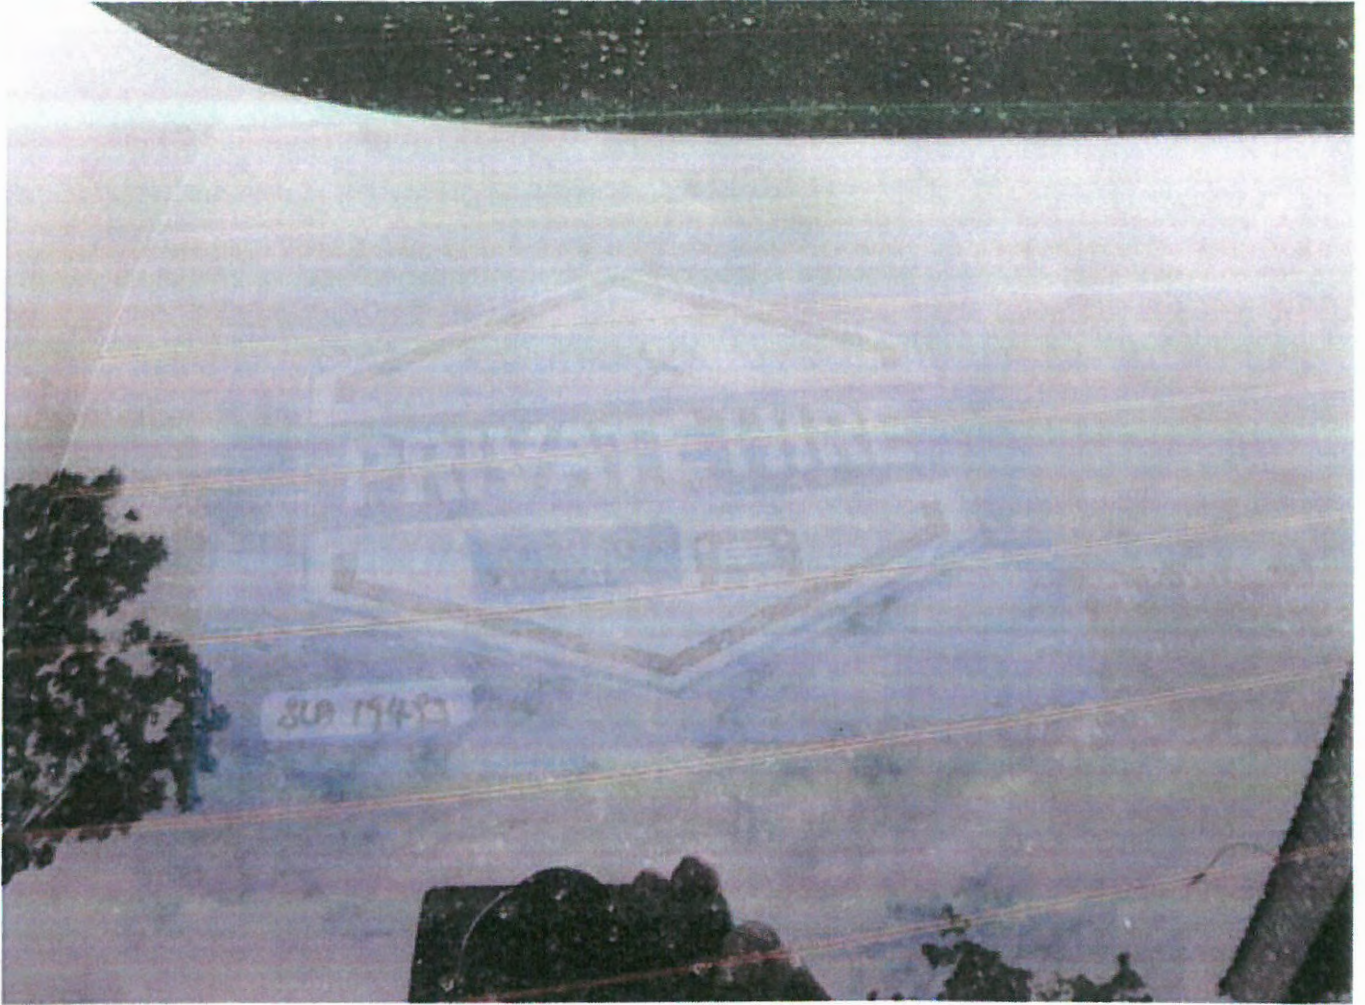
My vehicle suffered dented on the right front portion and right front wheel came off from the vehicle.

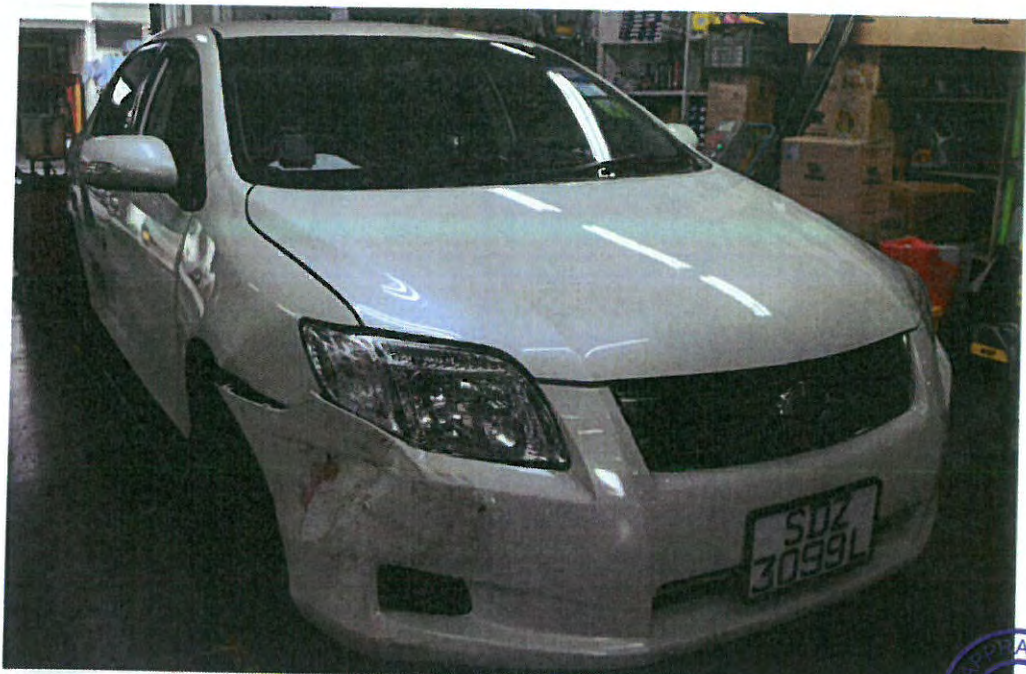
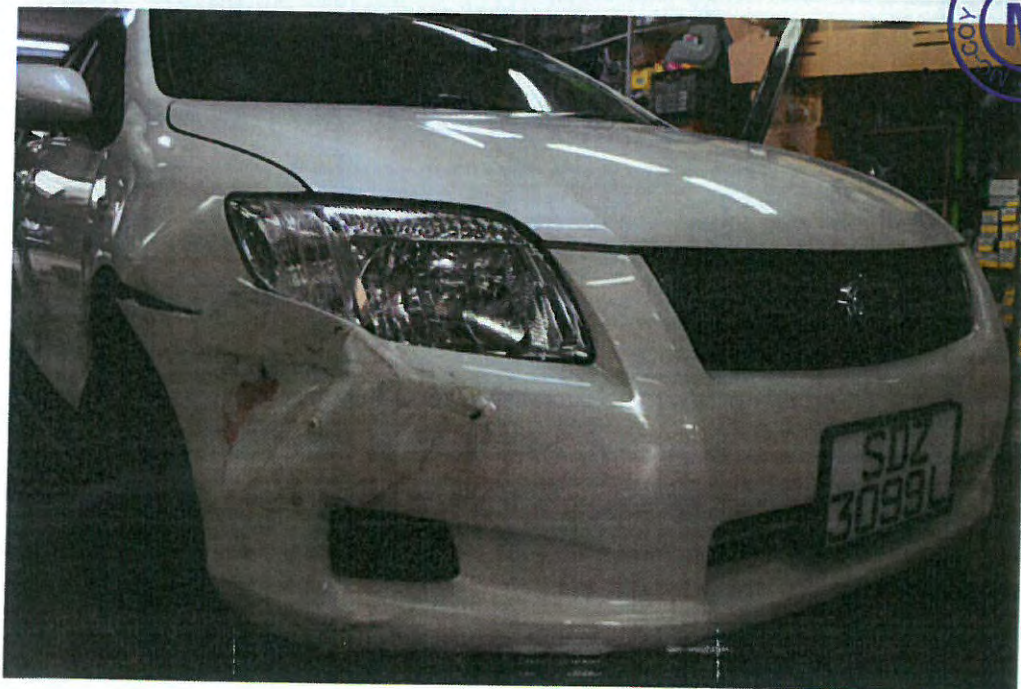
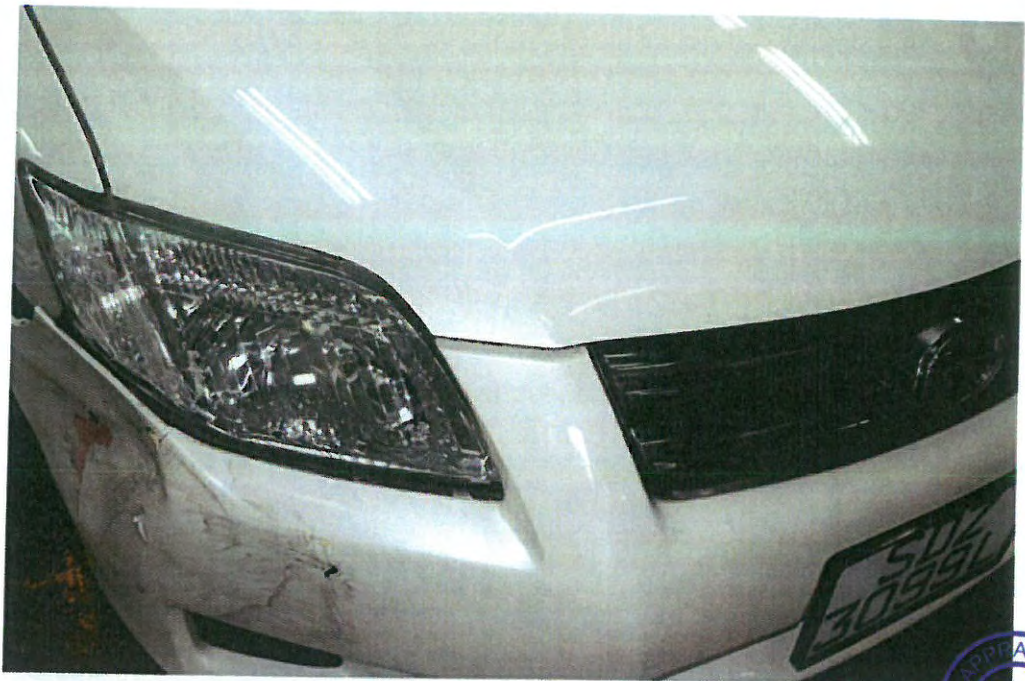
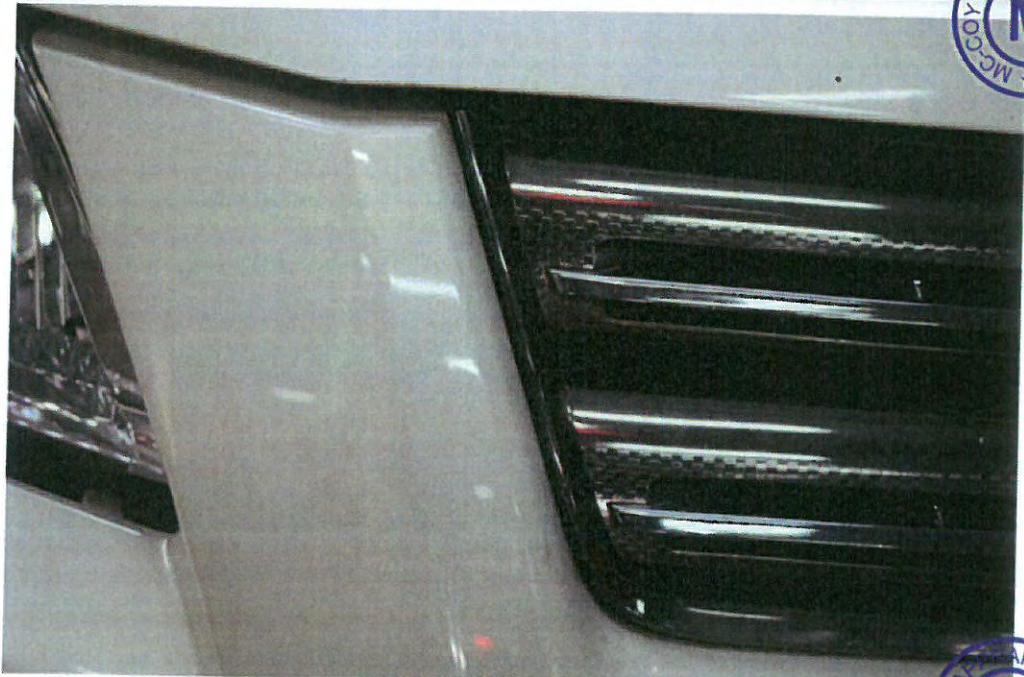
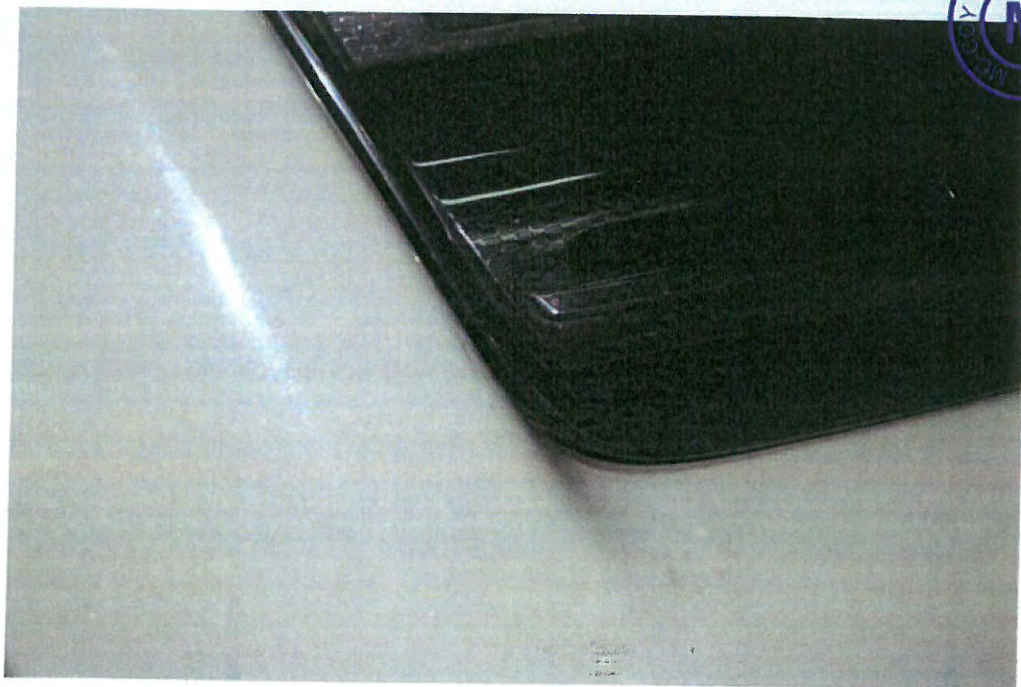
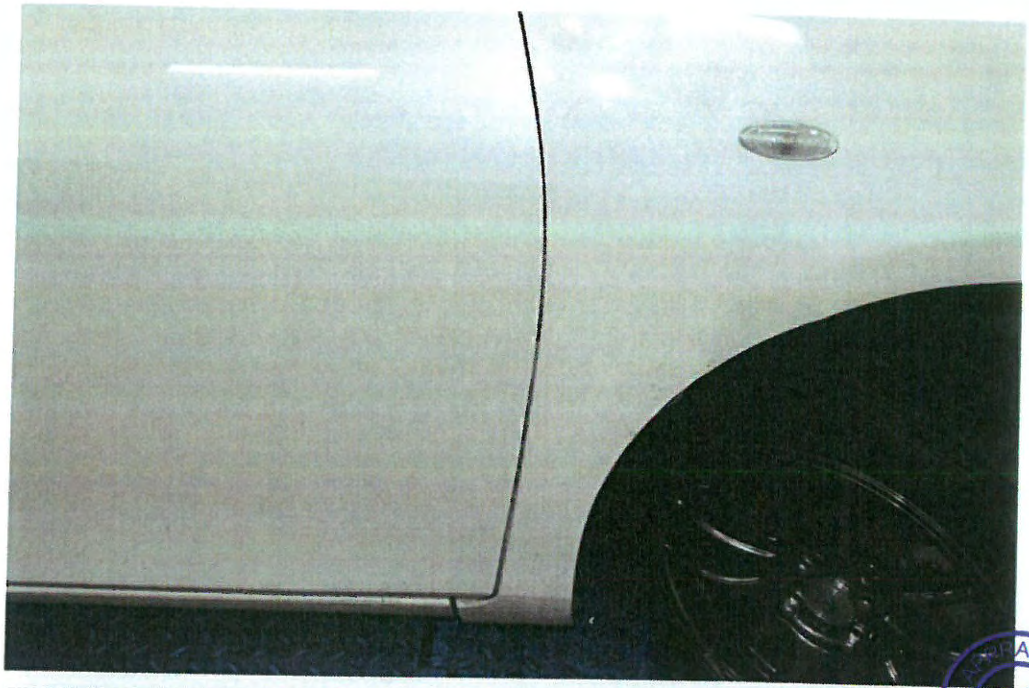
At the time of inspection, we noted that the vehicle has sustained an impact damages on the front o/s portion(s). For more detail of the damages, please see photograph attached.

4. Estimated normal period of repair : 8 working days to complete.
5. Enclosed number of photograph : 161 copies.
6. In accordance to your instruction, we have **Not Authorised** repair to the vehicle and the survey was done on a **"Without Prejudice"** basis. We hope that this report will be of assistance to you in dealing with the matter.
7. Should you discover any discrepancy in the report, please kindly notify us **within 2 weeks**, or the report will be treated as correct.
