Report Reference : TP / 19024-10/MY / 2019
Date of Report : 7 Nov 2019

THIRD PARTY SURVEY
ACCIDENT HAPPENED ON 22 Oct 2019

As per your instruction dated **24 Oct 2019** with regard to the above matter. We have carried out a physical inspection on the said vehicle **SDZ 3099 L**. We enclosed herewith our report and findings as follows:

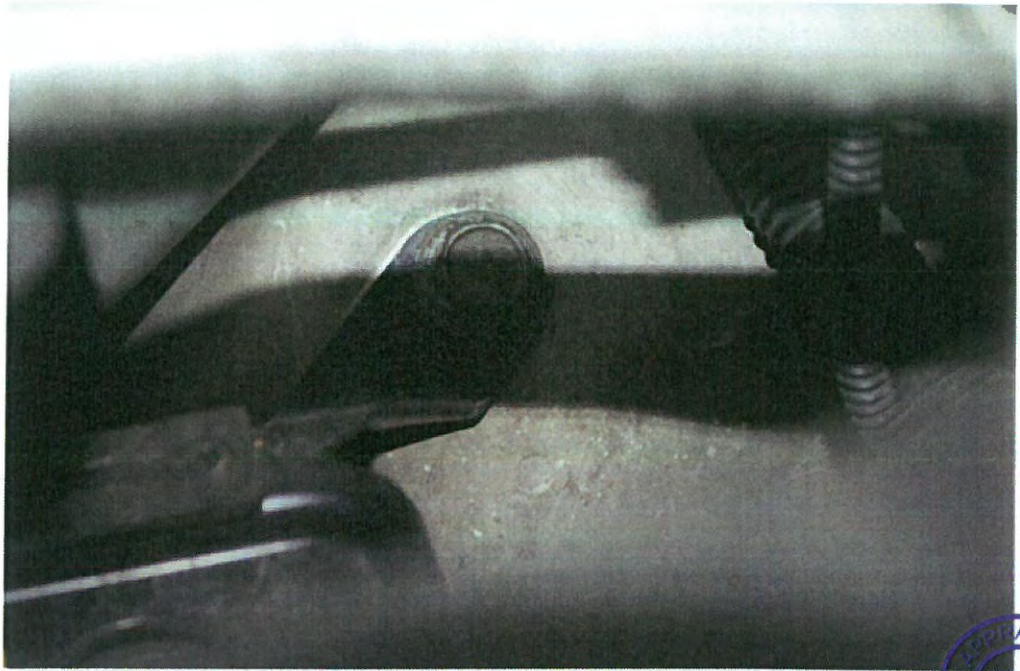
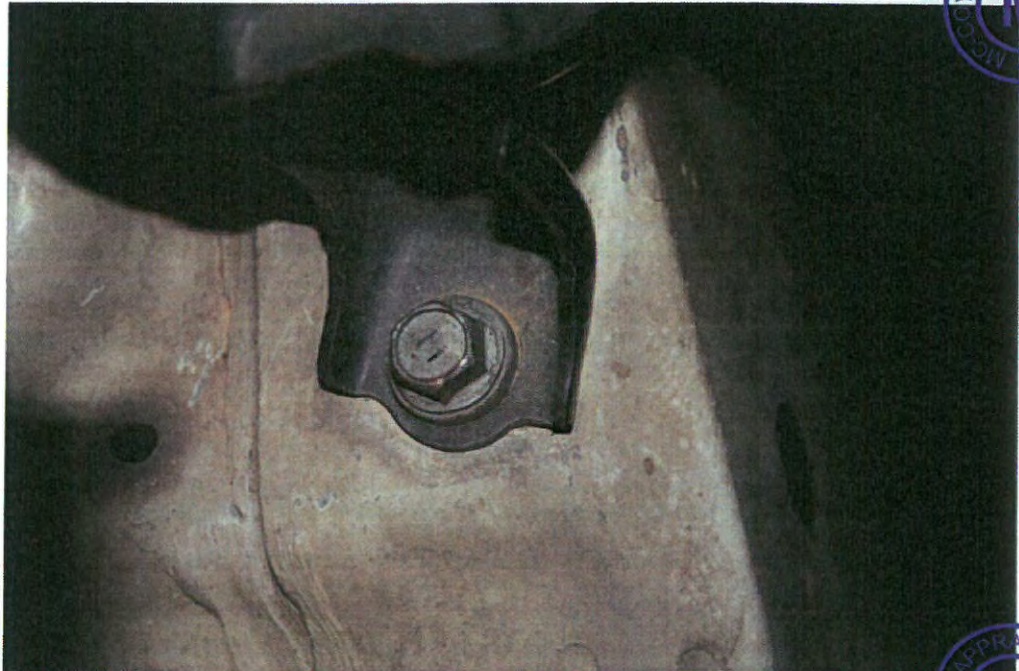
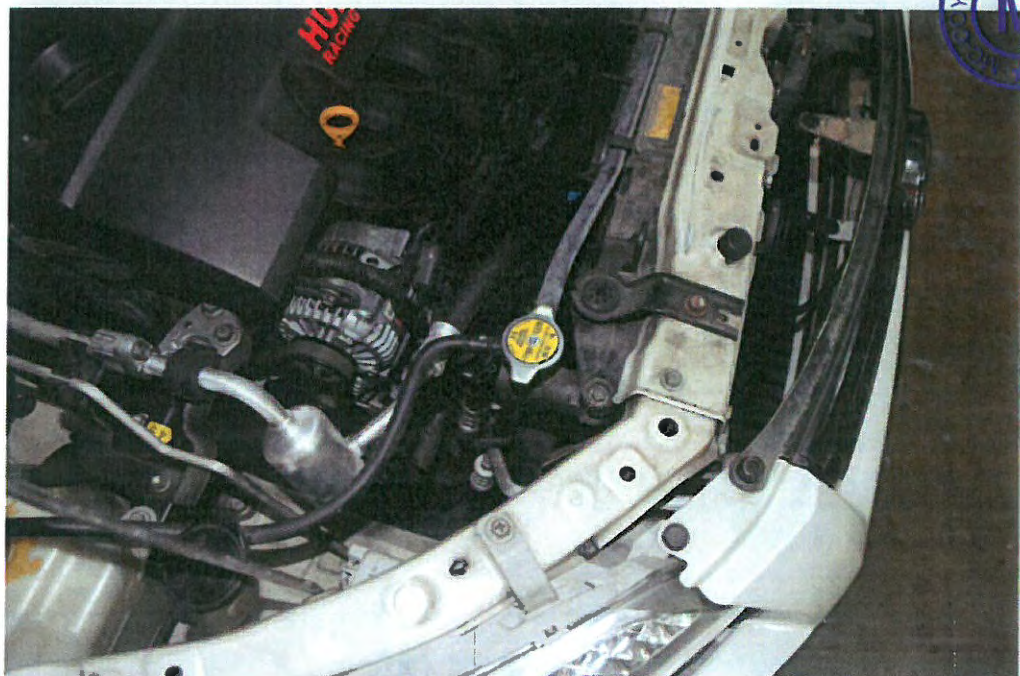
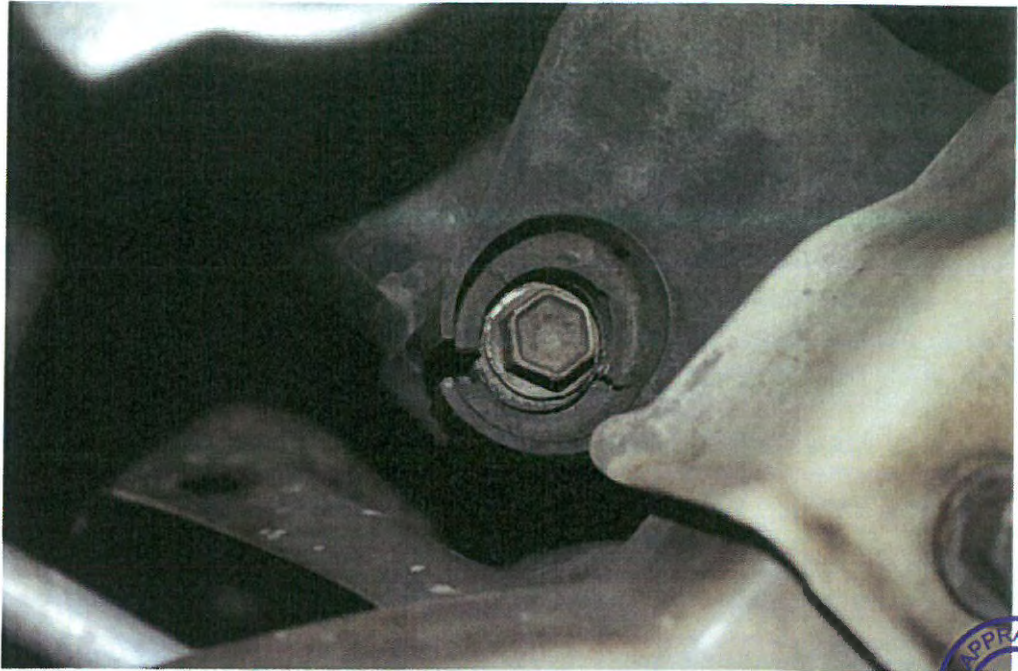
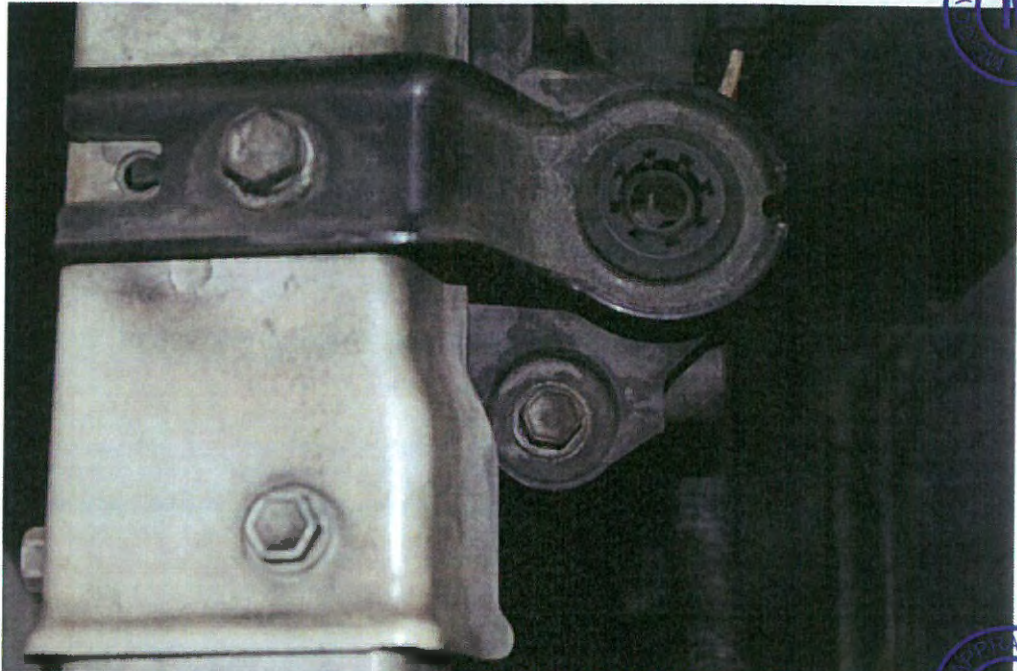
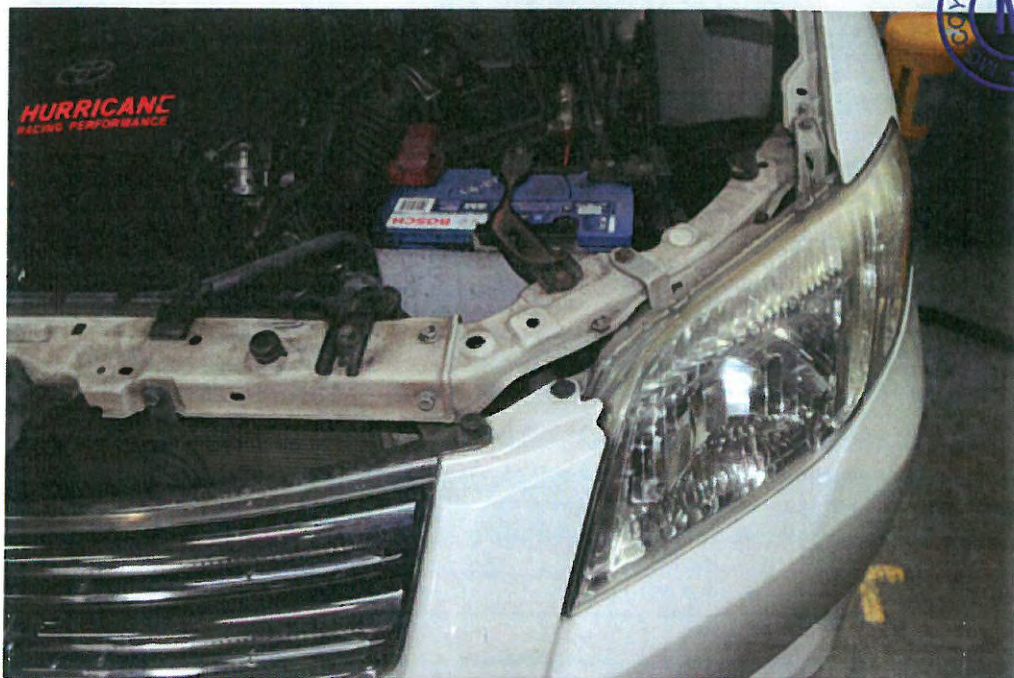
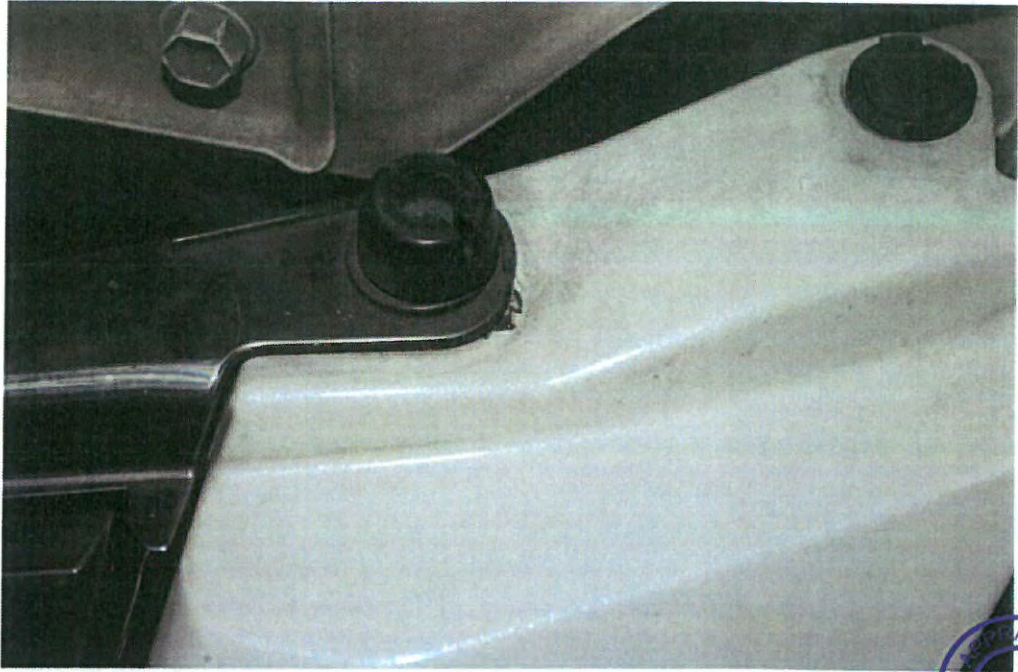
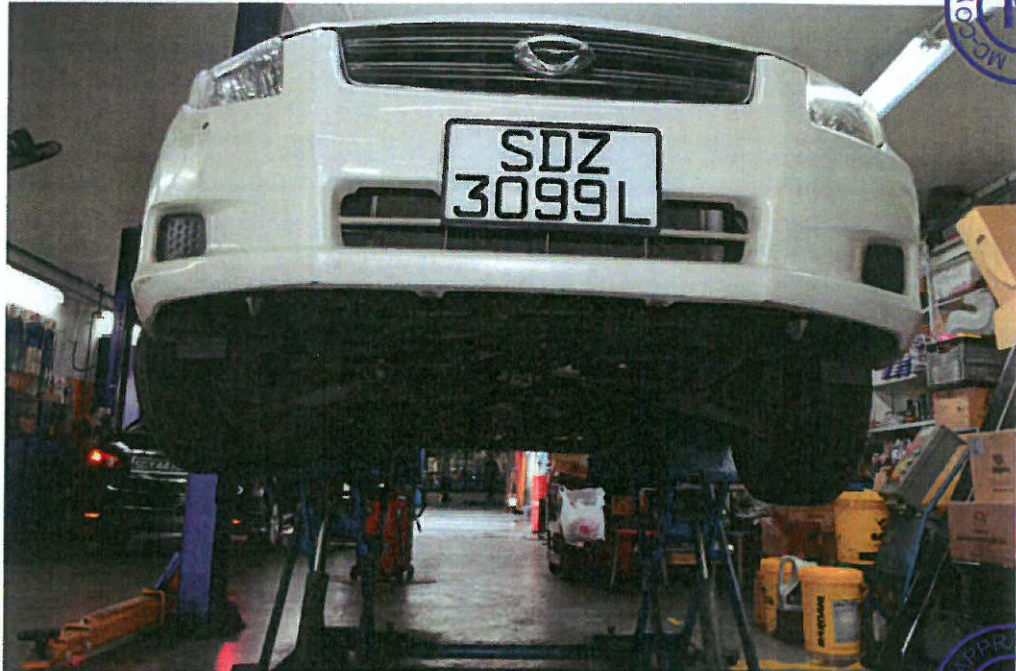
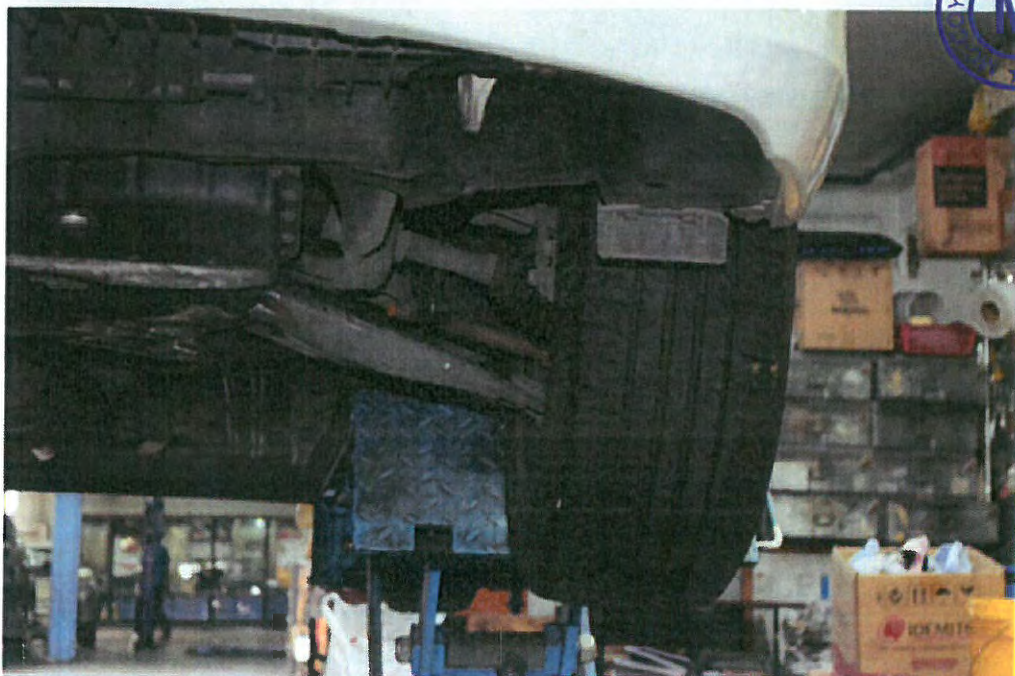
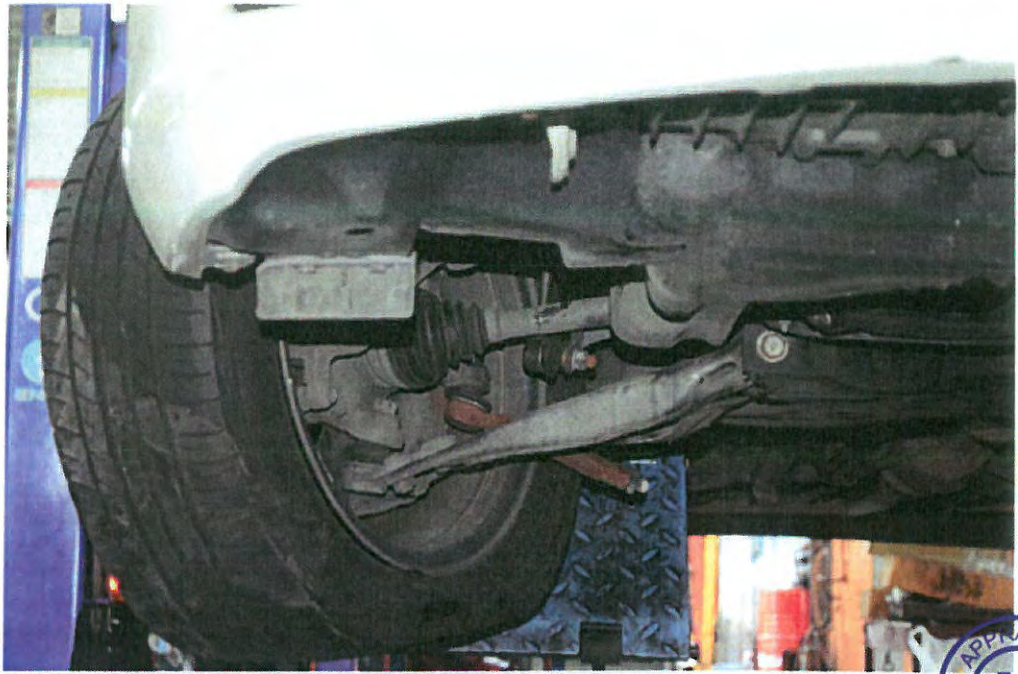
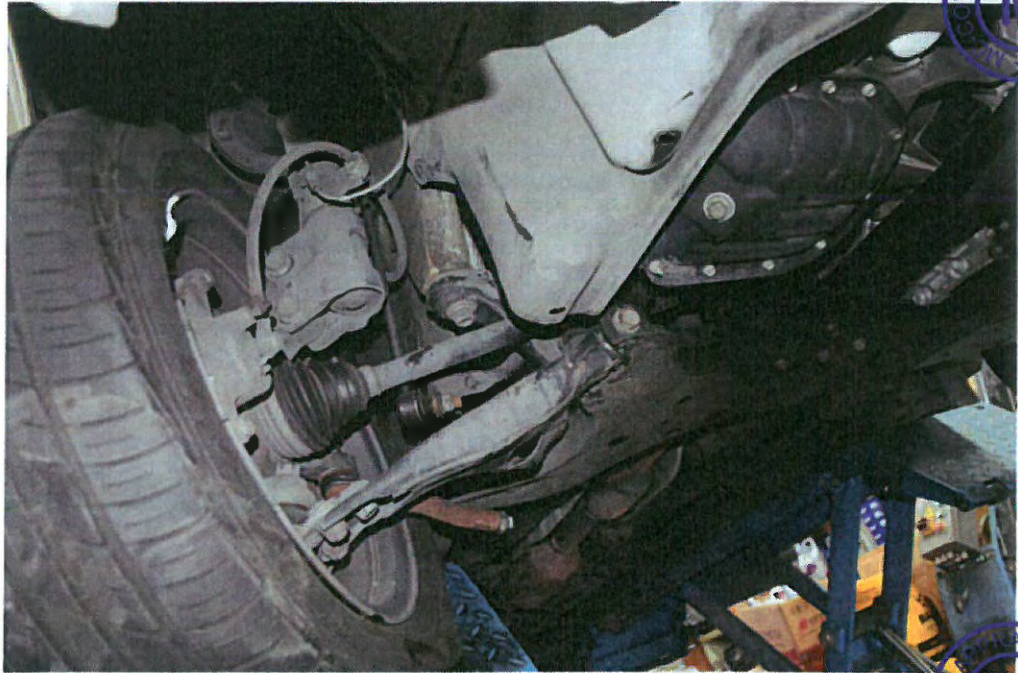
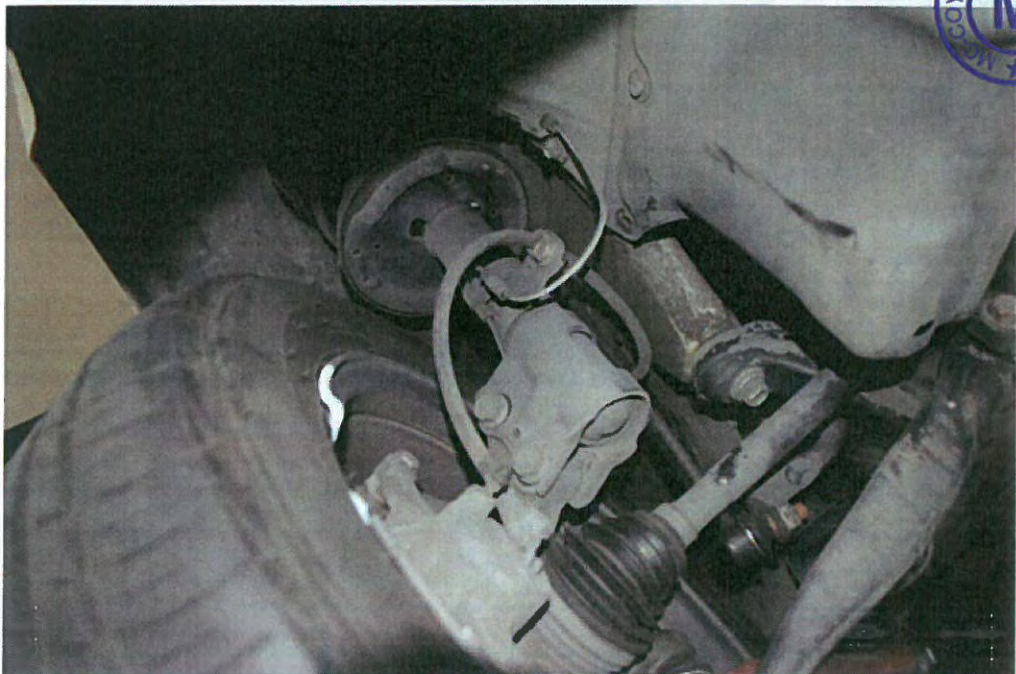
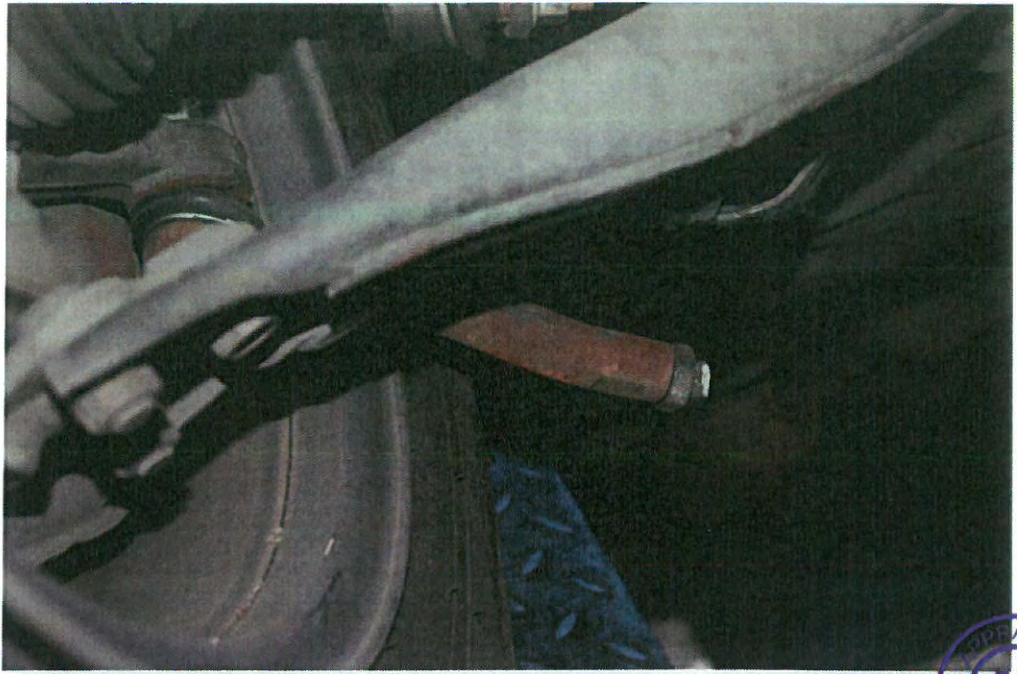
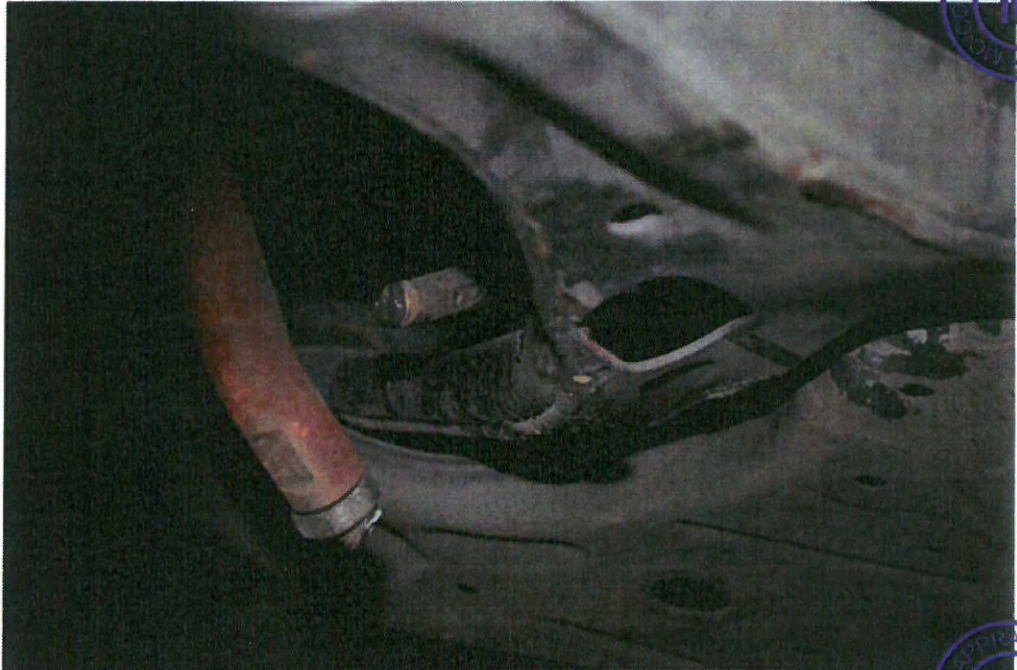
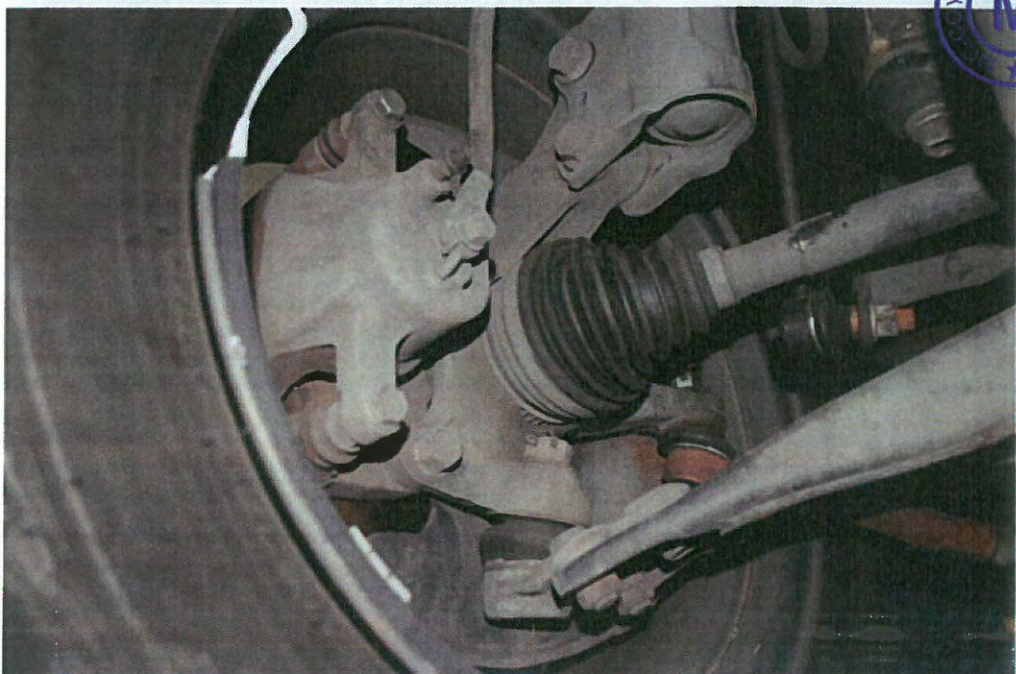
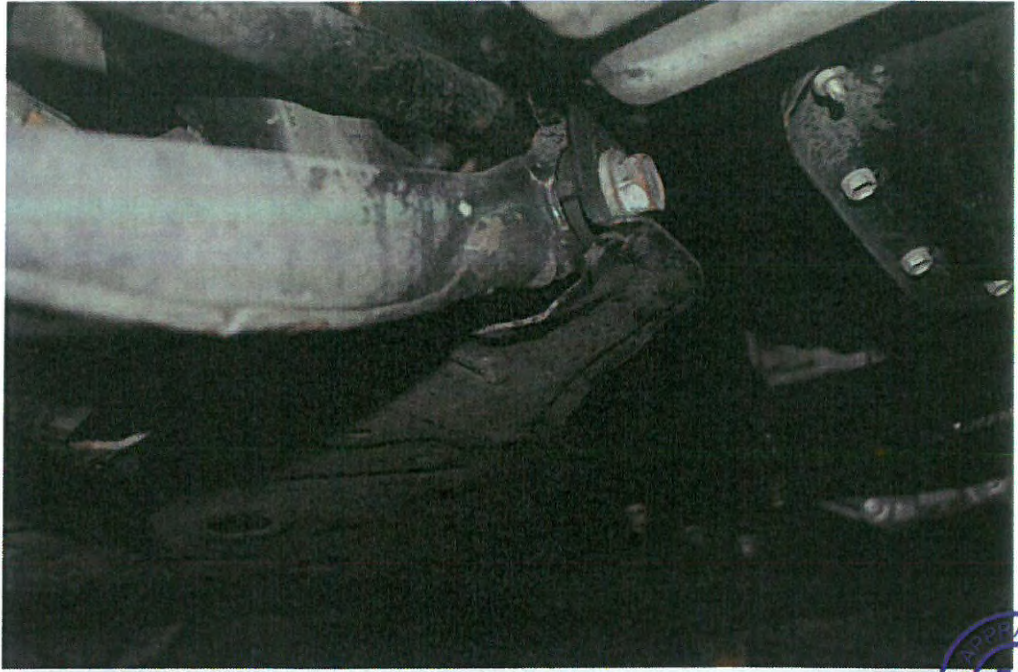
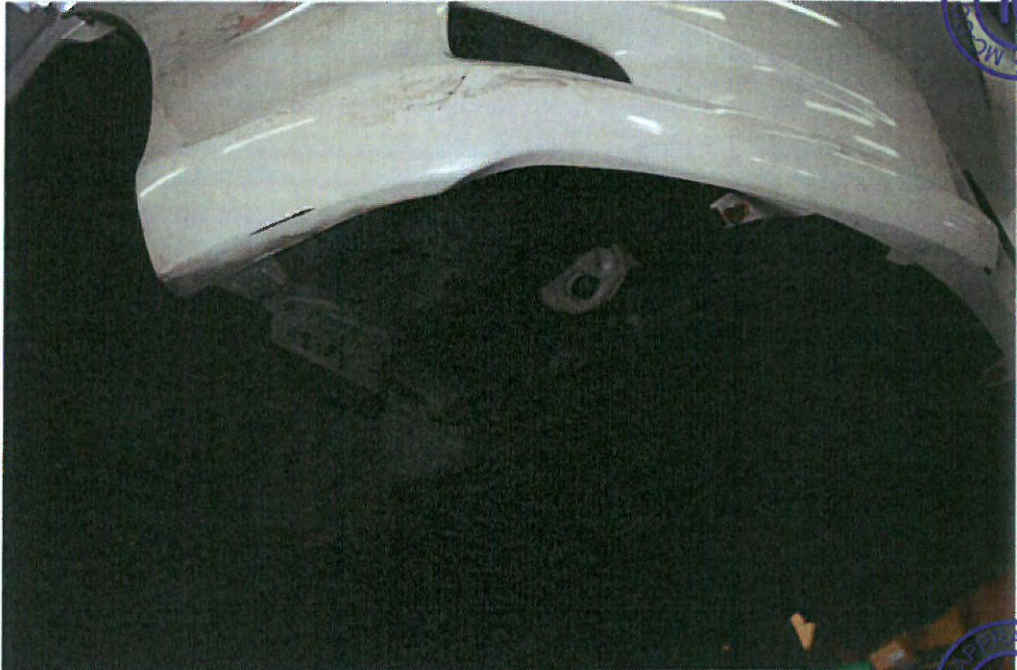
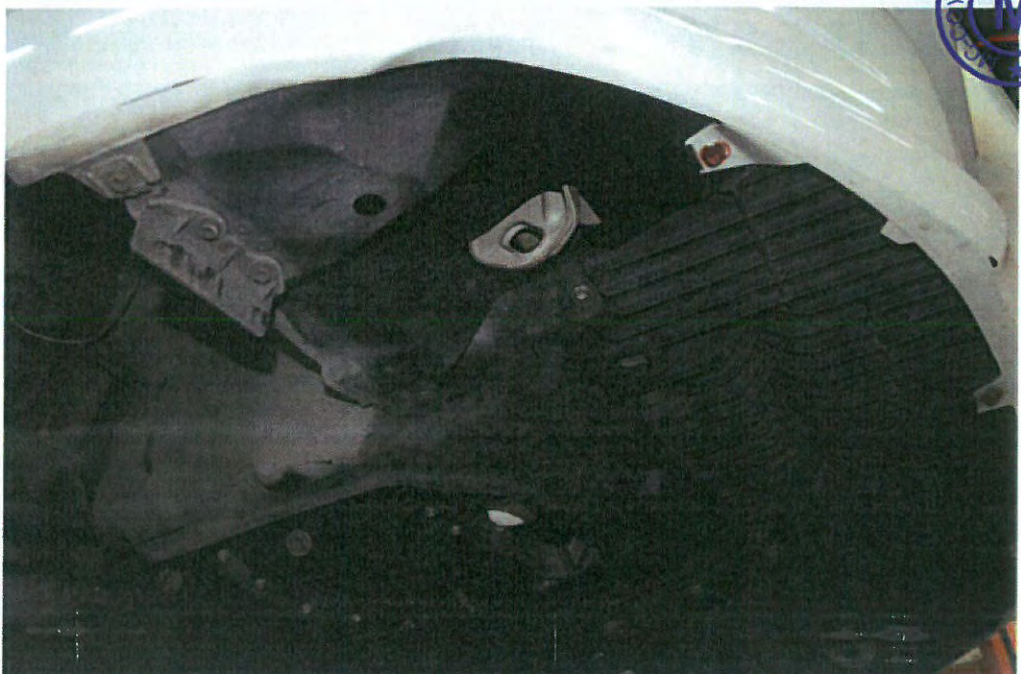
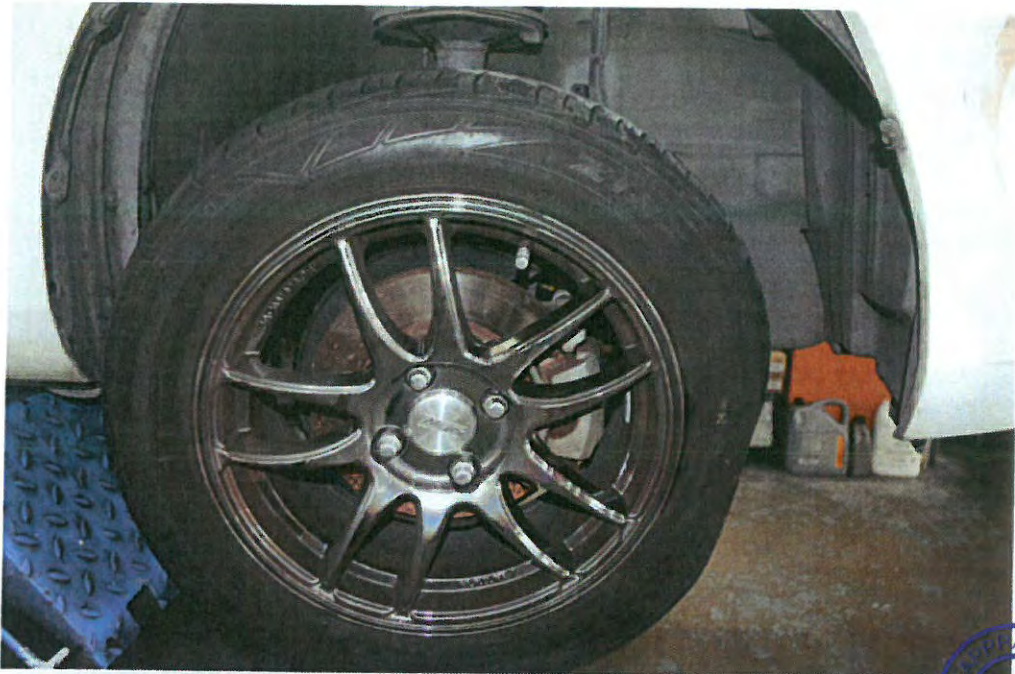
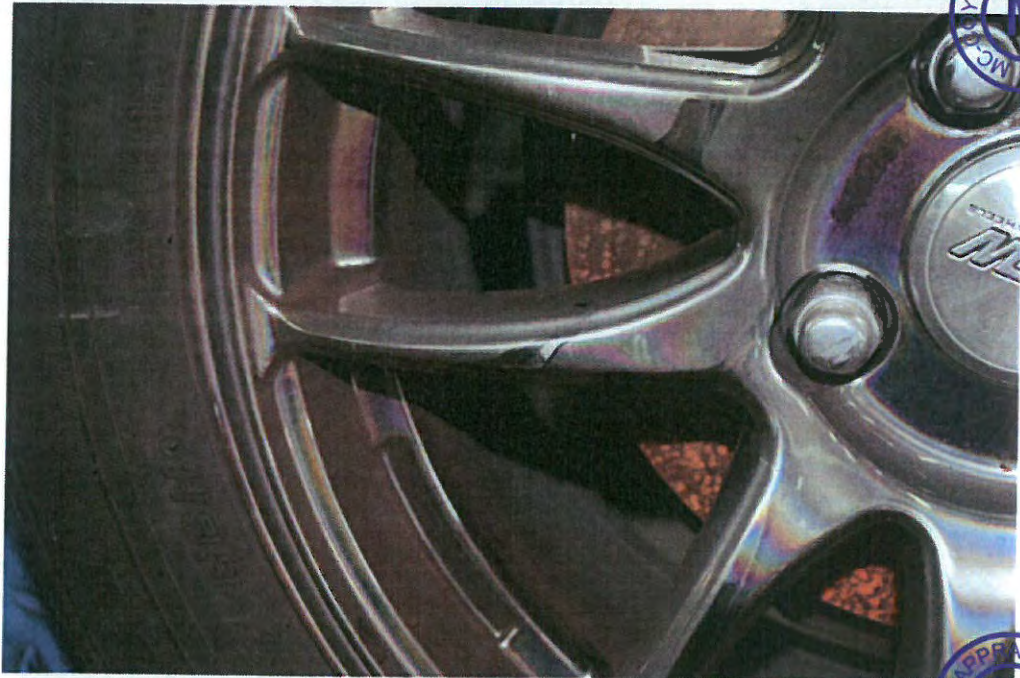
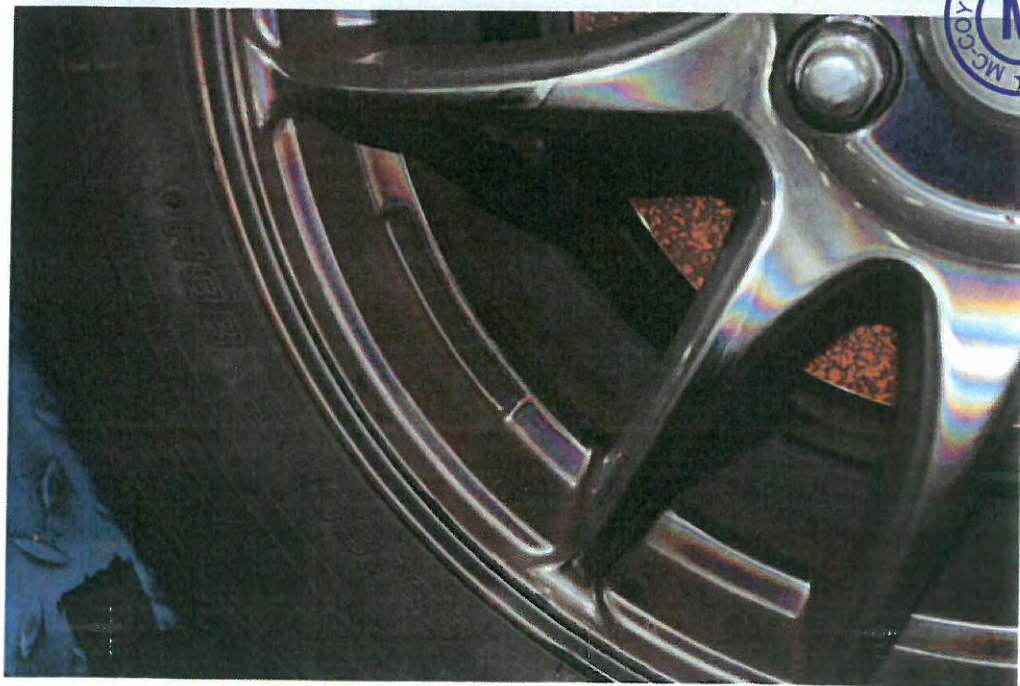
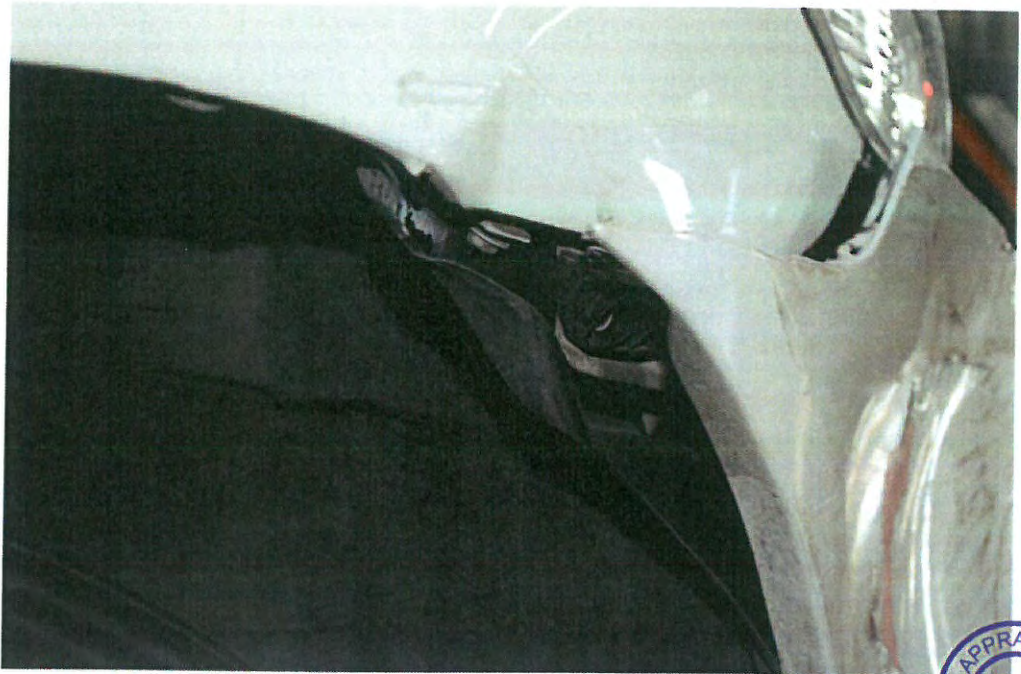
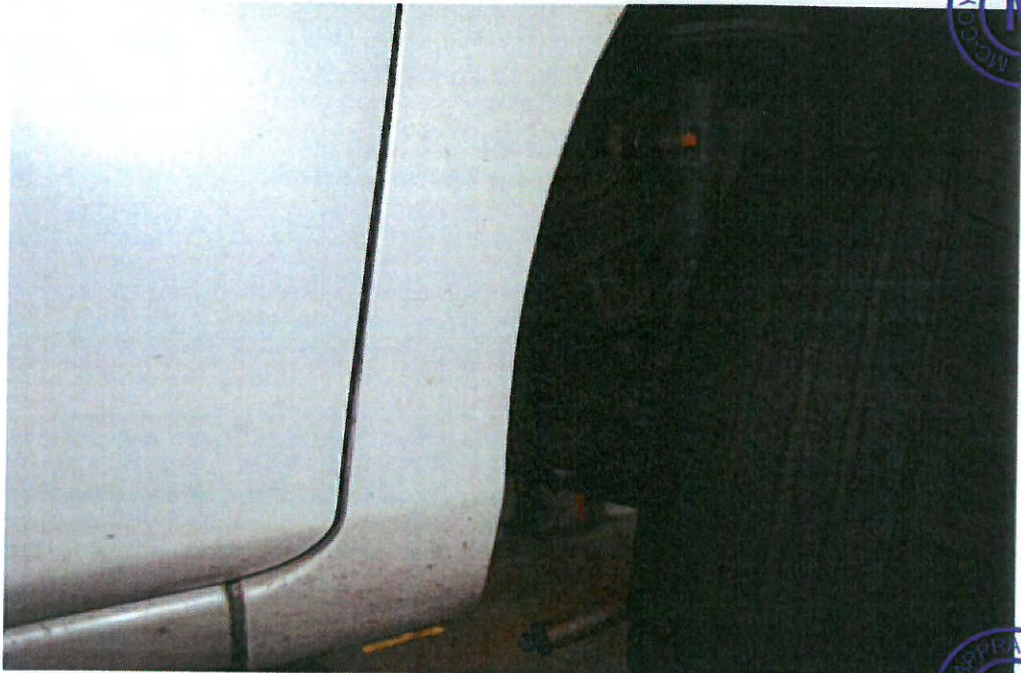
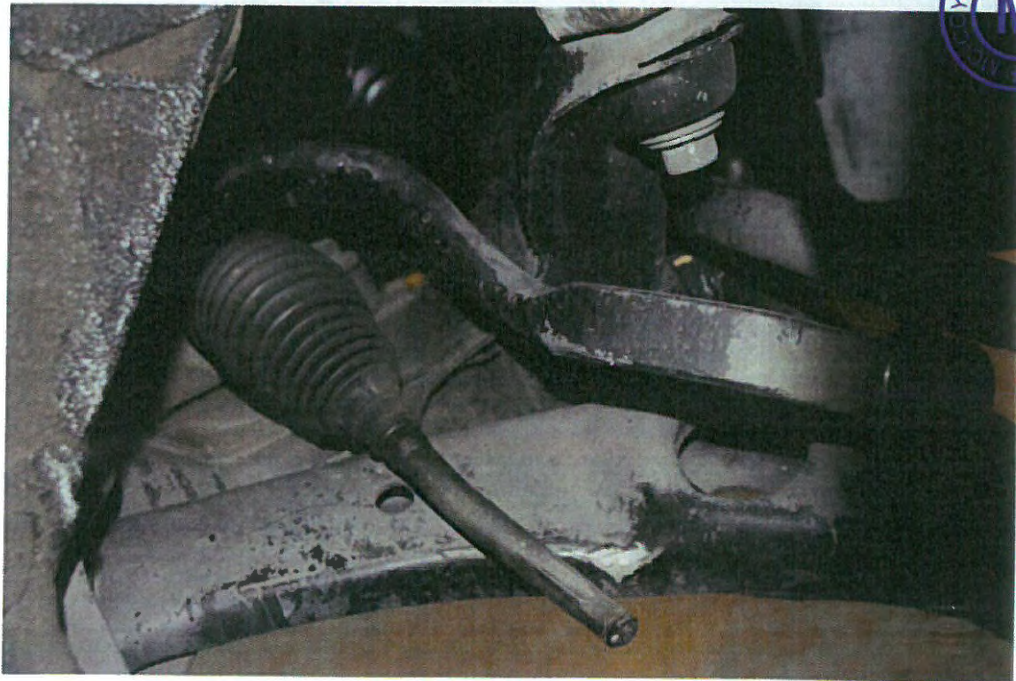
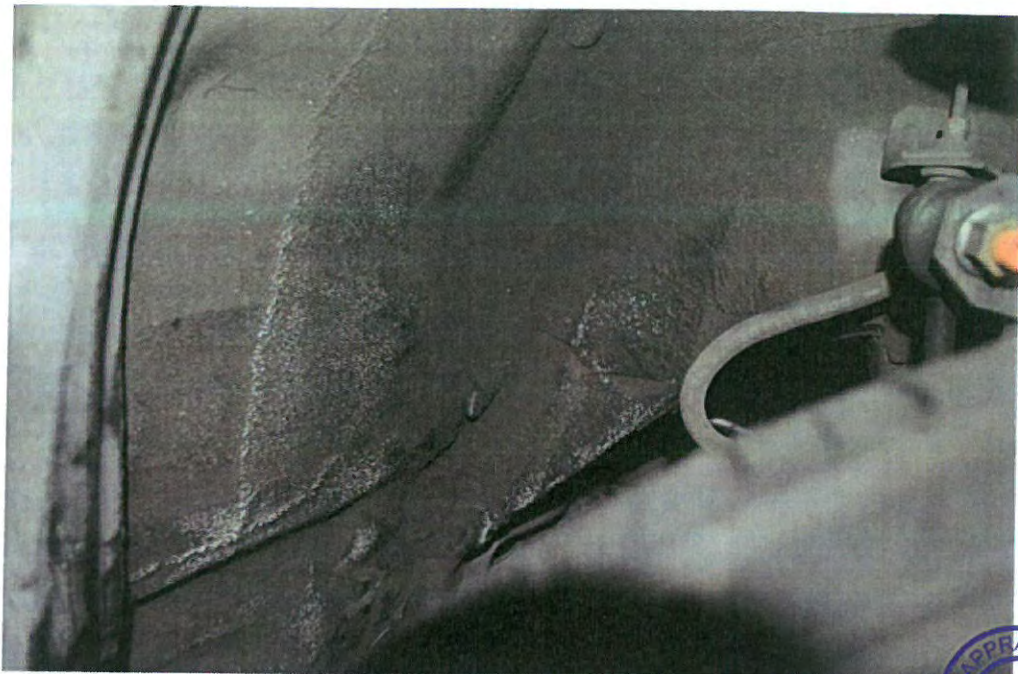
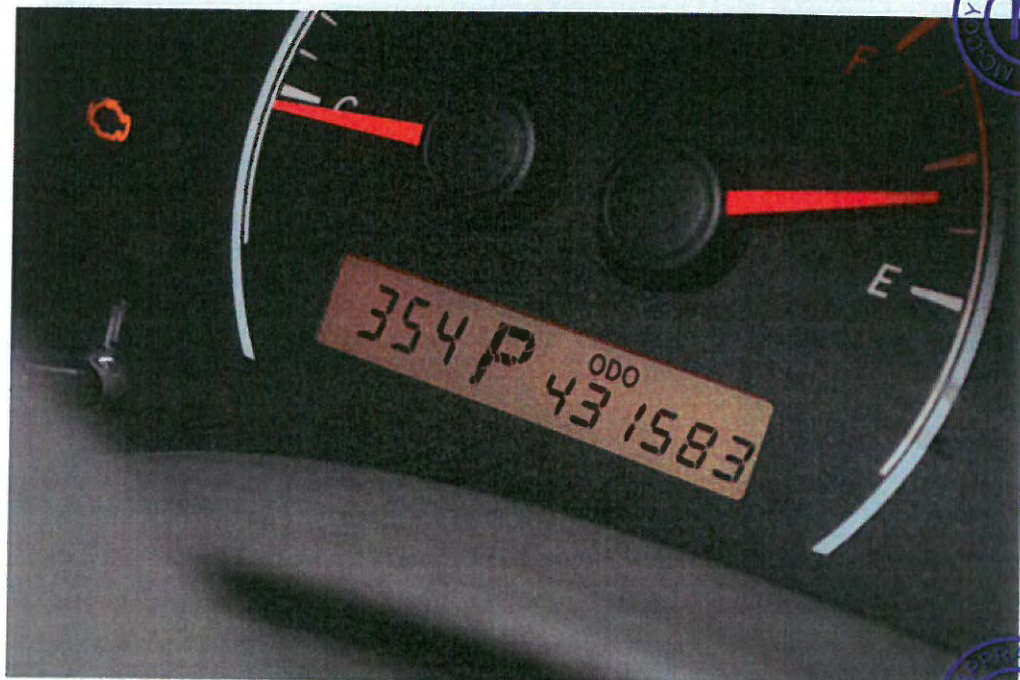
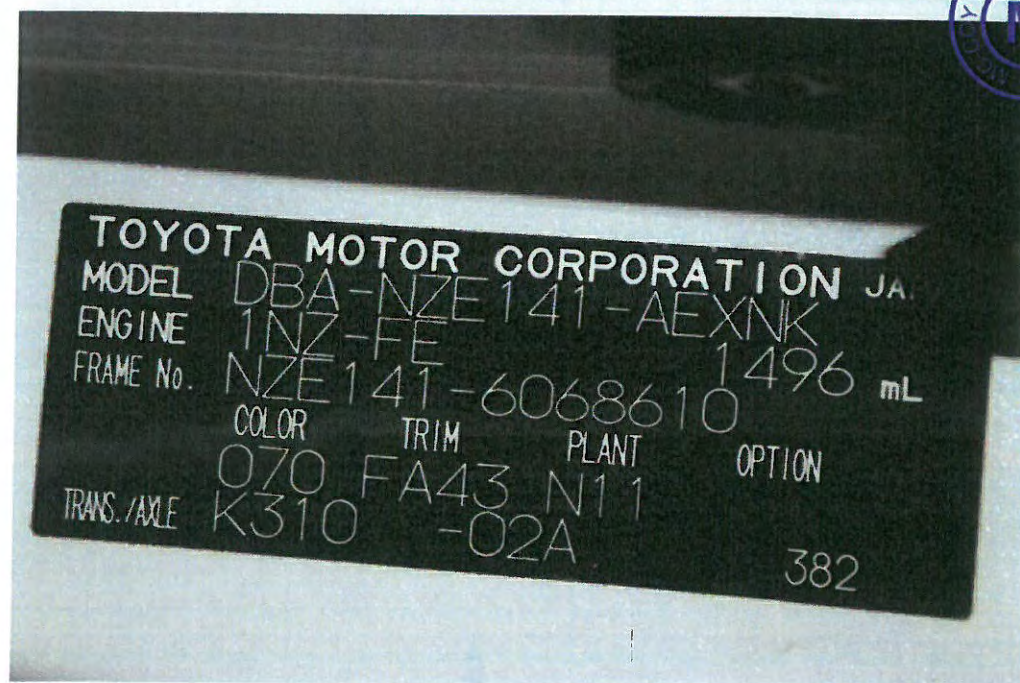
At the time of inspection, we noted that the vehicle has sustained an impact damages on the front o/s portion(s). For more detail of the damages, please see photograph attached.

4. Estimated normal period of repair : 8 working days to complete.
5. Enclosed number of photograph : 161 copies.
6. In accordance to your instruction, we have **Not Authorised** repair to the vehicle and the survey was done on a **"Without Prejudice"** basis. We hope that this report will be of assistance to you in dealing with the matter.
7. Should you discover any discrepancy in the report, please kindly notify us **within 2 weeks**, or the report will be treated as correct.
