Vehicle No. SLT 7520Y

Claim No. DM23HO00738/JS

#### ADJUSTMENT ON REPAIR COST FOR VEHICLE NO. SLT 7520Y

# PHOTOGRAPHS FOR VEHICLE NO. SLT 7520Y

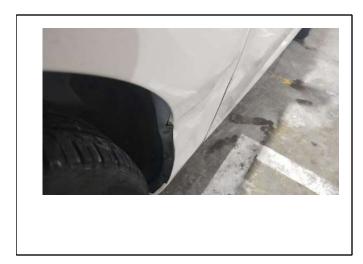
4.		•	on of Damages	
	THE VEHICLE SU	STAINED DAMAGES AT THE N/S	BODY.	
	DAMAGES SEE D	ETAILS.		
5.		General	Information	
	Accident Date	04/04/2023	Inspection Date	12/04/2023
	Survey held at	AKA AUTO PTE LTD		
		25 KAKI BUKIT ROAD 4, #05-36	, SYNERGY @ KB, SINGA	APORE 417800
5a.		Re	emarks	
		ON WAS CONDUCTED ON A"WIT CE TO YOUR INSTRUCTIONS, W		
5b.		Estimate	Days of Repair	
	ESTIMATED NOR	MAL PERIOD FOR REPAIR:	3 Work	ing Days

Qty	Description of Parts	Condition	Estimate By Workshop (\$))	Our Adjusted (\$)
	REPLACEMENT OF PARTS			
1	FRONT LH FENDER	DENTED	786.00	786.00
1	FRONT LH FENDER INNER SHIELD	DEFORMED	201.00	201.00
1	FRONT LH DOOR	TO REPAIR SEE LABOUR	1,298.00	-
1	FRONT LH DOOR WEATHERSTRIPE	NOT NECESSARY	142.00	-
1	FRONT LH WHEEL RIM	NOT NECESSARY	1,258.00	-
	LESS 5% DISCOUNT		-184.25	-49.35
			3,500.75	937.65
	SPECIAL NETT ITEMS			
1	FRONT LH FENDER INNER SHIELD CLIPS (SN)	NECESSARY	30.00	30.00

30.00	30.00
	<u>LABOUR</u>			
	PANEL BEATING. INCLUSIVE OF THE REPAIR OF FRONT LH DOOR.		600.00	400.00
	SPRAY PAINTING.		800.00	500.00
	WIRING.		50.00	30.00
	TO APPLY TUFF COAT.		100.00	30.00
	TO TRANSFER DOOR FITTINGS.	NOT NECESSARY	150.00	-
	TO PERFORM WHEEL ALIGNMENT.	NOT NECESSARY	150.00	-
	TO APPLY CERAMIC COATING.	NOT NECESSARY	680.00	
			2,530.00	960.00
	GRAND TOTAL		6,060.75	1,927.65
	RECOMMENDED COST OF LUMP SUM REPAIRS			1,500.00

RECOMMENDED COST OF LUMP SUM REPAIRS (TO ITS PRE-ACCIDENT CONDITION) 1,500.00
