# ONG BENG PHENG, (OWNER OF SMS 6116G) ACCIDENT ON 15 FEBRUARY 2023 INVOLVING SMS 6116G AND GBK 3920T AT 851A MULTI STOREY CARPARK LEVEL 5

#### ACCIDENT DAMAGED VEHICLE INSPECTION REPORT

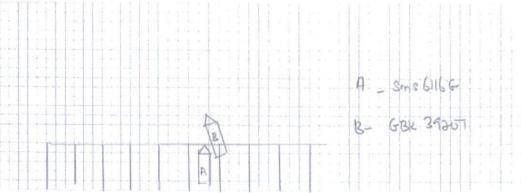
Sketch Plan

PARKING LOW

Describe Circumstances of the	ne Accident	
0.0	e Report. 7/20220216/2001.	
150+20 -40 DOJK	e 100pm. 1120236516 12001.	
Ail )		1 - 0
Tro party a	dmitted and written a note atta	eres.
TI claime GUAN ATT.	Marie (A)	
11 comp GRILLY HALL	SERVICE ST	
West-Marie Co. (1997)		
······································		
Declaration		
VWe declare the foregoing particula	rs are true in every respect	
The second and toregoing particular		X
(na)	(ACB)	(2)
X ST	a	
(2)	7	King ( )
Policyholder's Signature / Date & Time	Driver's Signature (# driver is not the policyholder) / Date & Timo	Witnessed by Reporting Centre Personnel
	141

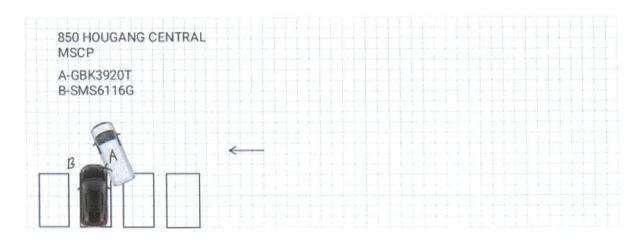
Sketch Plan

scribe Circumstances of the		
REFER TO POLICE REPO	RT NO T/20230216/2034	
Declaration		
IWe declare the foregoing particula	rs are true in every respect	
	(\	FLASH ACCIDENT
	1 hm	REPORTING OFFICER
	Allo	FRO ZIKRUL
Policyholder's Signature / Cate & Time	Driver's Signature (if driver is not the policyholder) / Date & Time 17/02/23 1330HRS	Witnessed by Reporting Centre Personnel
