Your Ref: Mitsubishi Engine
(number 4G63LA9851)
Our Ref : CI/TP23005034/D

INSPECTION REPORT OF A MITSUBISHI ENGINE WITH NUMBER 4G63LA9851

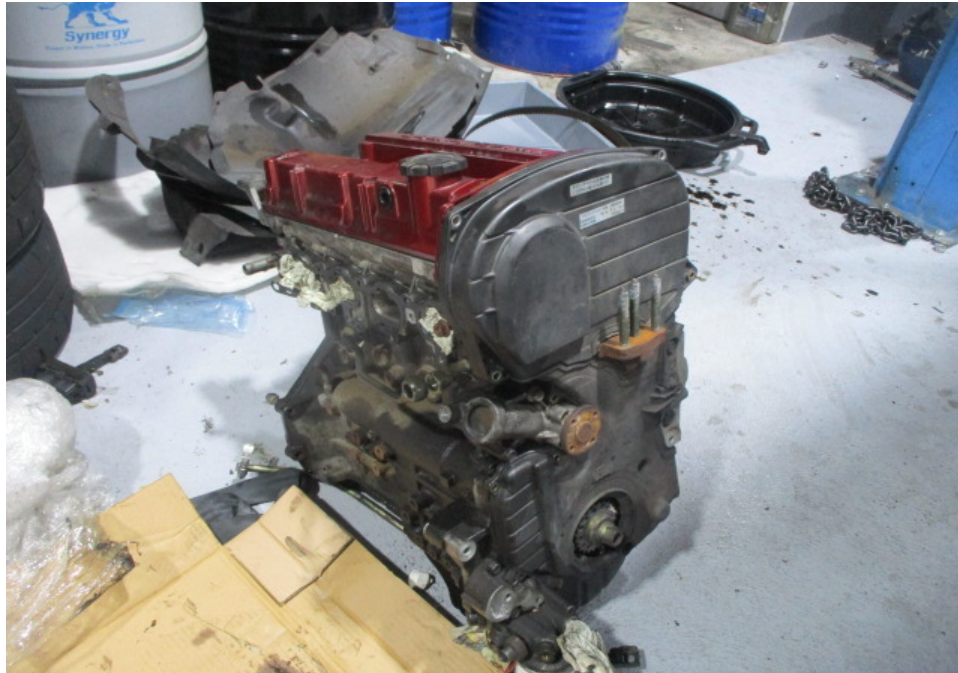
Photo 1 shows a general view of the Mitsubishi engine that I had inspected. The Mitsubishi engine was observed to be a used engine and was not fitted on any motor car. It was also observed to be a complete assembly with all mechanical parts still intact, within the engine housing.

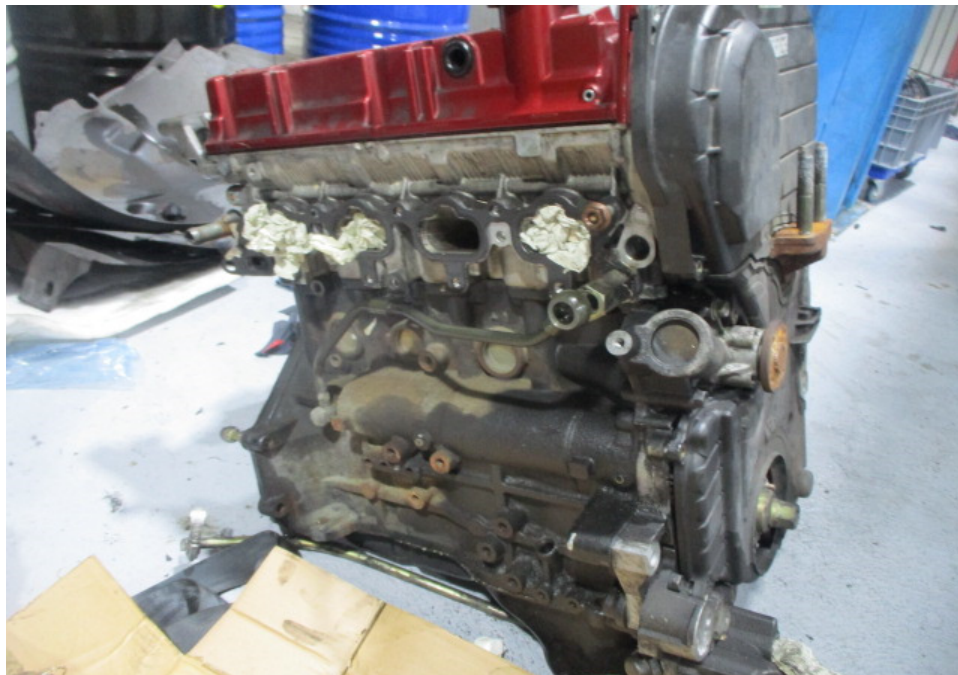
Photo 2 shows a general view of the Mitsubishi engine that I had inspected. My visual examination of the engine housing revealed the housing to be of serviceable/satisfactory condition. There was no crack and/or hole observed on the engine housing.

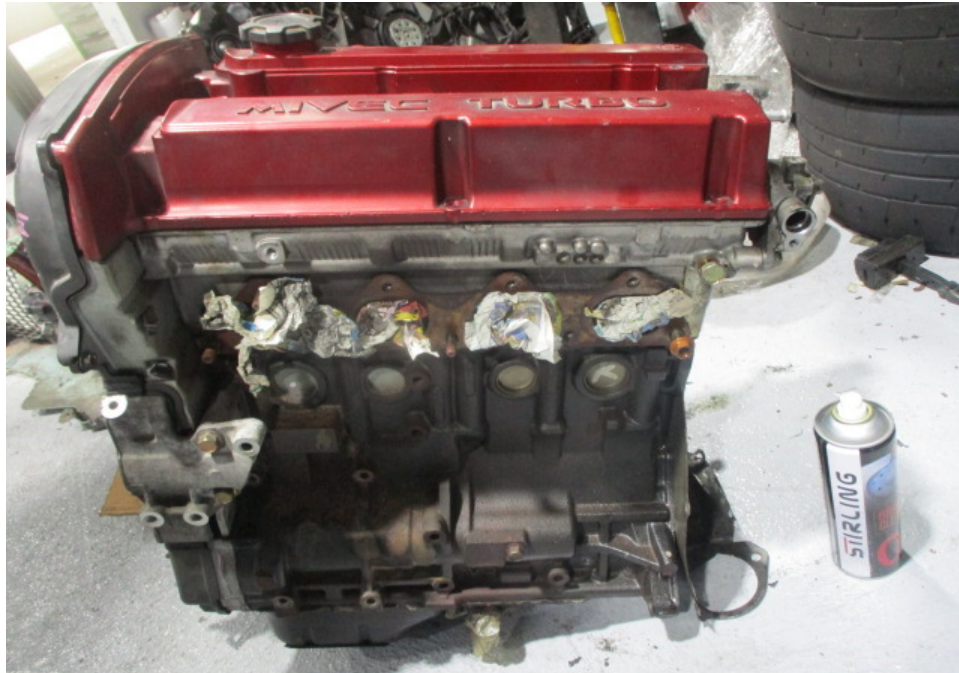
Photo 3 shows a general view of the Mitsubishi engine that I had inspected. My visual examination of the engine housing revealed the housing to be of serviceable/satisfactory condition. There was no crack and/or hole observed on the engine housing.

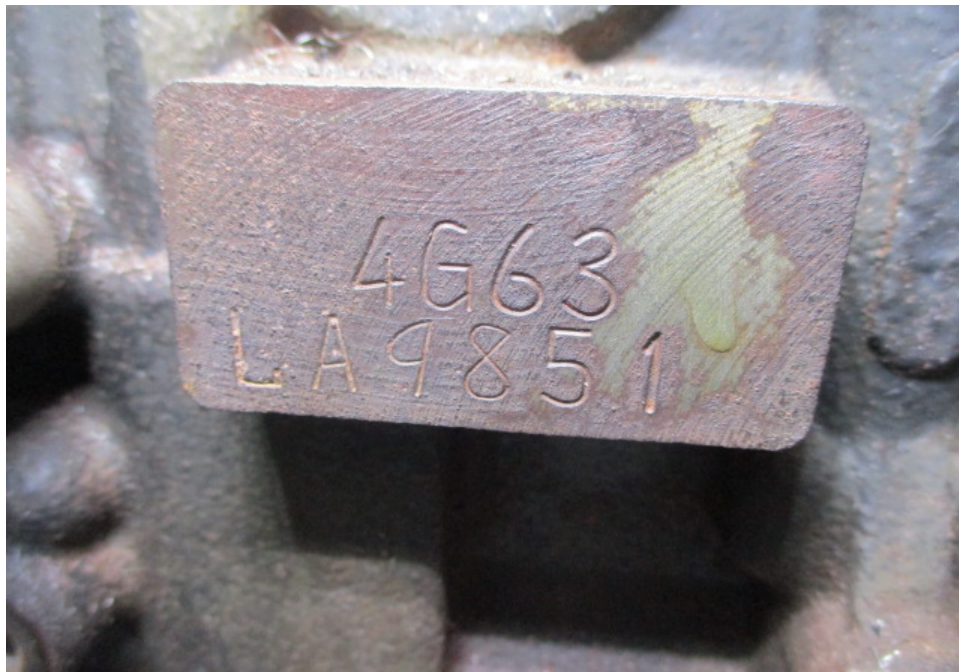
Photo 4 shows the engine number engraved on the housing of the Mitsubishi engine that I had inspected. The engine number was 4G63LA9851.

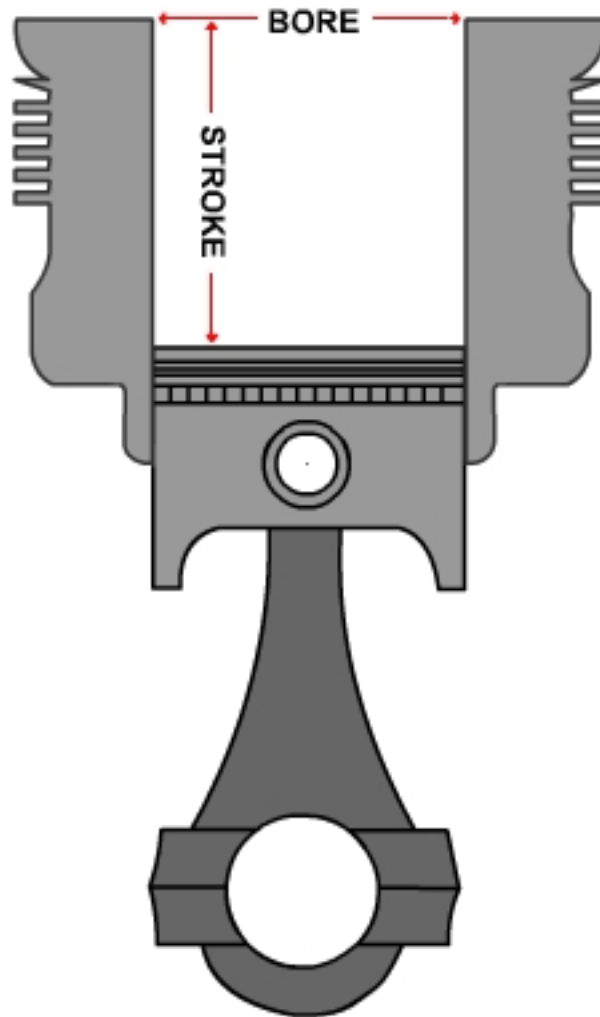
9. The bore refers to the measurement of the inside diameter of the cylinder while the stroke refers to the distance the piston moves in one direction of upward or downward movement in the cylinder. See diagram below for illustration purposes.

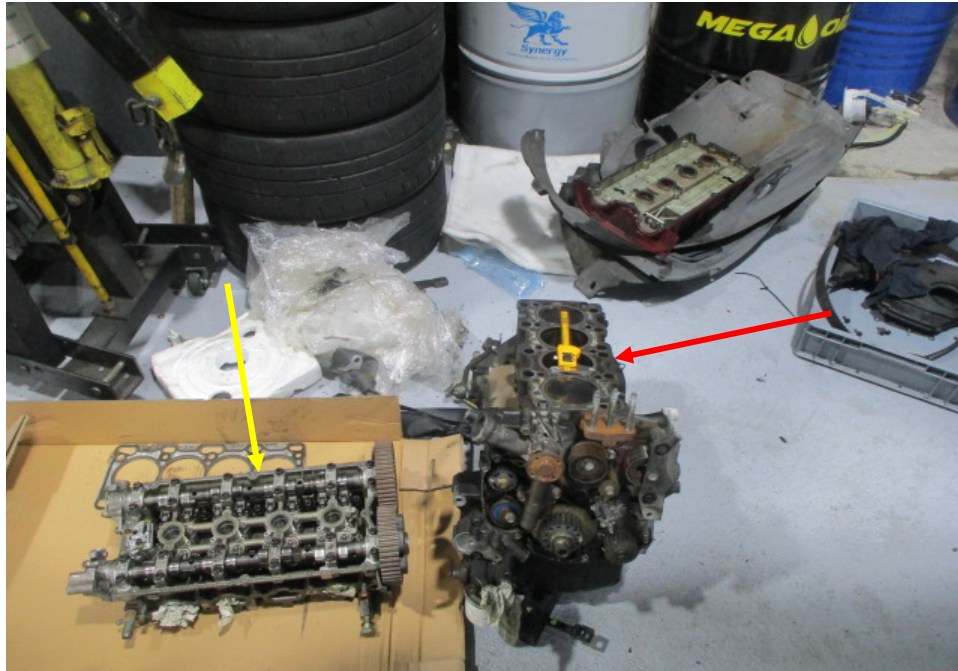
Photo 5 shows the top block (yellow arrow) of the Mitsubishi engine separated from its bottom block (red arrow). This was to enable me to carry out measurements of its cylinders, in particular the bore and stroke measurements of each cylinder, which typically can be used to determine the engine displacement or more commonly referred to as engine cc.

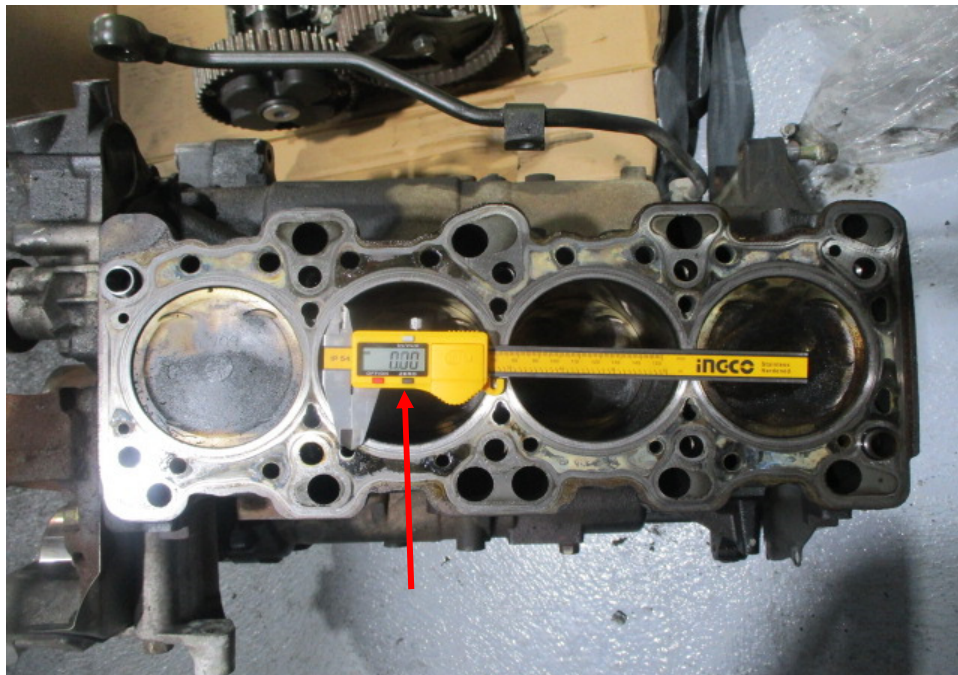
Photo 6 shows the bottom block of the Mitsubishi engine and the digital Vernier Caliper (arrowed) that was used to measure the bore and stroke measurements of each cylinder, which typically can be used to determine the engine displacement or more commonly referred to as engine cc. The digital Vernier Caliper was calibrated before the start of the measurements.

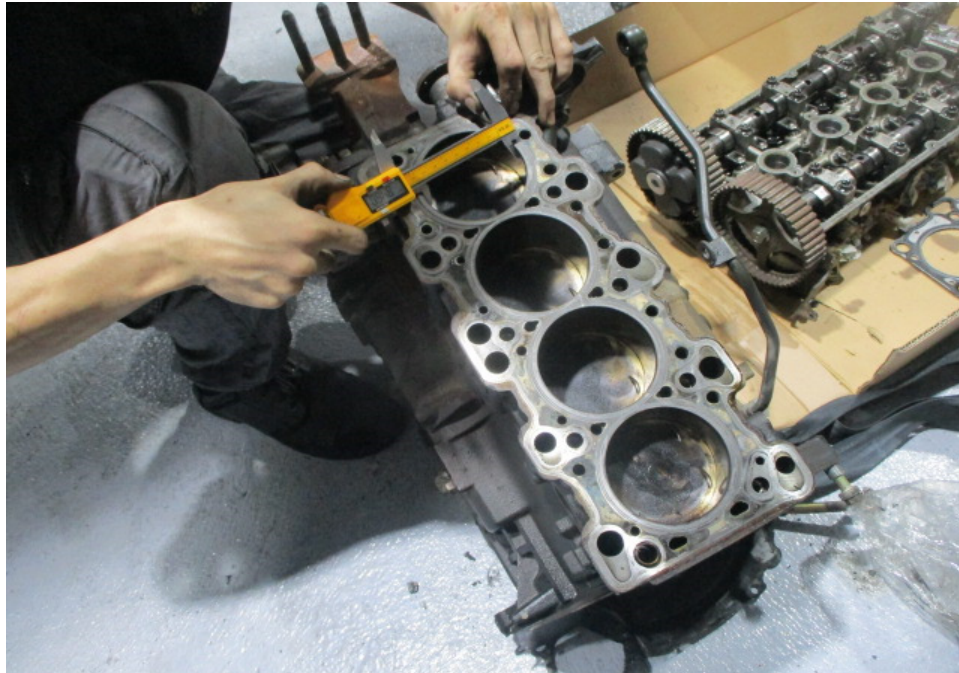
Photo 7 shows measurement being carried out to the bore of cylinder 1 of the Mitsubishi engine. The bore and stroke measurements of the Mitsubishi engine were carried out using a digital Vernier Caliper that was calibrated before the start of the measurements.

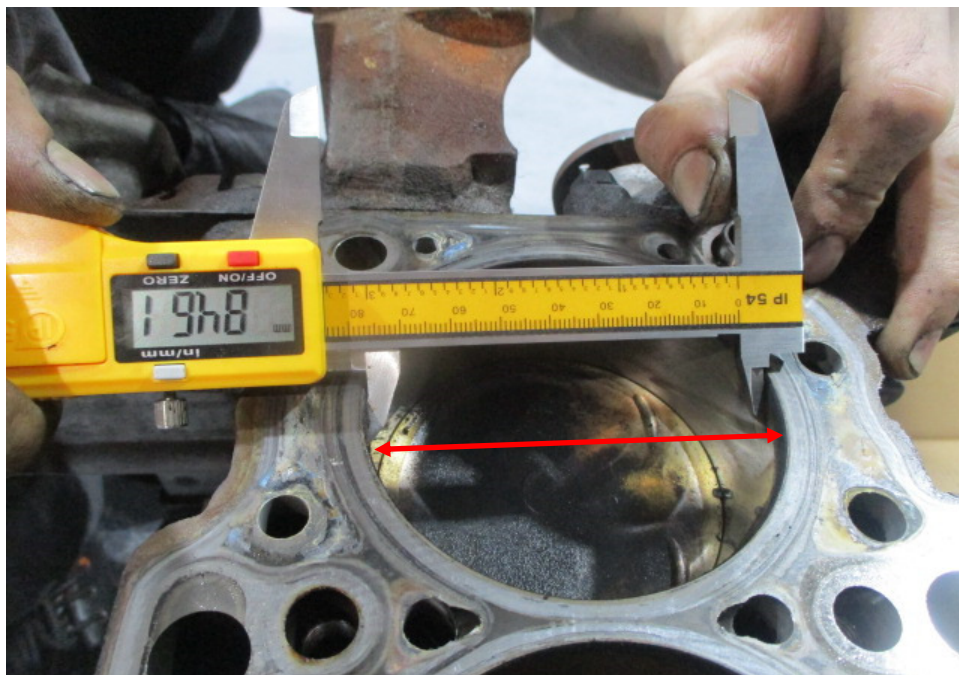
Photo 8 shows measurement being carried out to the bore (arrowed) of cylinder 1 of the Mitsubishi engine. The bore measurement of cylinder 1 was recorded to be 84.61 mm.

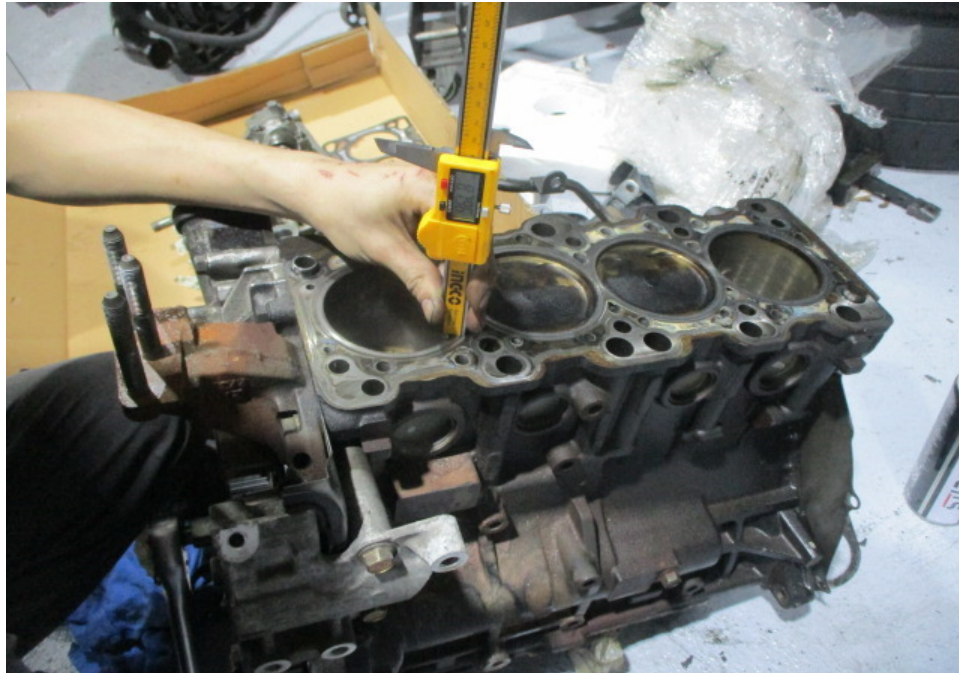
Photo 9 shows measurement being carried out to the stroke of cylinder 1 of the Mitsubishi engine. The bore and stroke measurements of the Mitsubishi engine were carried out using a digital Vernier Caliper that was calibrated before the start of the measurements.

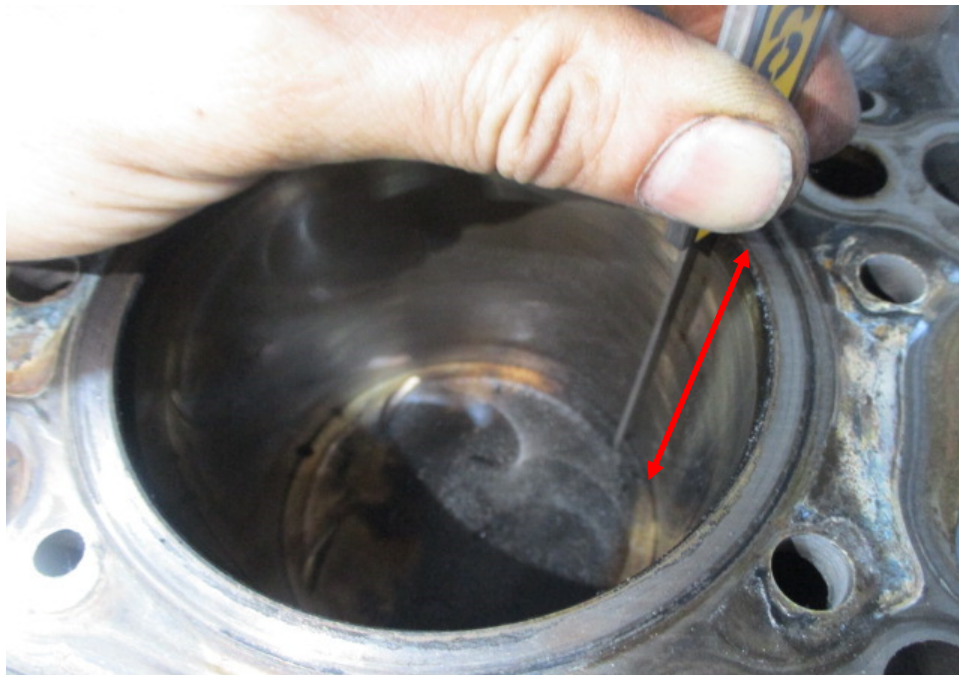
Photo 10 shows measurement being carried out to the stroke (arrowed) of cylinder 1 of the Mitsubishi engine. The bore and stroke measurements of the Mitsubishi engine were carried out using a digital Vernier Caliper that was calibrated before the start of the measurements.

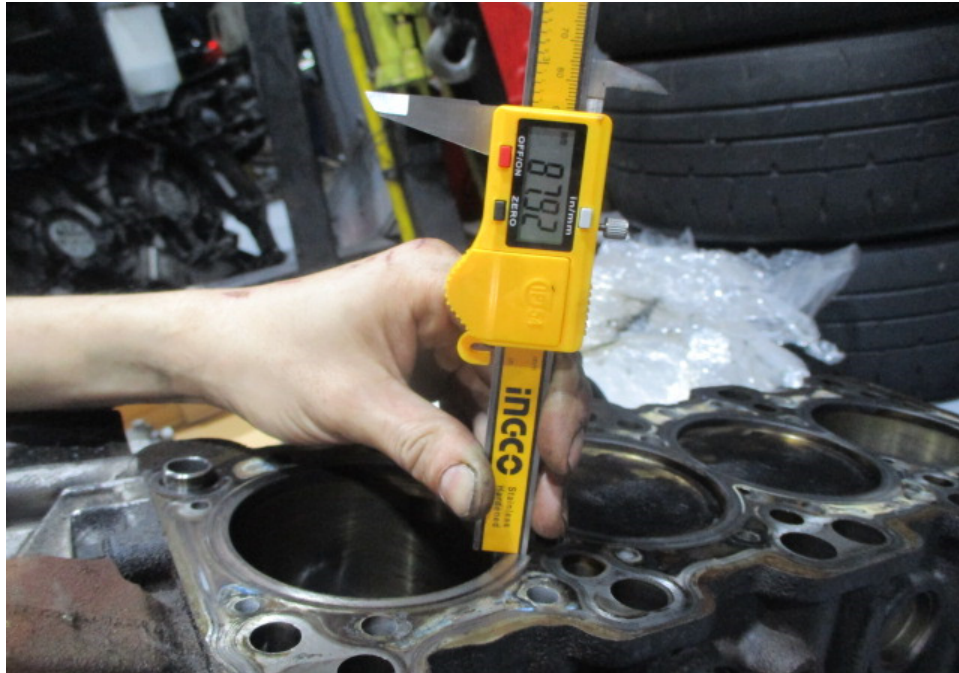
Photo 11 shows the stroke measurement of cylinder 1, which was recorded to be 87.92mm.

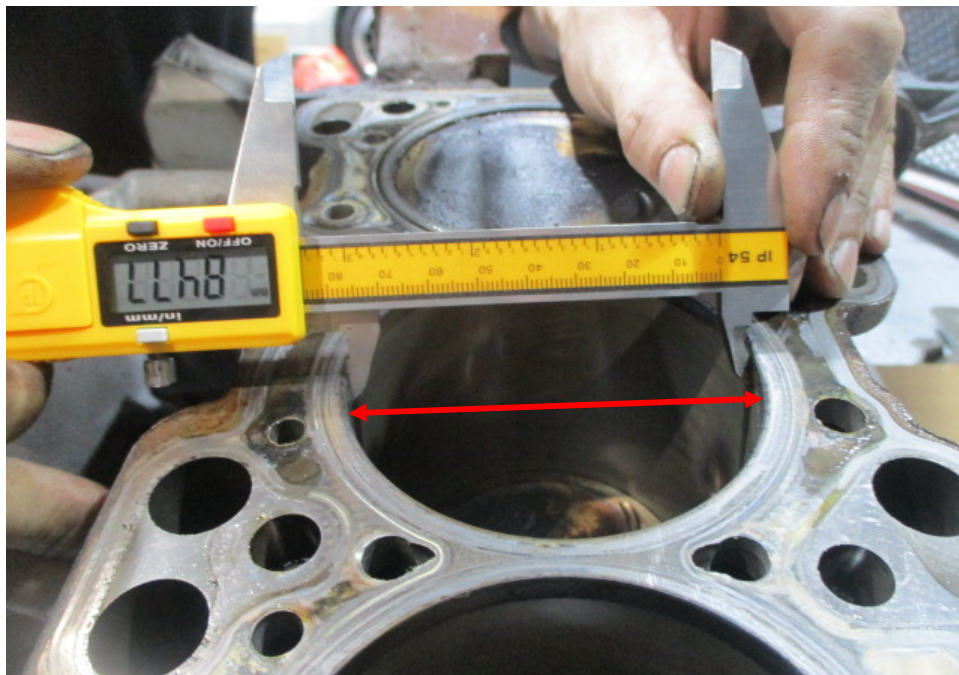
Photo 12 shows measurement being carried out to the bore (arrowed) of cylinder 2 of the Mitsubishi engine. The bore measurement of cylinder 2 was recorded to be 84.77mm.

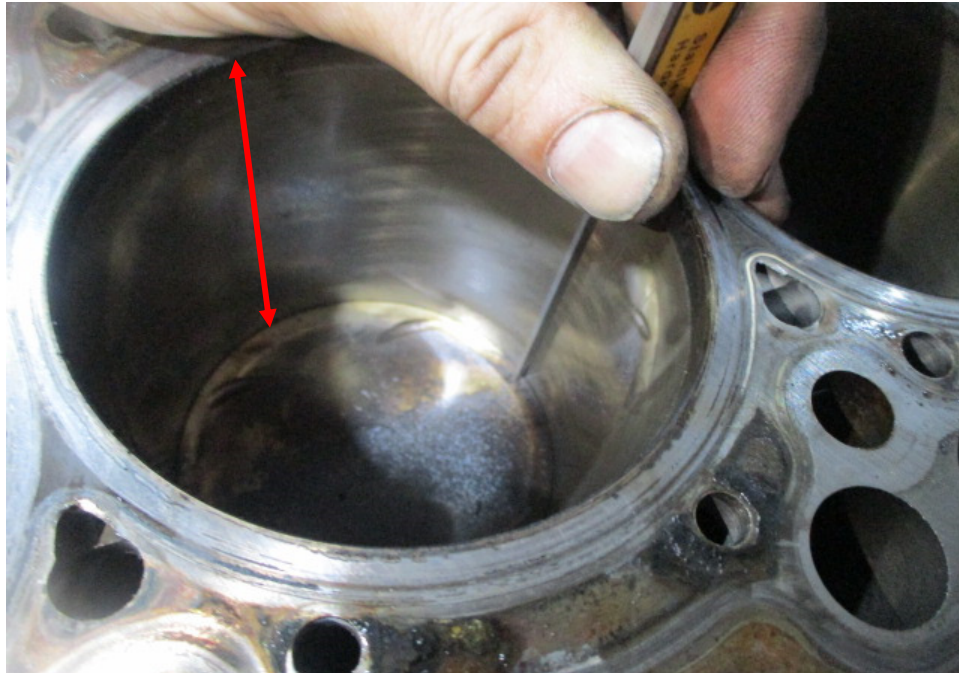
Photo 13 shows measurement being carried out to the stroke (arrowed) of cylinder 2 of the Mitsubishi engine. The bore and stroke measurements of the Mitsubishi engine were carried out using a digital Vernier Caliper that was calibrated before the start of the measurements.

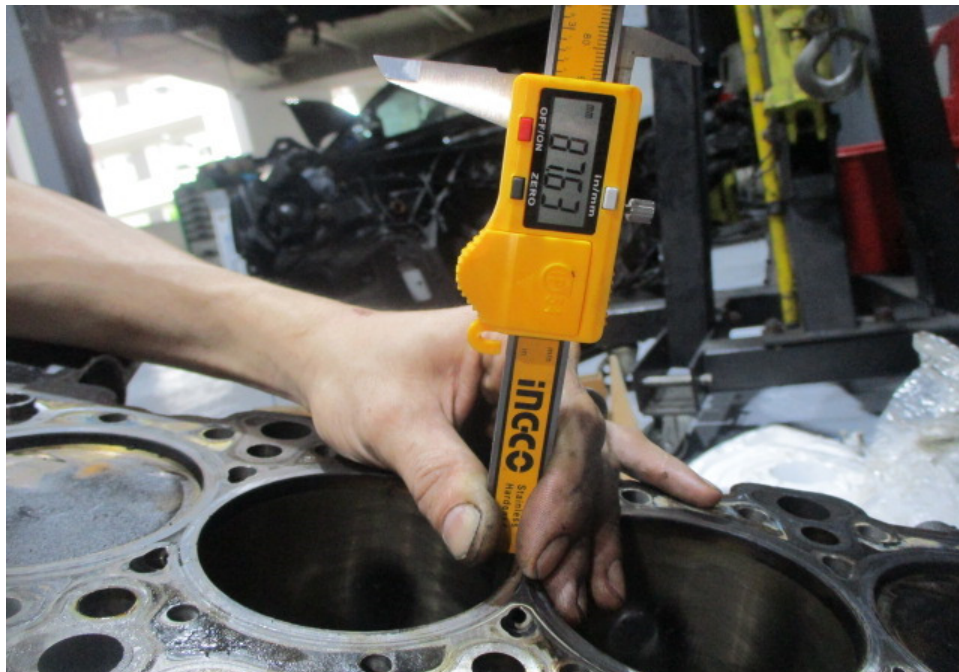
Photo 14 shows the stroke measurement of cylinder 2, which was recorded to be 87.63mm.

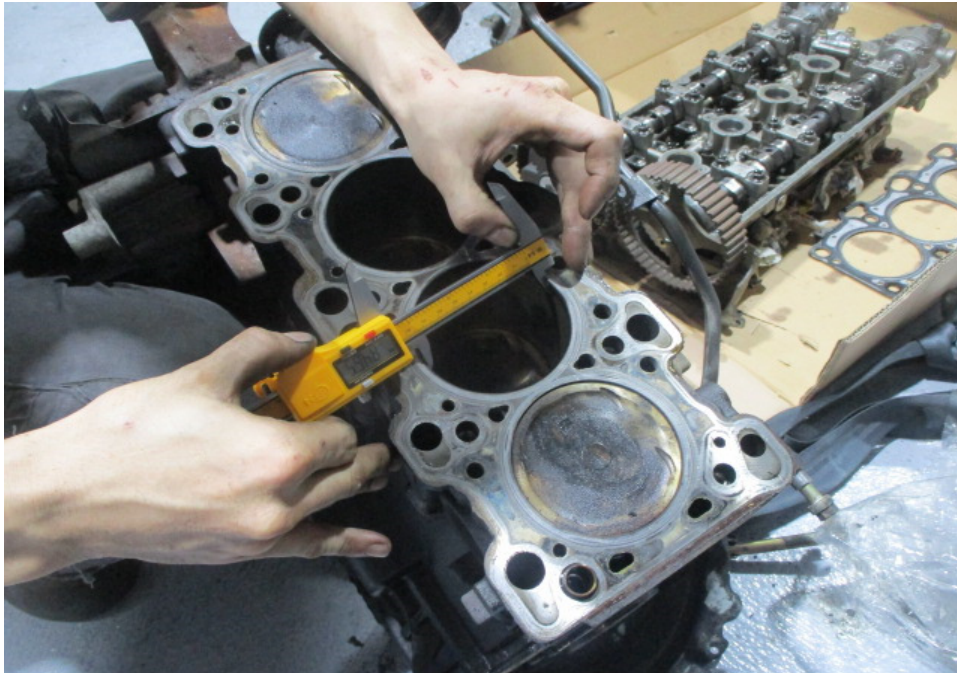
Photo 15 shows measurement being carried out to the bore of cylinder 3 of the Mitsubishi engine. The bore and stroke measurements of the Mitsubishi engine were carried out using a digital Vernier Caliper that was calibrated before the start of the measurements.

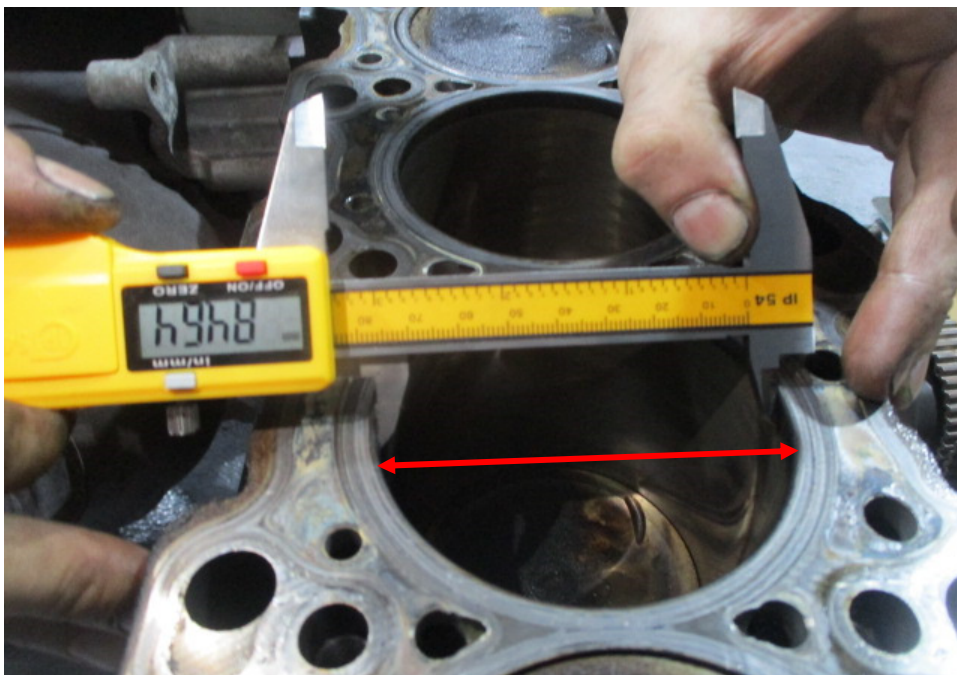
Photo 16 shows measurement being carried out to the bore (arrowed) of cylinder 3 of the Mitsubishi engine. The bore measurement of cylinder 3 was recorded to be 84.64mm.

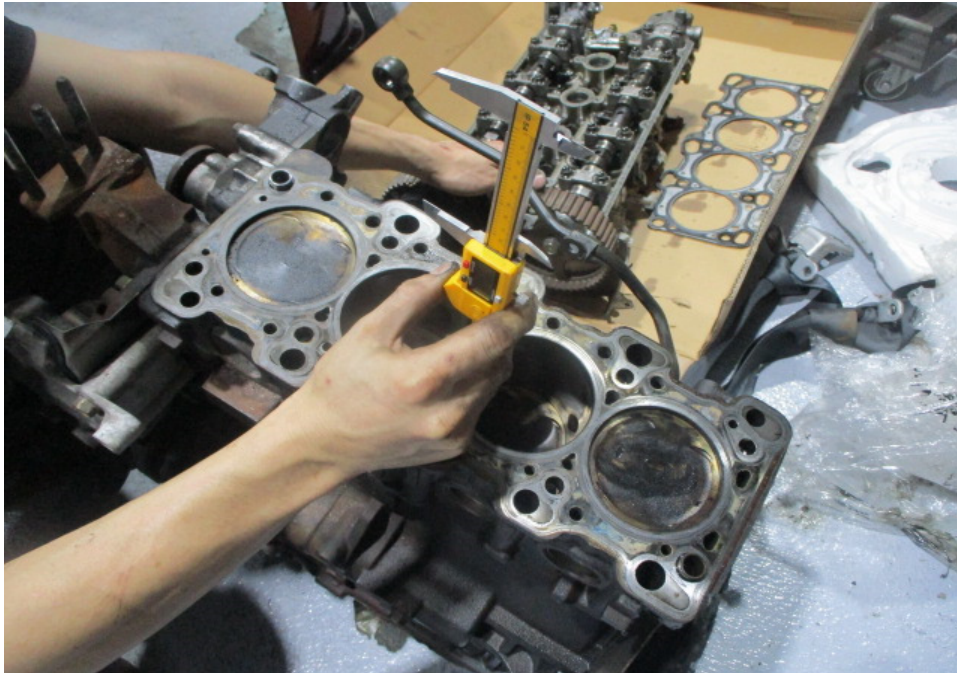
Photo 17 shows measurement of the stroke of cylinder 3 of the Mitsubishi engine that I had inspected. The bore and stroke measurements of the Mitsubishi engine were carried out using a digital Vernier Caliper that was calibrated before the start of measurements.

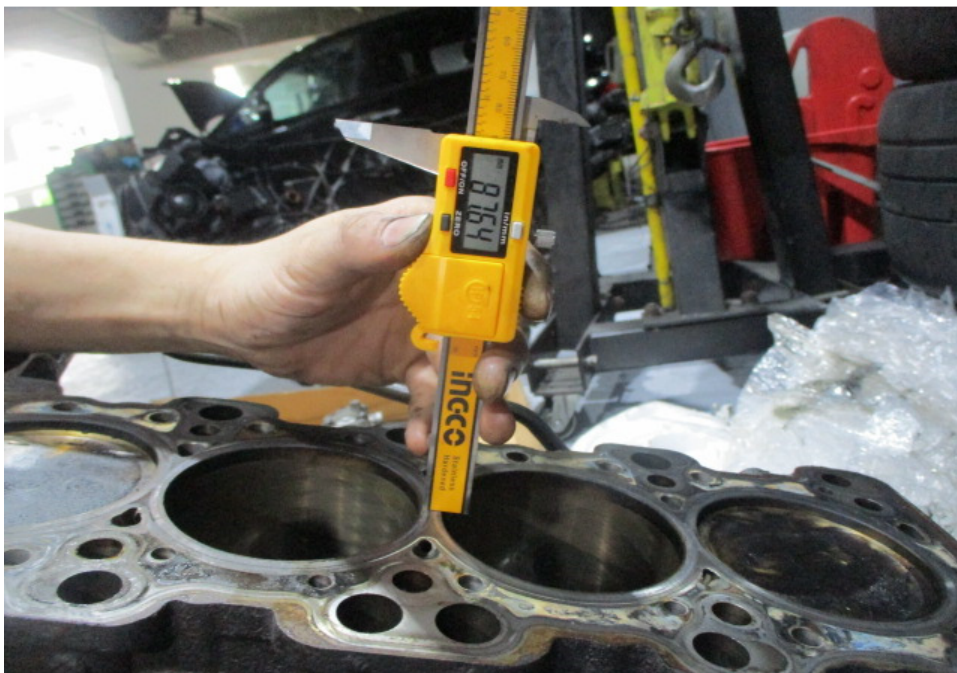
Photo 18 shows the stroke measurement of cylinder 3, which was recorded to be 87.64mm.

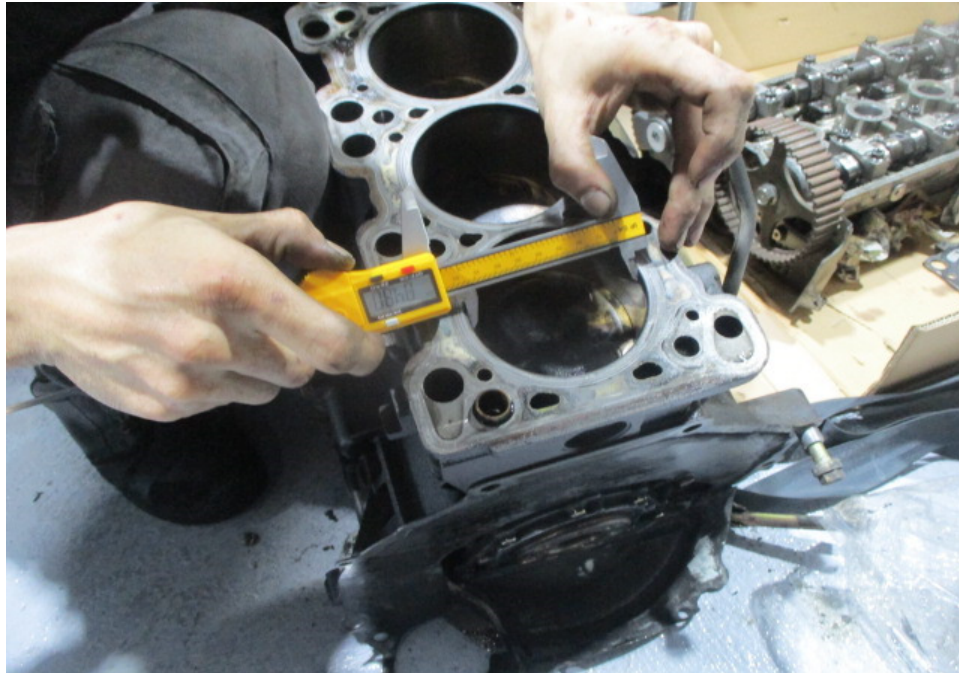
Photo 19 shows measurement being carried out to the bore of cylinder 4 of the Mitsubishi engine. The bore and stroke measurements of the Mitsubishi engine were carried out using a digital Vernier Caliper that was calibrated before the start of the measurements.

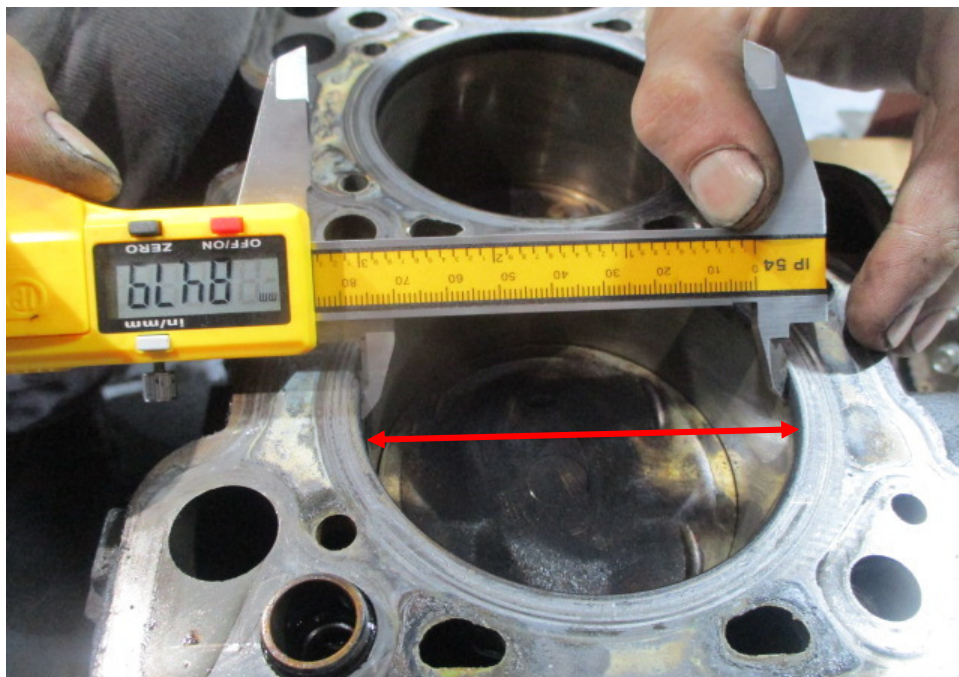
Photo 20 shows measurement being carried out to the bore (arrowed) of cylinder 4 of the Mitsubishi engine. The bore measurement of cylinder 4 was recorded to be 84.79mm.

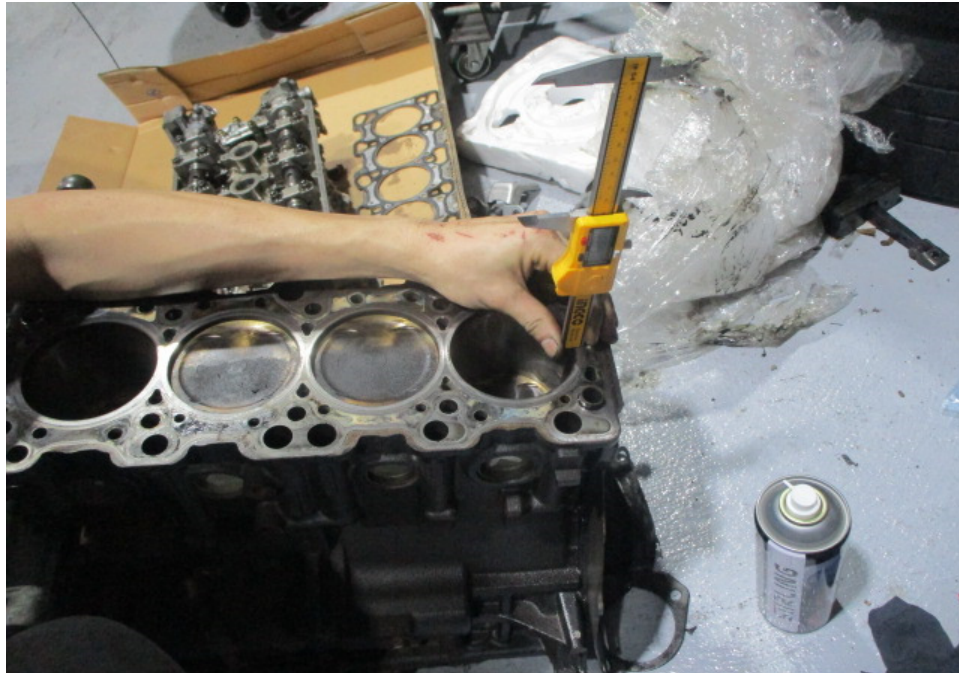
Photo 21 shows measurement of the stroke of cylinder 4 of the Mitsubishi engine that I had inspected. The bore and stroke measurements of the Mitsubishi engine were carried out using a digital Vernier Caliper that was calibrated before the start of measurements.

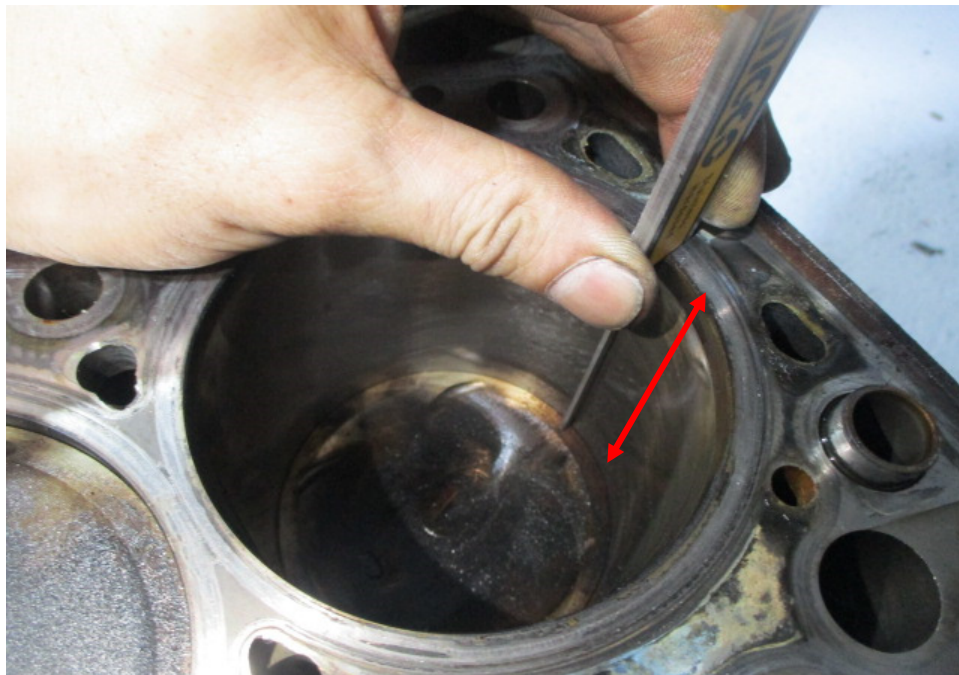
Photo 22 shows measurement being carried out to the stroke (arrowed) of cylinder 4 of the Mitsubishi engine. The bore and stroke measurements of the Mitsubishi engine were carried out using a digital Vernier Caliper that was calibrated prior to the start of measurements.

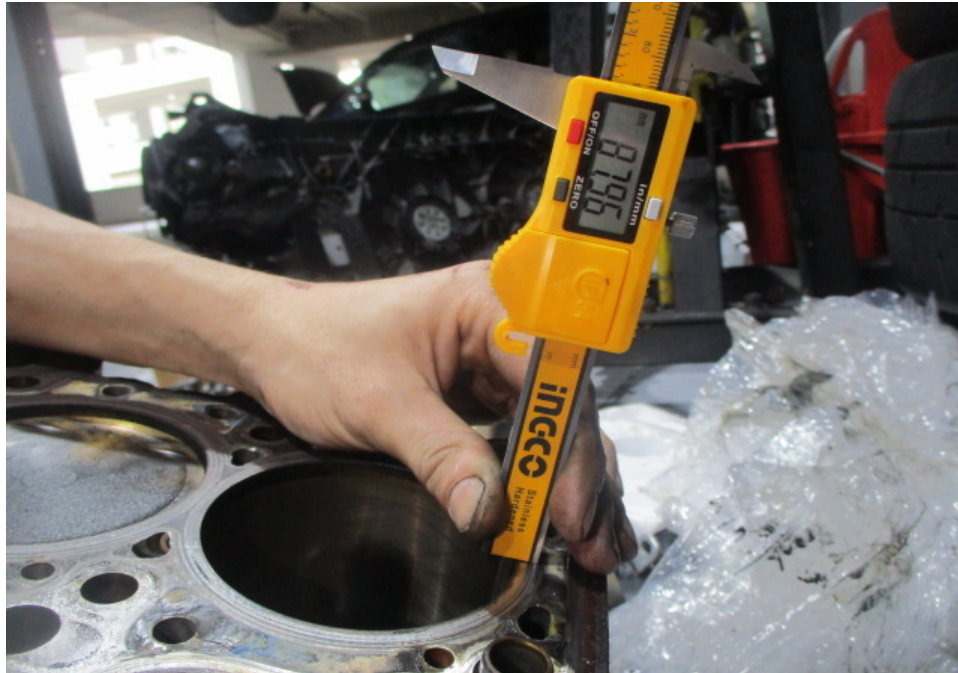
Photo 23 shows the stroke measurement of cylinder 4, which was recorded to be 87.96mm.
