VEHICLE DETAIL

Vehicle No	XE 5178 C	SCDF Ref. No.	ACC-IND-23-13
		Adar Form No.	3047

REPAIR DESCRIPTIONS

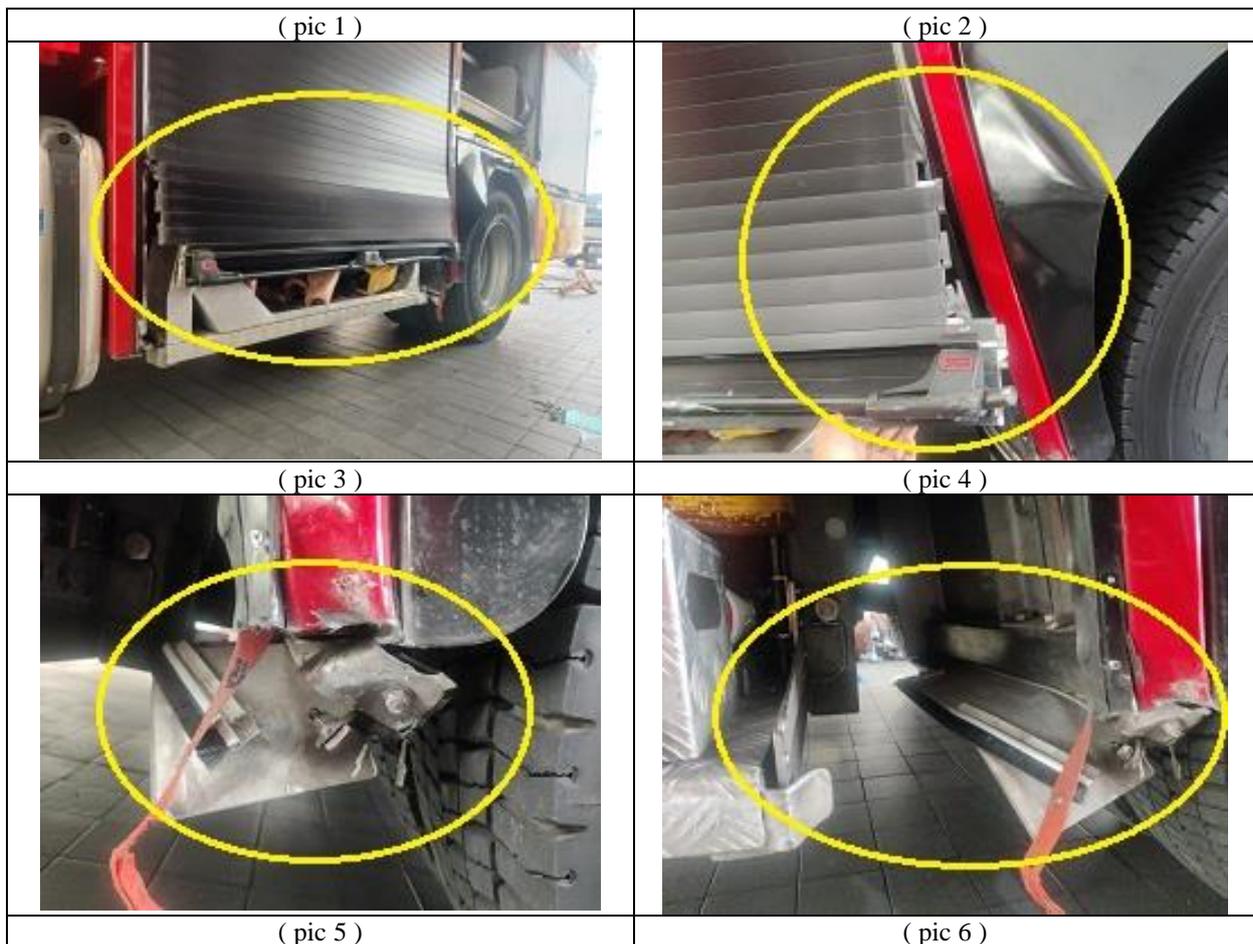
- 1) To dismantle LH side compartment (pic 1)
- 2) To dismantle Locker 1 slider track (pic 1)
- 3) To dismantle No.1 roller shutter (pic 2)
- 4) To cut and weld locker pillar (2-4)
- 5) To remove and replace shelf support base & support brackets (pic 3-4)
- 6) To cut and weld locker 1 front body bottom frame (pic 3-4)
- 7) To cut and weld angle support for bottom frame (pic 3-4)
- 8) To cut and weld LH rear mudguard step (pic 5)
- 9) To remove & replace swing down support brackets (pic 5)
- 10) To realign & panel beat rear wheel arch (pic 5)
- 11) To putty & respray rear LH wheel arch (pic 5)
- 12) To replaced No. 1 shutter (pic 6)
