ACCIDENT INVOLVING SGT 7524X & SHB 6716Z ALONG ECP TOWARDS CITY (BEFORE MARINE PARADE EXIT) ON 7 FEBRUARY 2022 @ 0830HRS

DAMAGED VEHICLE (SGT 7524 X) INSPECTION REPORT (WITHOUT PREJUDICE)

ASSESSMENT OF REPAIRS AND SPARE PARTS COSTS FOR VEHICLE NO: SGT 7524 X

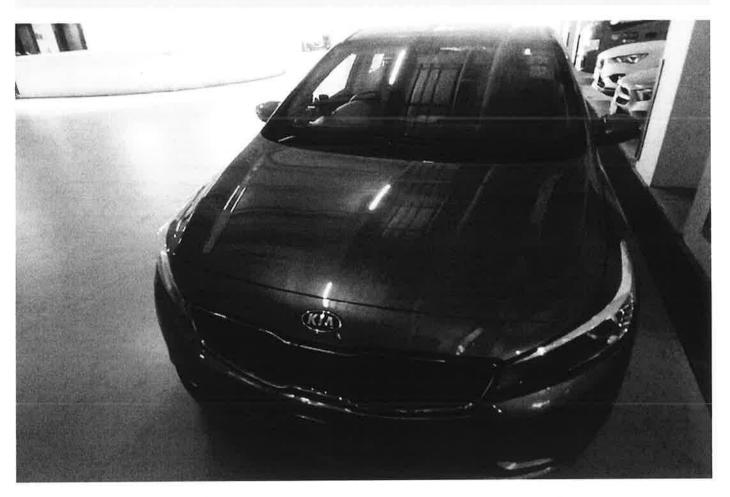
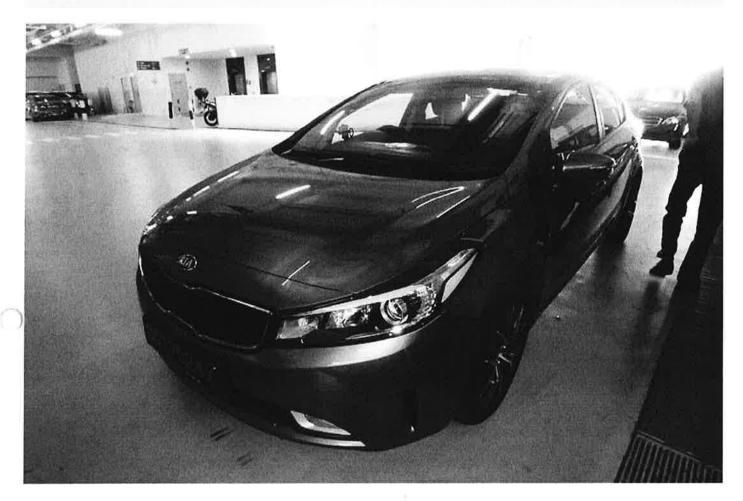
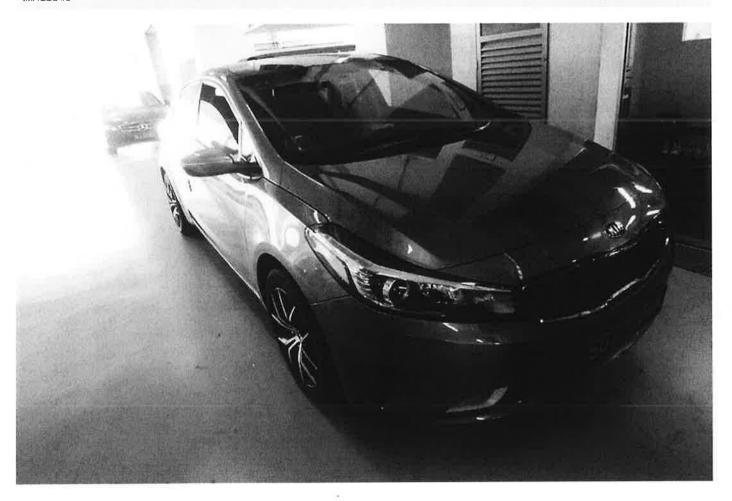
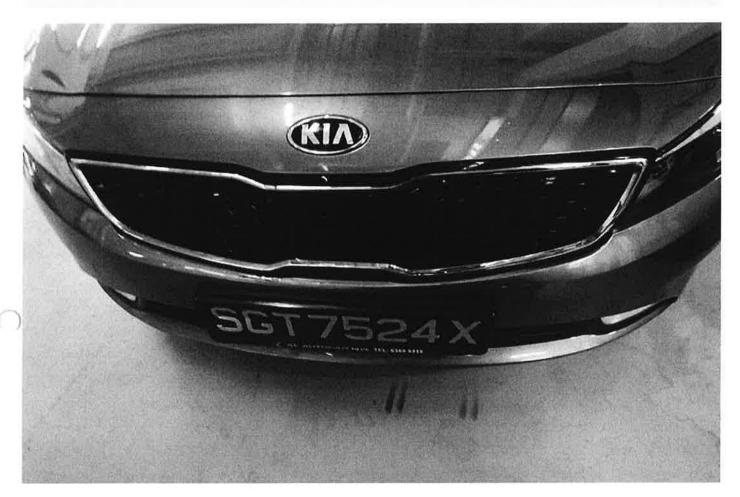
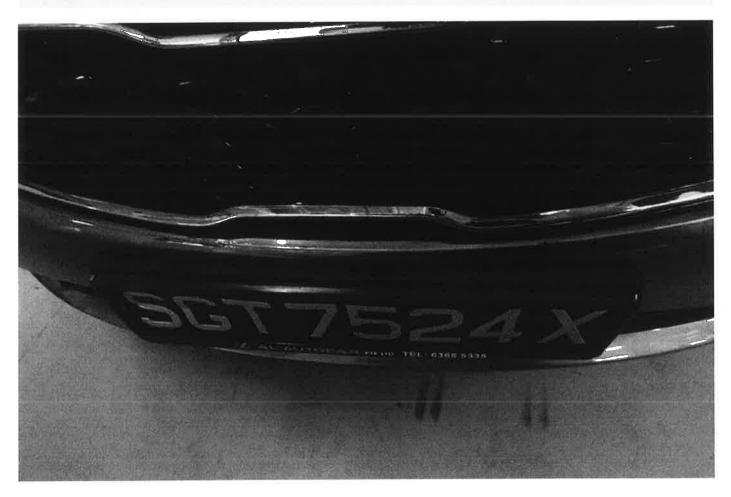
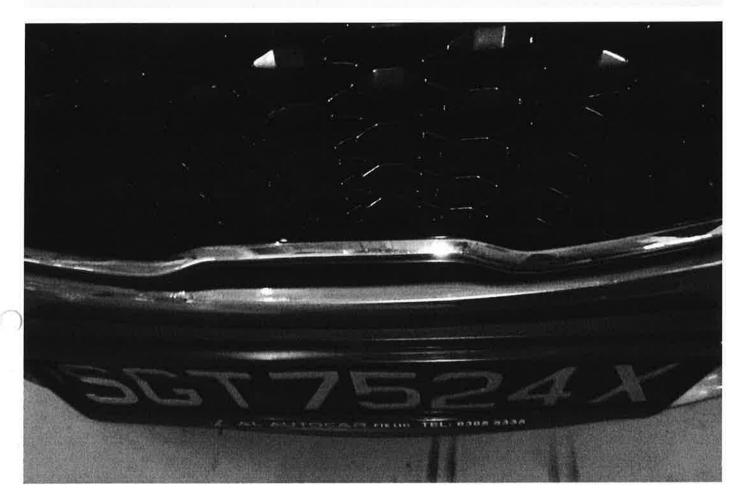
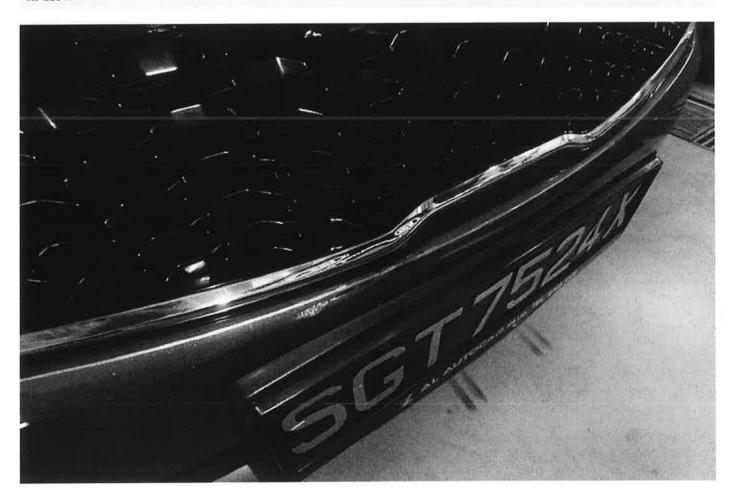
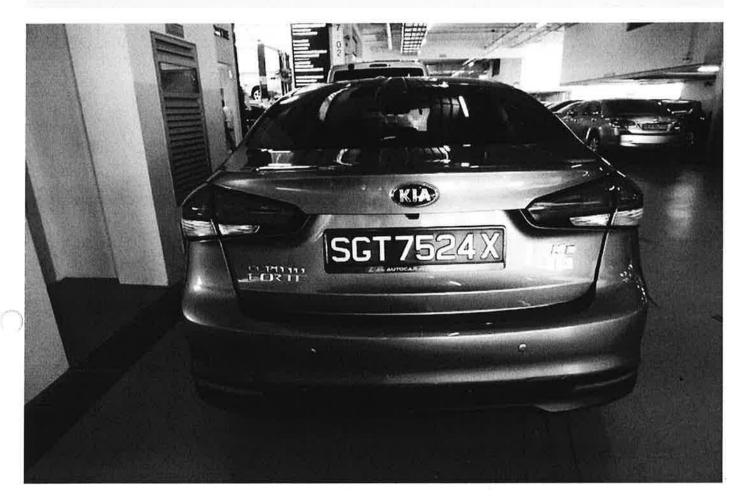
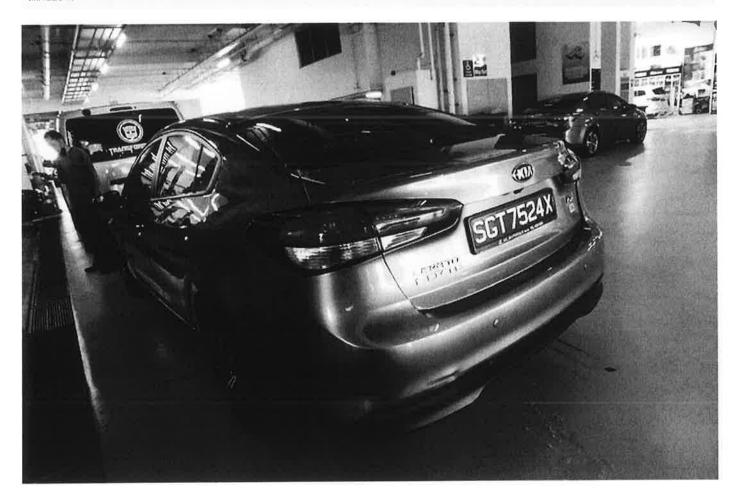
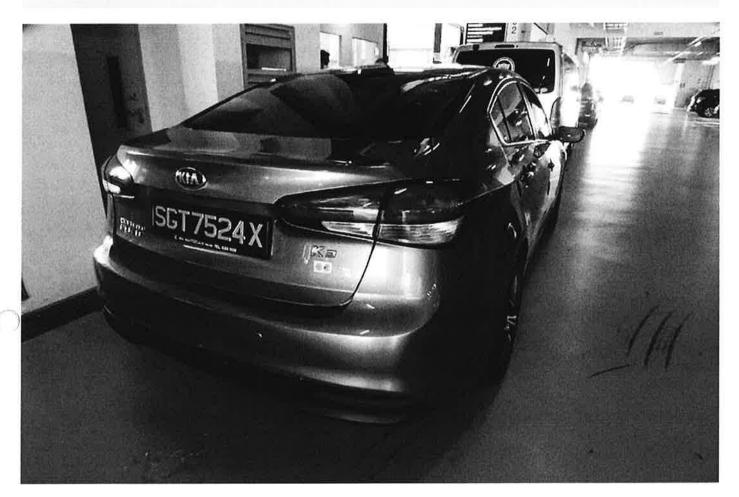
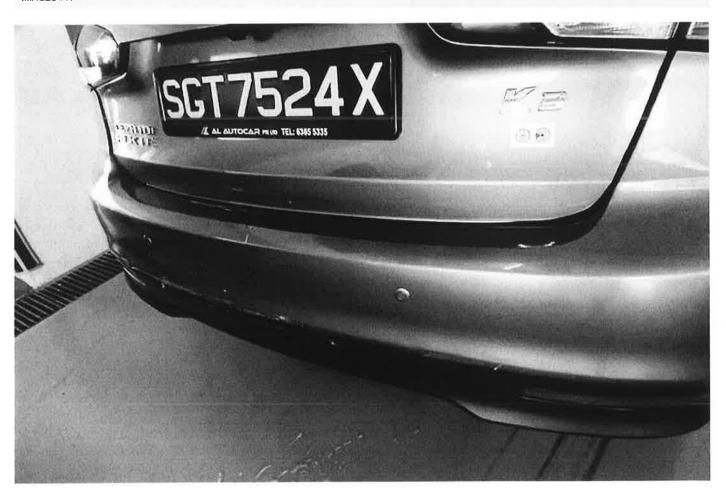
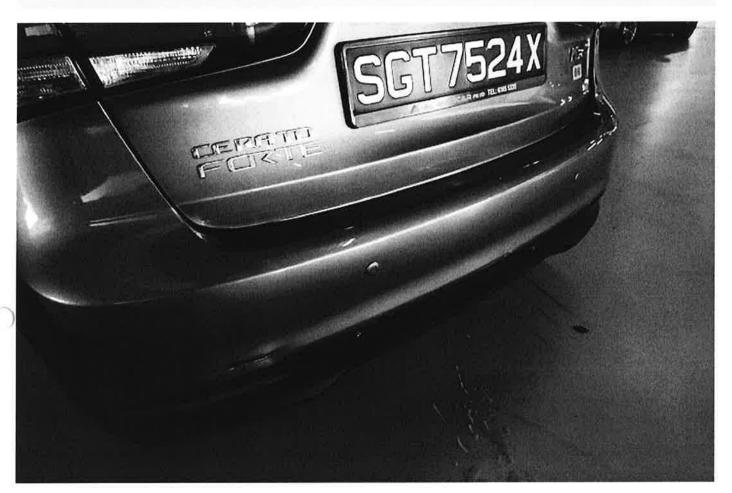
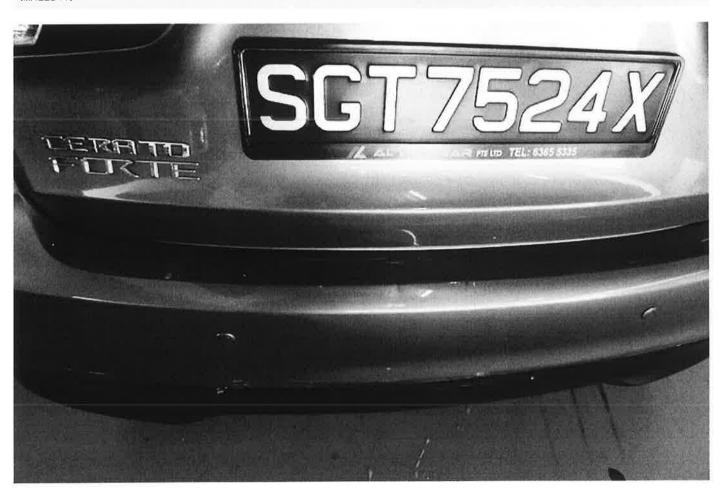
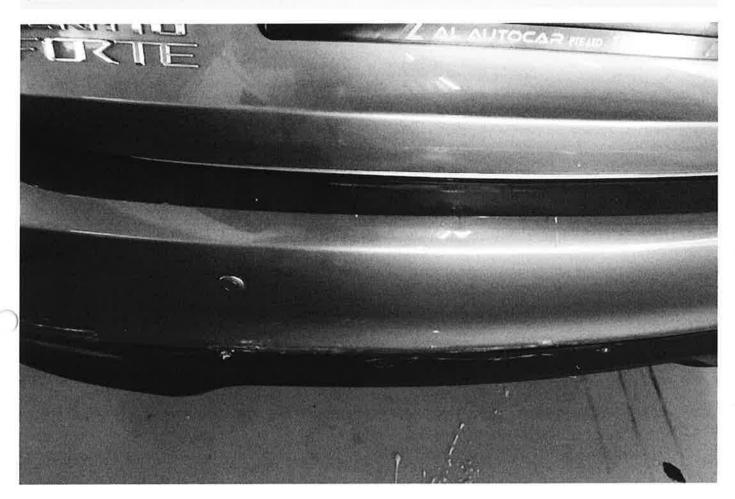
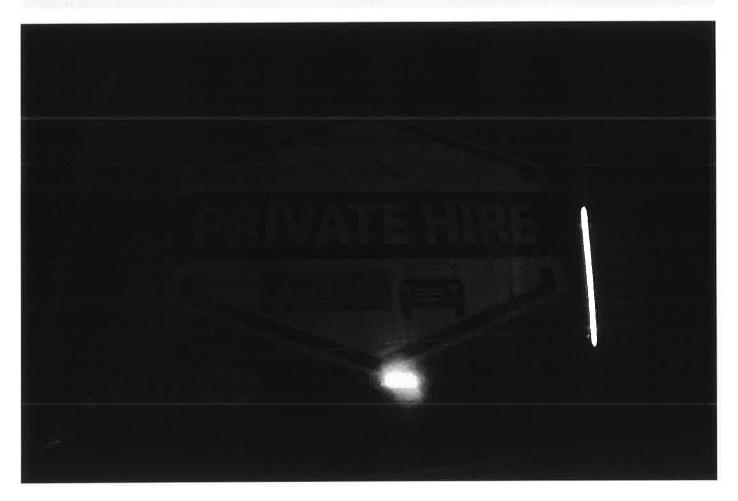
To the rear and subsequently to the front section.

The impact of the collision has damaged/affected the boot lid, rear bumper, rear end panel, tail lamp, parking sensor, front bumper, headlamps, air con condenser, radiator, front support panel and etc.

Please refer to the Annex for a detailed account of the damages and photographs taken.

Our adjusted cost of lump sum repair is **\$16,600.00** and an estimated **12** days is required to repair the vehicle. Please refer to the Annex for a detailed account of the cost estimates.
