VEHICLE DAMAGE ASSESSMENT REPORT

Ref No	: 2022/03006	Date of Report	: 9/3/2022
Claim Type	: Third Party	Date of Request	: 4/3/2022
Third party vehicle	: PC8050Y	Date of Accident	: 25/2/2022
Insured Vehicle	:	Date of Inspection	: 4/3/2022
Your Reference No	: -

Registration Plate No	: PC8050Y	Engine Modification	: NIL
Model / Make	: ISUZU LT434P	Pre-accident damage	: NIL
Colour	: Multicolor	General Condition	: Good
Manufacturing Year	: 2017	General Paint Work	: Good
Engine No	: 6HK1699331	Steering	: Serviceable
Engine Capacity	: 7800 cc	Handbrake	: Serviceable
Chassis No	: JALLT434PH7000078	Footbrake	: Serviceable
Odometer No	: 268248		
Transmission	: Auto

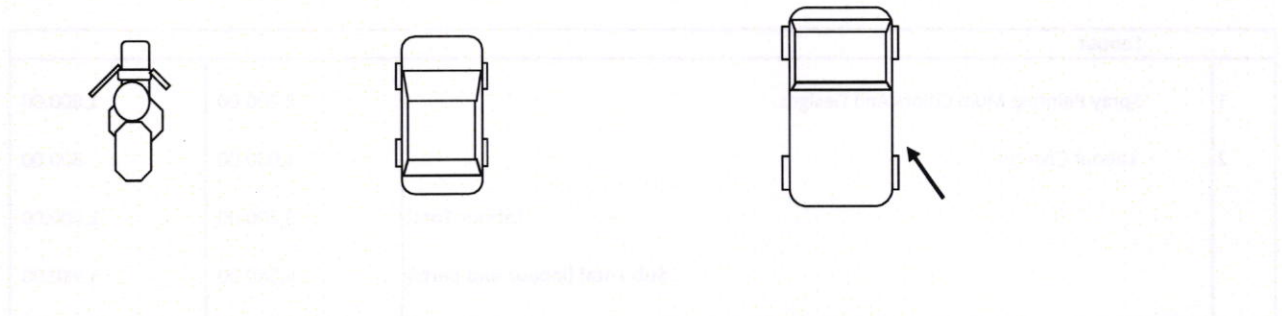
At the time of inspection, this vehicle sustained damages to the **Rh Portion**.

Rear rh last compartment door dented, rh side panel dented and scatch etc.

We have not authorised repair. Under normal circumstances, estimated **4** working days are required to repair the vehicle.
