Vehicle No: GBD8213E

SINGAPORE ACCIDENT STATEMENT

ACCIDENT STATEMENT Date of Submission 29/10/2022 15:38 (SGT) Reported by Date of Accident 28/10/2022 07:50 (SGT) Exact Location of Accident PIE, Singapore Additional Location Information Country/State of Loss Singapore

Accident report SJ0G22AT000R

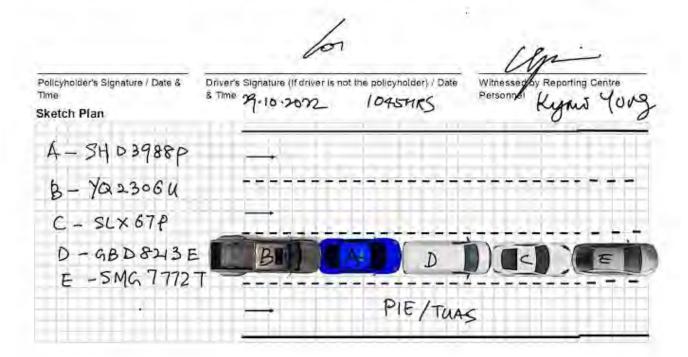
SKETCH PLAN

Type of Accident	Chain Collision

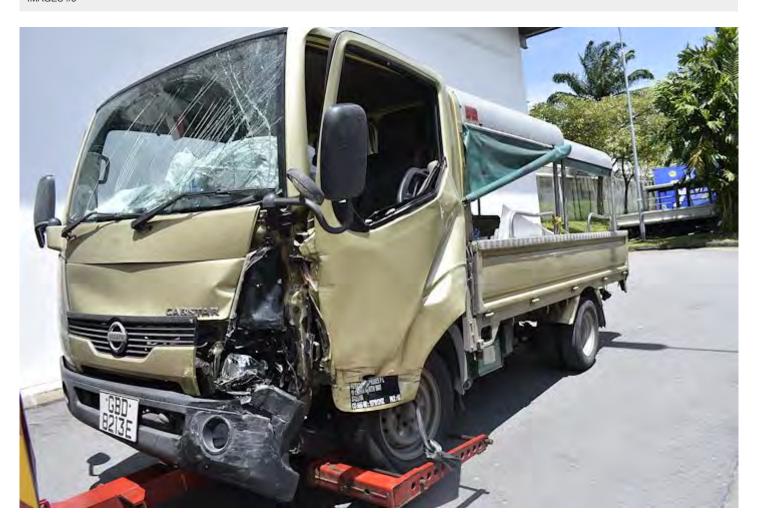
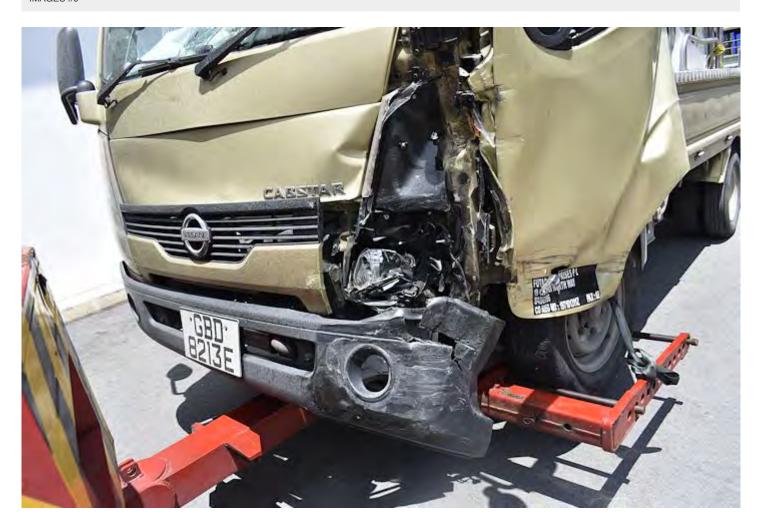
The vehicle and buckled	sustained an ; front panel,	impact on its front n/s n/s pillar, n/s wheel ar	and rear portion resurch, n/s door back pa	-	l reinforcement, front	cabin lock,
The vehicle and buckled cabin spring	sustained an ; front panel, , cabin mour	impact on its front n/s n/s pillar, n/s wheel ar nting bent; w/screen, n	and rear portion resuch, n/s door back pa /s headlamp, grille, v	nel, front bumper bracket and	l reinforcement, front ed/broken; rear chassi	cabin lock, s, tailgate,
The vehicle and buckled cabin spring tailgate lower	sustained an ; front panel, , cabin mour	impact on its front n/s n/s pillar, n/s wheel ar nting bent; w/screen, n	and rear portion resuch, n/s door back pa /s headlamp, grille, v	nel, front bumper bracket and riew mirror, dashboard cracke	l reinforcement, front ed/broken; rear chassi	cabin lock, s, tailgate,
The vehicle sand buckled; cabin spring tailgate lower damages)	sustained an ; front panel, , cabin mour er members,	impact on its front n/s n/s pillar, n/s wheel ar nting bent; w/screen, n	and rear portion resuch, n/s door back pa /s headlamp, grille, v	nel, front bumper bracket and riew mirror, dashboard cracken p, reverse sensor cracked. (s	l reinforcement, front ed/broken; rear chassi	cabin lock, s, tailgate,

ADJUSTMENT ON REPAIR COST AND REPLACEMENT OF PARTS

Veh.No:	GBD8213E		· · · · · · · · · · · · · · · · · · ·	
QTY	DESCRIPTION OF PARTS AND LABOUR	CONDITION	REPAIRER EST	OUR REVISED
	T		(\$)	(\$)
	To apply primer, to putty and paint front panel, n/s front door, n/s front pillar, n/s front wheel arch panel, cabin			-
	floor panel, grille, wiper panel, n/s door back panel, tail			
	gate, tailgate lower member, side gate and other affected areas.		2,800.00	2,200.00
	areas.		2,800.00	2,200.00
	To remove damaged parts, jack out, straighten and			
	knock n/s front pillar inner, cabin floor panel, n/s front			
	door back panel, rear chassis frame, side gate. Cut and			
	weld front panel, front n/s pillar, front n/s wheel arch,			
	tailgate lower member and renew recommended parts.		3,800.00	3,000.00
	Total Labour Charges		10,060.00	7,390.00
	GRAND TOTAL		41,978.43	34,810.36
Note:	The repairer had agreed to undertake the			
	repair on Lump Sum basis of \$27,850.00 nett

to reinstate this vehicle to its pre-accident			1
	condition.			
	(repairer discretion to repair parts, to replace with second hand parts, or to			-
	replace with OEM or Genuine parts)			
		End of Report		·
				İ
		ļ
