ASS. REC. BY: Taufik | REF: CS/CTI24070283/Tqp3

Veh No: SCZ37Y Yr Regn: 2016, 06

Make: Audi A4 c.c 1395

Full Report
Registration: SCZ37Y
Printed: 17/07/2024 8:48 AM

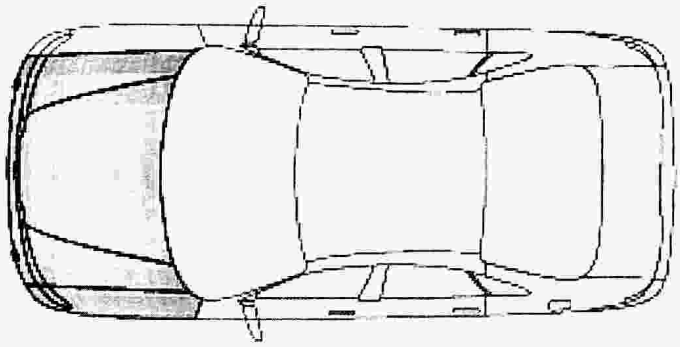
Damage Areas

Des. of Damages: (Frt) / Rear / O/S / N/S / U/C / Rooftop or ______

The U/C / Chassis frame / Body Structure affected due to collision.
