Ref: NS/INC17018027/Srbe2

1.	Policy Particulars :- THIRD PARTY CLAIM			
	Insured Veh.	SGS 4739T	**Veh. Inspected**	SMB 3164B
	Policy No.	5058782492-03	**Coverage ($)**	0.00
	Claim No.	MT/0909389-002	**Excess ($)**	0.00
	Assign From		**Assign Date**	18/09/2017

4.	Description of Damages
	THE VEHICLE SUSTAINED DAMAGES AT THE O/S FRONT PORTION. DAMAGES SEE DETAILS.

ADJUSTMENT ON REPAIR COST FOR VEHICLE NO. SMB 3164B

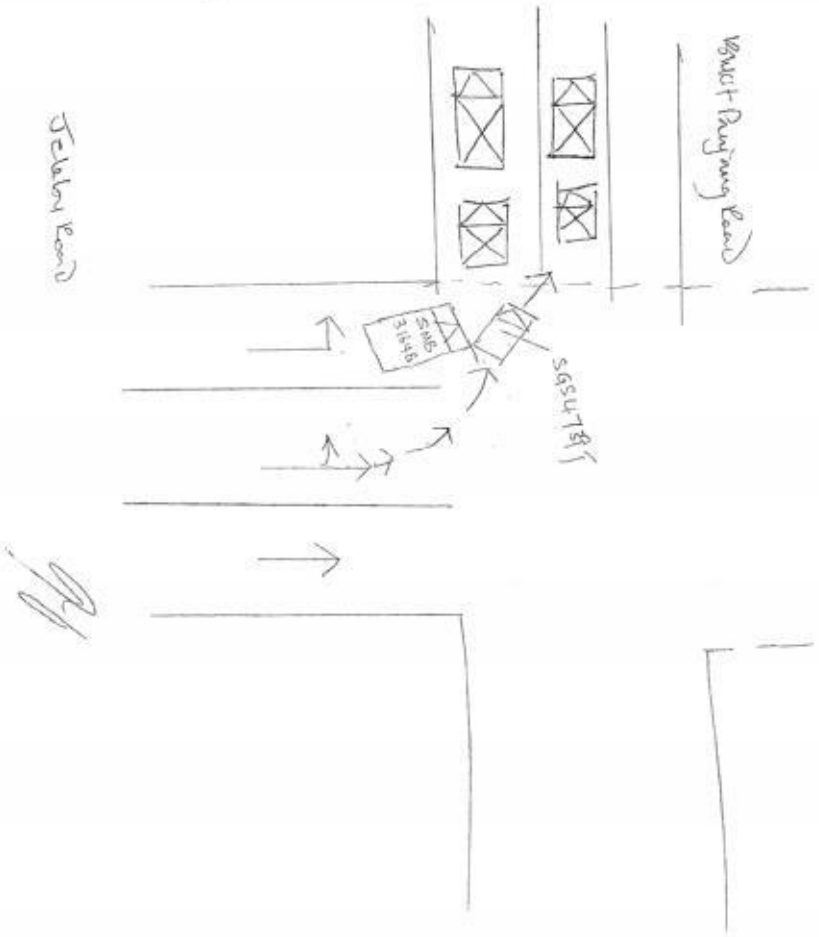
Sketch Plan Pg. 3

Whilst travelling from Jelebu Road towards Bukit Panjang Road
Vehicle SGS4739J from my right lane cut into my lane and cruise
my bus front right corner portion collided into the rear left
portion of SGS4739J. That's all

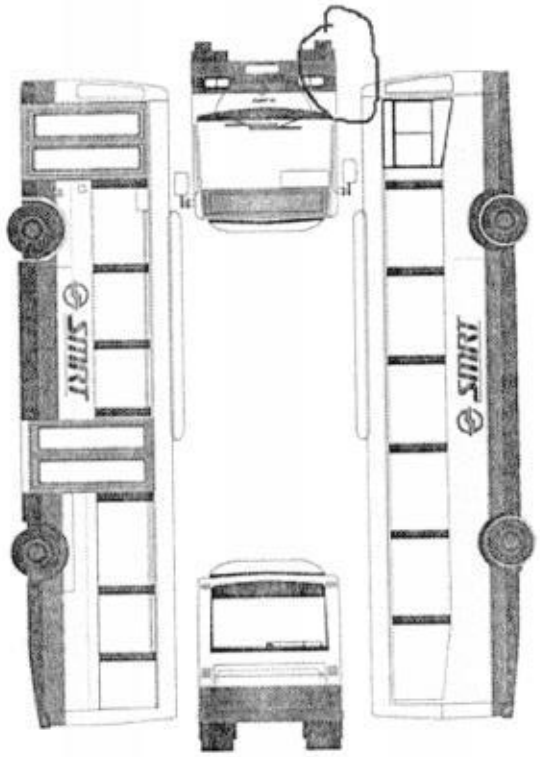
FRONT RIGHT PORTION.
TP: SGS4739T

Job Scope	Quotation from ARC	Adjusted by Surveyor, if applicable
TO REPAIR RH FRONT PORTION	530.00	~~0.00~~ 265
Total Labour	**530.00**	**0.00**

Job Scope	Quotation from ARC	Adjusted by Surveyor, if applicable
PROVIDE LABOUR AND MATERIAL TO PUTTY AND RESPRAY ABOVE REPAIR ITEMS	538.00	~~0.00~~ 350
Total Spray Painting & Panel Beating	**538.00**	0.00

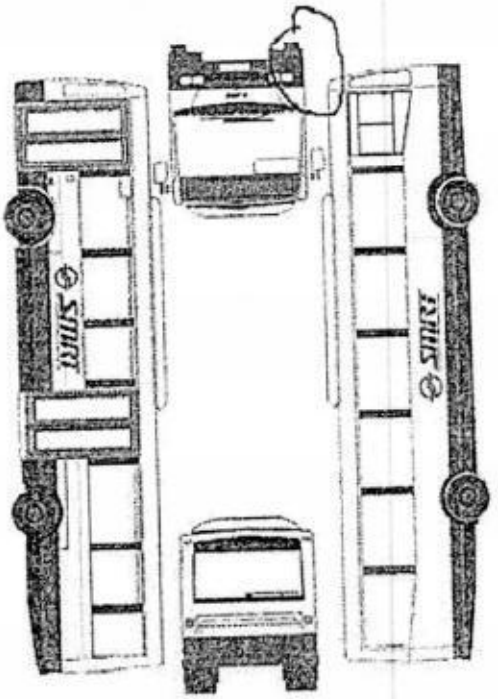
FRONT RIGHT PORTION.
TP: SGS4739T

Job Scope	Quotation from ARC	Adjusted by Surveyor, if applicable
TO REPAIR RH FRONT PORTION	530.00	265.00
Total Labour	**530.00**	**265.00**

Job Scope	Quotation from ARC	Adjusted by Surveyor, if applicable
PROVIDE LABOUR AND MATERIAL TO PUTTY AND RESPRAY ABOVE REPAIR ITEMS	538.00	350.00
Total Spray Painting & Panel Beating	**538.00**	**350.00**
