REF: CS/ASM18002219/KVbs2

To Inspect Vehicle No: SFS 3999C Insured:

PRELIMINARY ADVICE OF VEHICLE NO.SFS 3999C

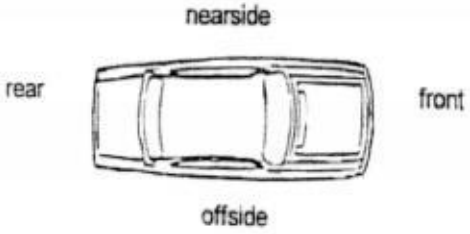
Description of Damage:
The vehicle sustained damages at the o/s front portion and o/s rear portion.

Survey date and time: 5/2/2018 at 1.35PM
We have authorise repair.
No of days :5 days

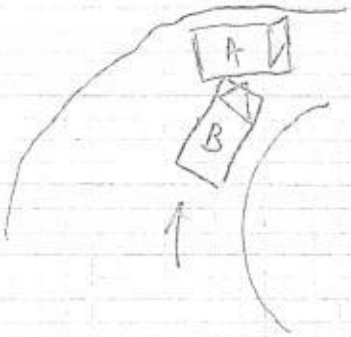
SKETCH PLAN

A = SFS3999C

B = SLN765K

Road condition was wet but was irrelavent for the accident. It was a merging lane turning into Tatachimaya. I was infront and the car behind decide to squeeze in from behind and the front left of the car hit into the driver side of my car. She start hitting from the back tyre but she did not stop and carry on all the way to the front. She did not stop as though a accident did not occur.
