Insured Vehicle No	: GBF3089U		
TP Vehicle No	: SHD1193D	Accident Date	: 17/03/2018
Make	: HYUNDAI I40	Assignment Date	: 19/03/2018
Date of Inspection	: 22/03/2018	Est. Duration of Repair	: 3.00
Inspection At	: PREMIER TAXIS PTE LTD - CHANGI (HQ) 23 CHANGI SOUTH AVE 2 #03-02 SINGAPORE 486443

VEHICLE DAMAGE INSPECTION REPORT

Our File No: CS/MSG18005237/T1QD3N2
Date: 07/06/2018

Handling Insurer:	MSIG Insurance (Singapore) Pte. Ltd.	**Policy No:**	29002413MKC		
Claimant Vehicle No :	SHD1193D	**Insured Vehicle No :**	GBF3089U		
Date of Loss:	17/03/2018	**Nature of Claim:**	TP	**Claim No:**	552630

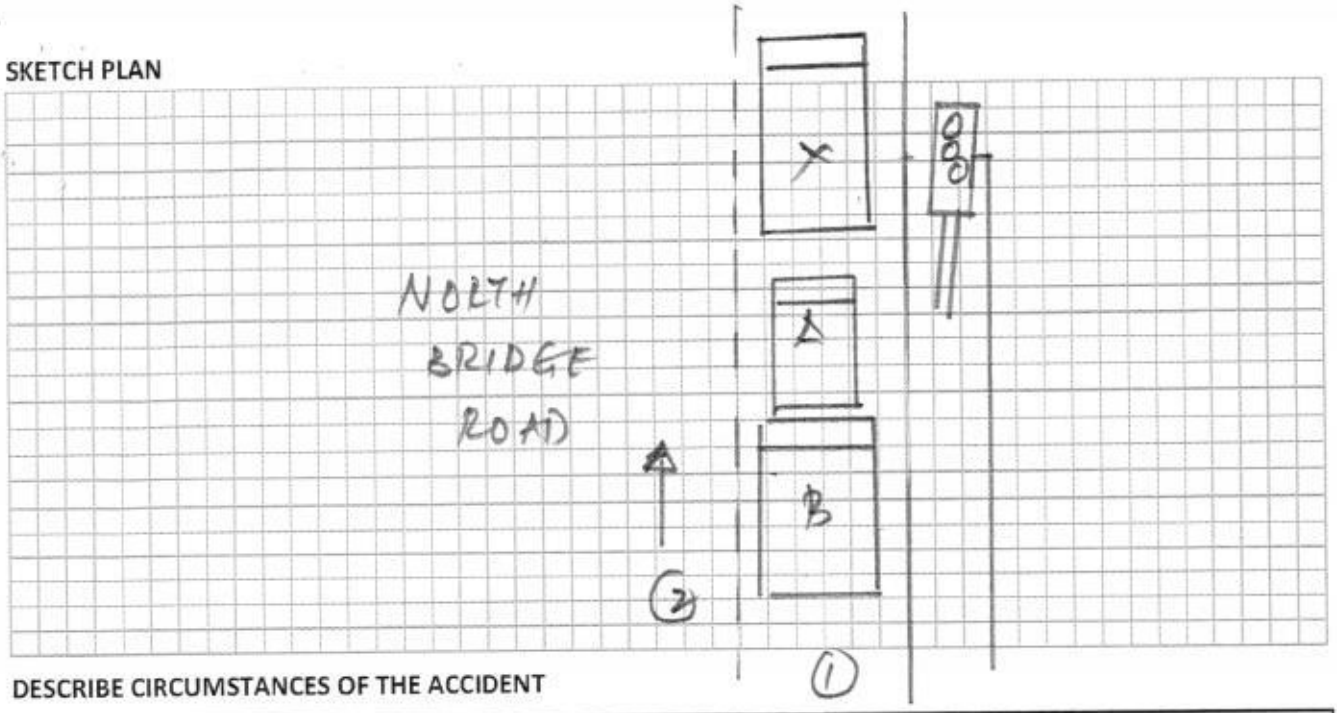
SKETCH PLAN

WHEN INSPECTED, I DISCOVERED THAT VEHICLE B (**GBF 3089 U – TOYOTA VAN**) WHICH WAS BEHIND ME, FAILED TO STOP IN TIME, HAD COLLIDED ONTO THE REAR OF MY TAXI.

DUE TO THE IMPACT, MY TAXI HAD DAMAGES ON THE REAR PORTION AND I WAS NOT AWARE OF DAMAGES TO VEHICLE B.

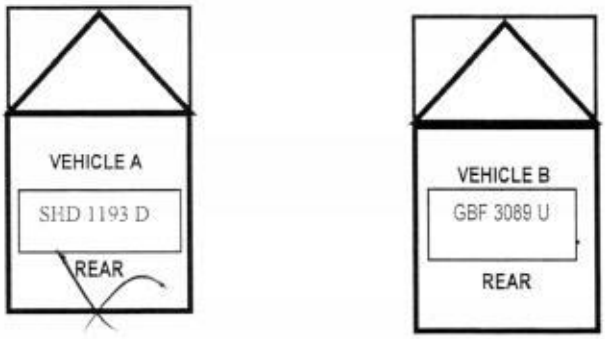
DAMAGES FOUND ON VEHICLE A & VEHICLE B

The vehicle sustained impact / damages rear portion and parts claimed are consistent to the accident.
