National Assessment Centre Services

NTUC INCOME INSURANCE CO-OPERATIVE LTD Ref: NS/INC18005693/Stb

1. Policy Particulars :- THIRD PARTY CLAIM

ADJUSTMENT ON REPAIR COST FOR VEHICLE NO. SHB 5490E

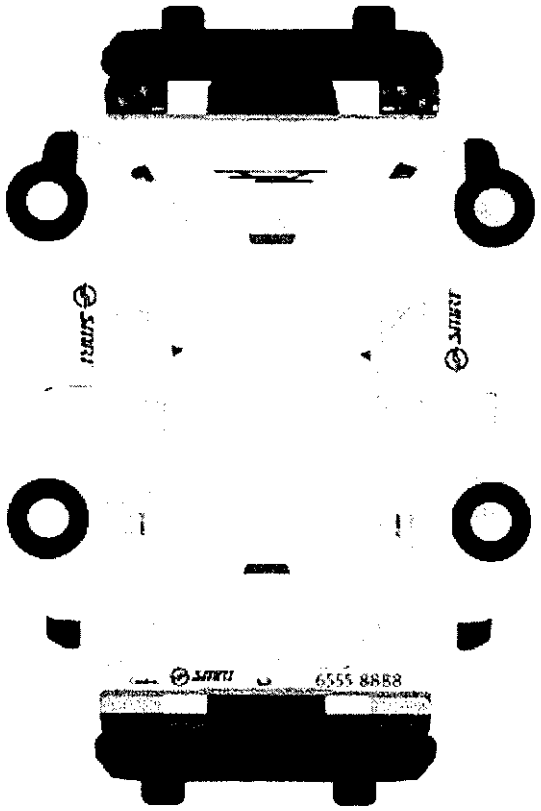
Sebastian.
26/3/18.
- Part by part repair.
- Question Mark Item Photo
- Photo Before Paint.

- To resurvey before/after spray painting
- To display damaged part(s) during resurvey
- Parts prices are subject to confirmation
- Third party survey is on a "Without Prejudice" basis
- No illegal modification(s) is allowed
- Supplementary item(s) must be resurveyed and is subject to final approval from Insurance Company

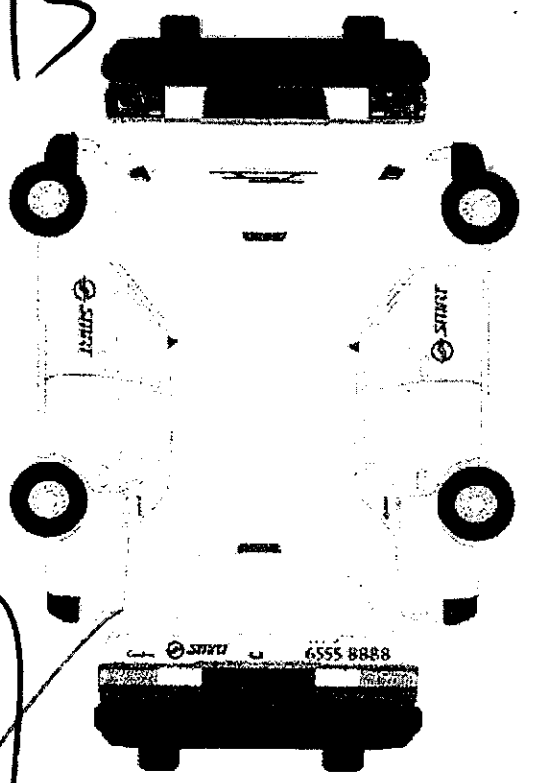
SGN2724A - NTUC IDAC P/P
BEFORE PAINT PHOTO ,FOR CHECK ITEM AND REPLACE ITEM PLEASE CALL SURVEYOR SEBASTIAN (LKK)
& Email :sebastianyeang @lkkauto.com HP:90036121
