Ref : CS/TP18010260/Urbn2

THE VEHICLE SUSTAINED DAMAGES AT THE N/S REAR PORTION.

ADJUSTMENT ON REPAIR COST FOR VEHICLE NO. SLN 8967S

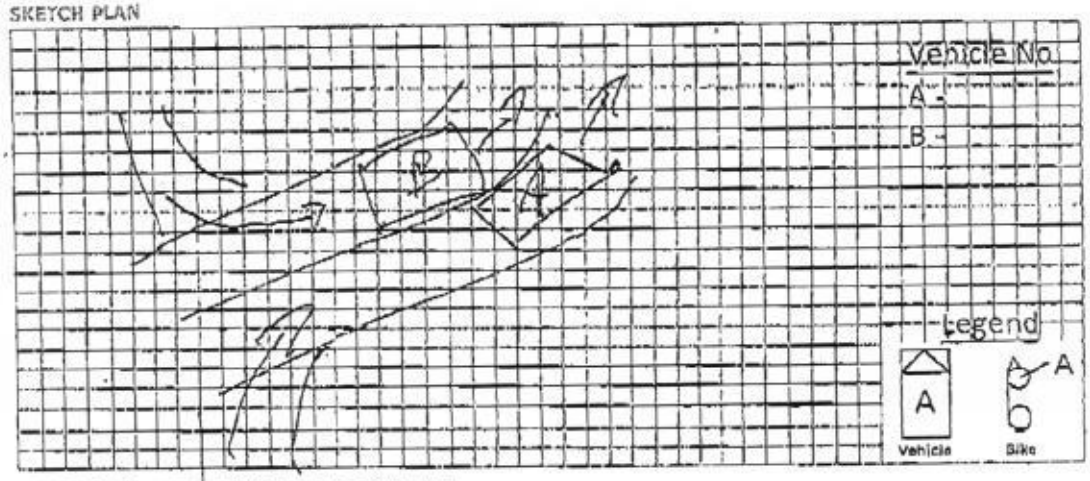
Sketch Plan #2 Pg. 1

TURNING RIGHT INTO MAIN ROAD. OPPOSING CAR WAITING TO TURN LEFT WITH GIVING WAY LINE. I DRIVE ON MY LANE AND OPPOSING CAR IMPACTED ME MY CAR ON MY REAR LEFT.
