- PRE-REPAIR INSPECTION - ACCIDENT INVOLVING OUR INSURED VEHICLE SLM660J AND SJN2322R ON 26/06/2018

Vehicle No: SJN 2322 R

VEHICLE DAMAGE INSPECTION REPORT

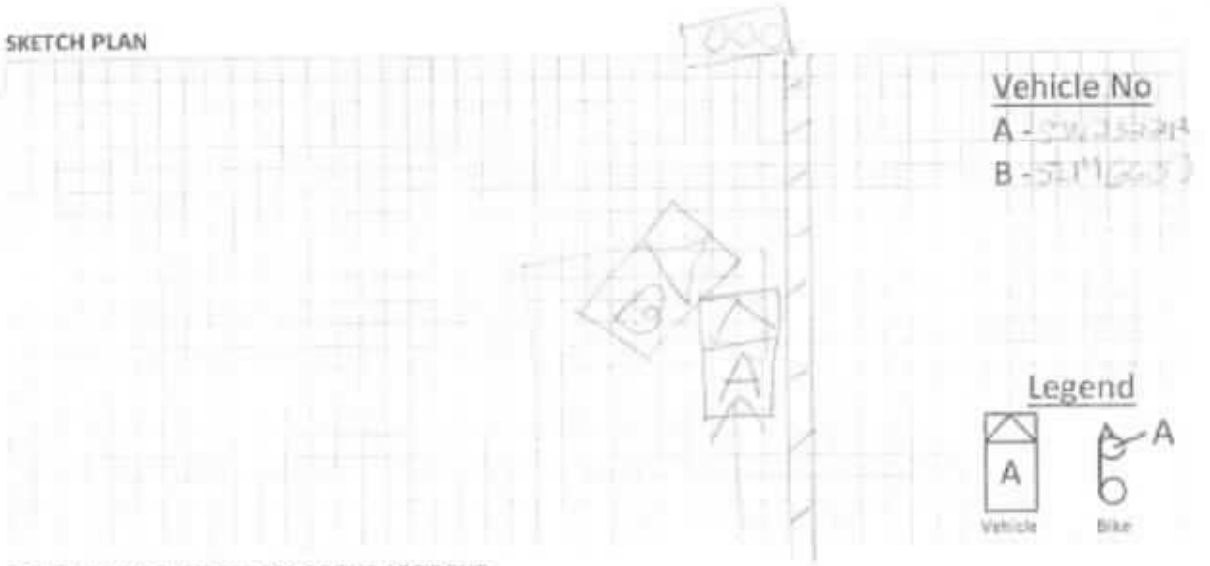
SKETCH PLAN

I am driving straight on my lane approaching the junction for a U-turn.
Traffic in front was clear & I was keeping my speed limit. The red car SLM6607 made a sudden turn out that cut into my lane that caused the accident.
We stopped at the side & took down each others particulars.
I have a video footage of the whole incident.
No one was injured during the accident. I was with 4 other passengers.

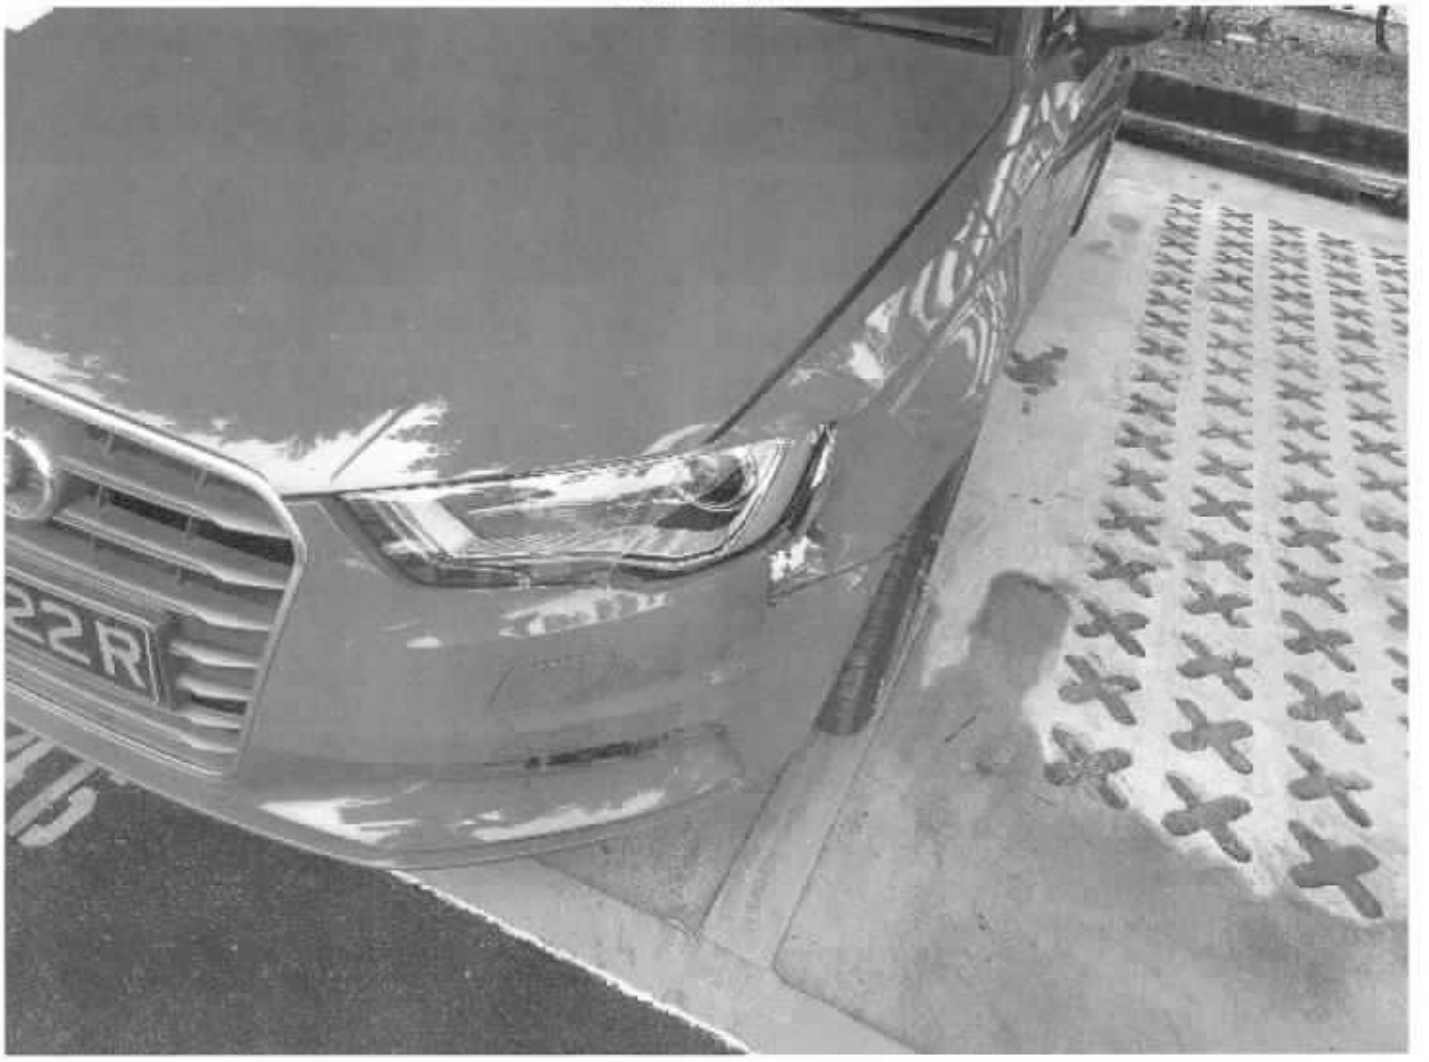
Accident Photo

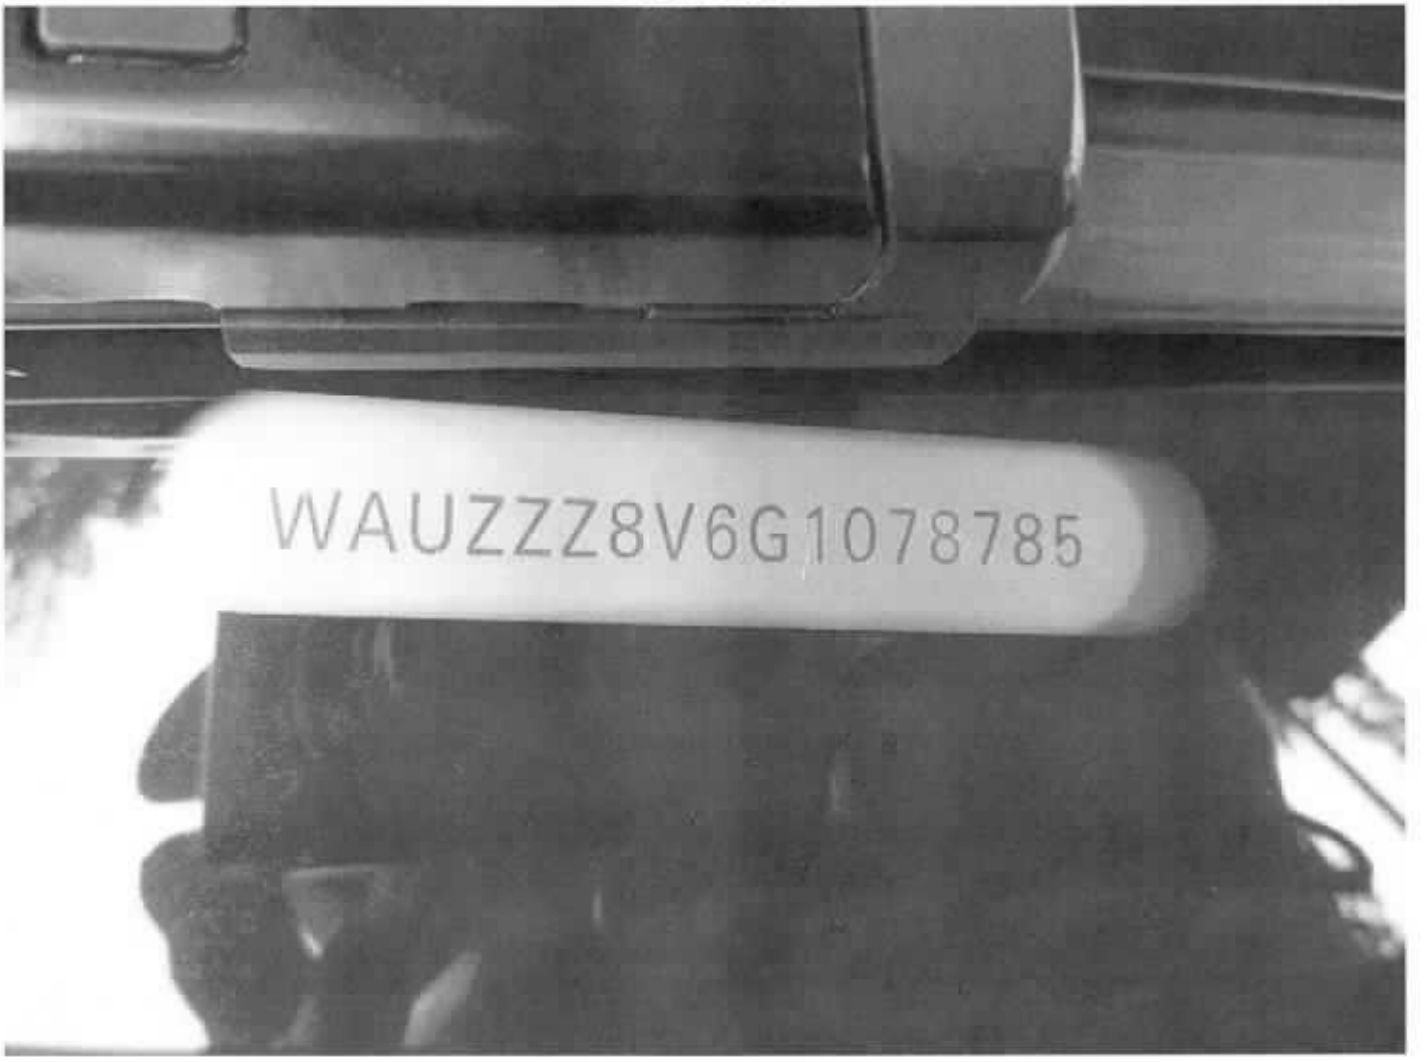
Accident Photo
