LKK Auto Consultants Pte Ltd

AIG ASIA PACIFIC INSURANCE PTE LTD

1.	Policy Particulars :- (THIRD PARTY CLAIM)			
	Insured Veh.	SLZ 1788A	Veh. Inspected	SLR 3657Z
	Policy No.		Coverage ($)	0.00
	Claim No.		Excess ($)	0.00
	Assign From	CHIN LEE YING	Assign Date	28/08/2018

VEHICLE DAMAGE INSPECTION REPORT

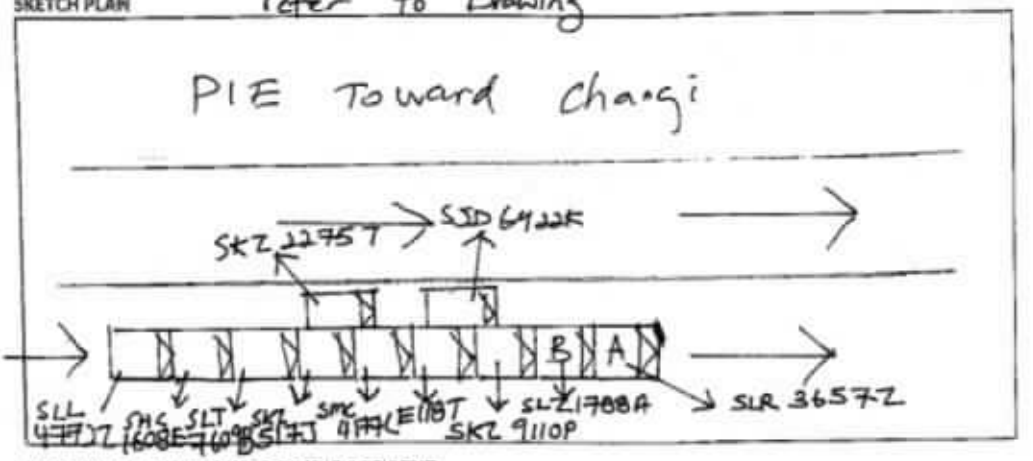
SKETCH PLAN refer to Drawing

There was road works going on and I slowed down to a complete stop. immediately after I stopped, my vehicle was hit multiple times from behind.
