Accident Photo

RE: INSURANCE CLAIM FOR SGX 9476 S, Audi A3 SEDAN 1.0 TFSI.

VEHICLE DAMAGE INSPECTION REPORT

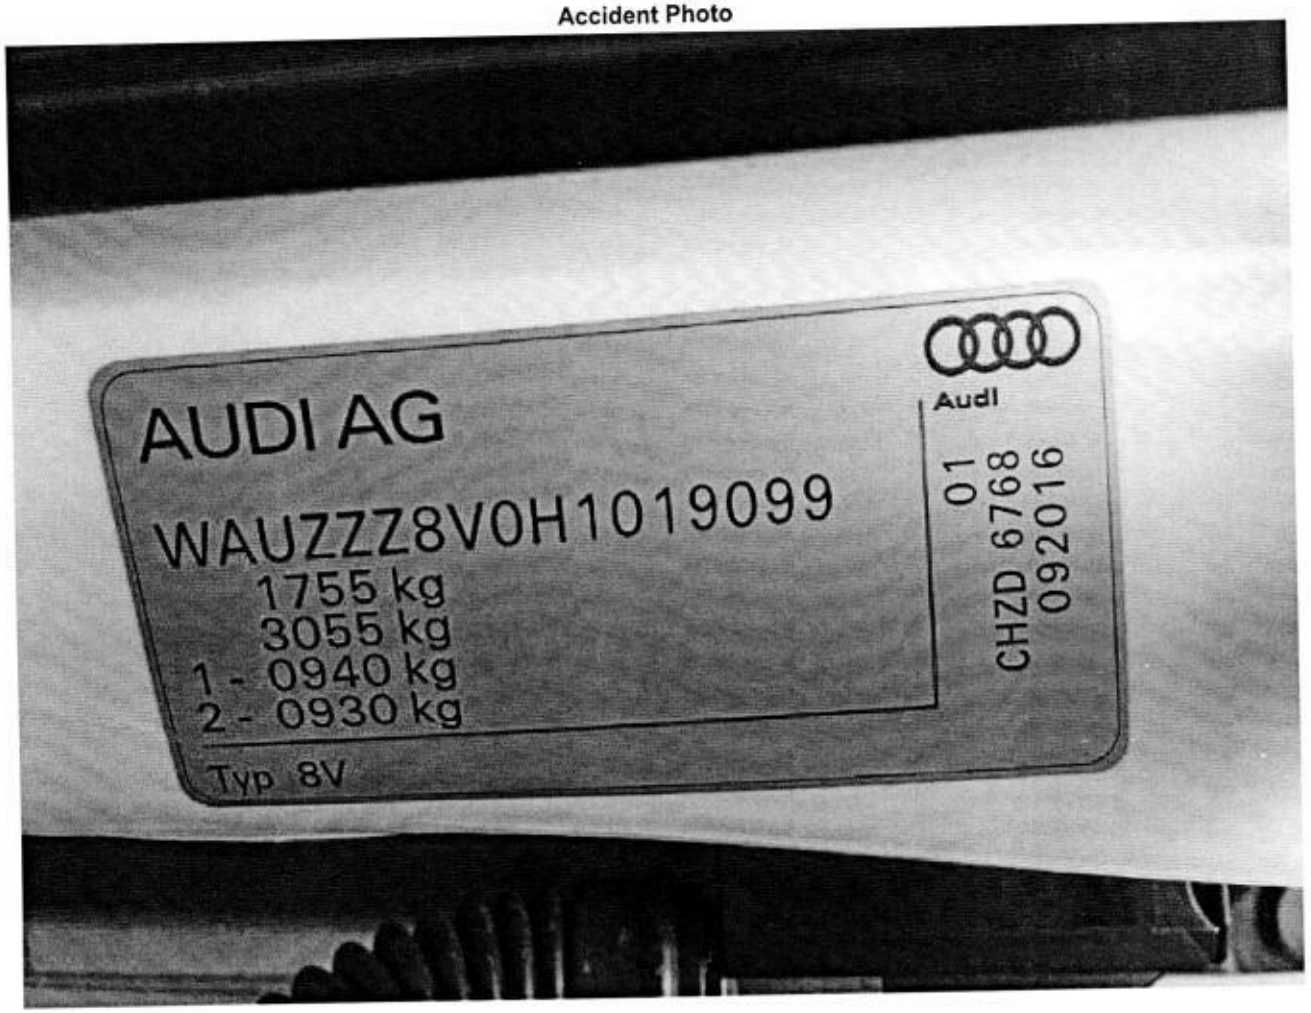
Accident Photo
