Preliminary Advice

VEHICLE DAMAGE INSPECTION REPORT

Our File No: CS/FWD19001712/DSD3S2
Date: 14/02/2019

Reg No:	**SJR1275D**		
Make & Model:	VOLKSWAGEN NEW GOLF, 1.4 TSI 5K14Q5 (A)	Engine No:	CAX211568
Reg. Date:	09/06/2009 (Man. Year: 2009)	Chassis No:	WVWZZZ1KZ9W517204
Colour:	Black	Odometer:	0 km
Engine Capacity:	1390 cc		
Market Value/New Car Price:	S$14,000.00		
Sum Insured (S$):	**Market Value/New Car Price**

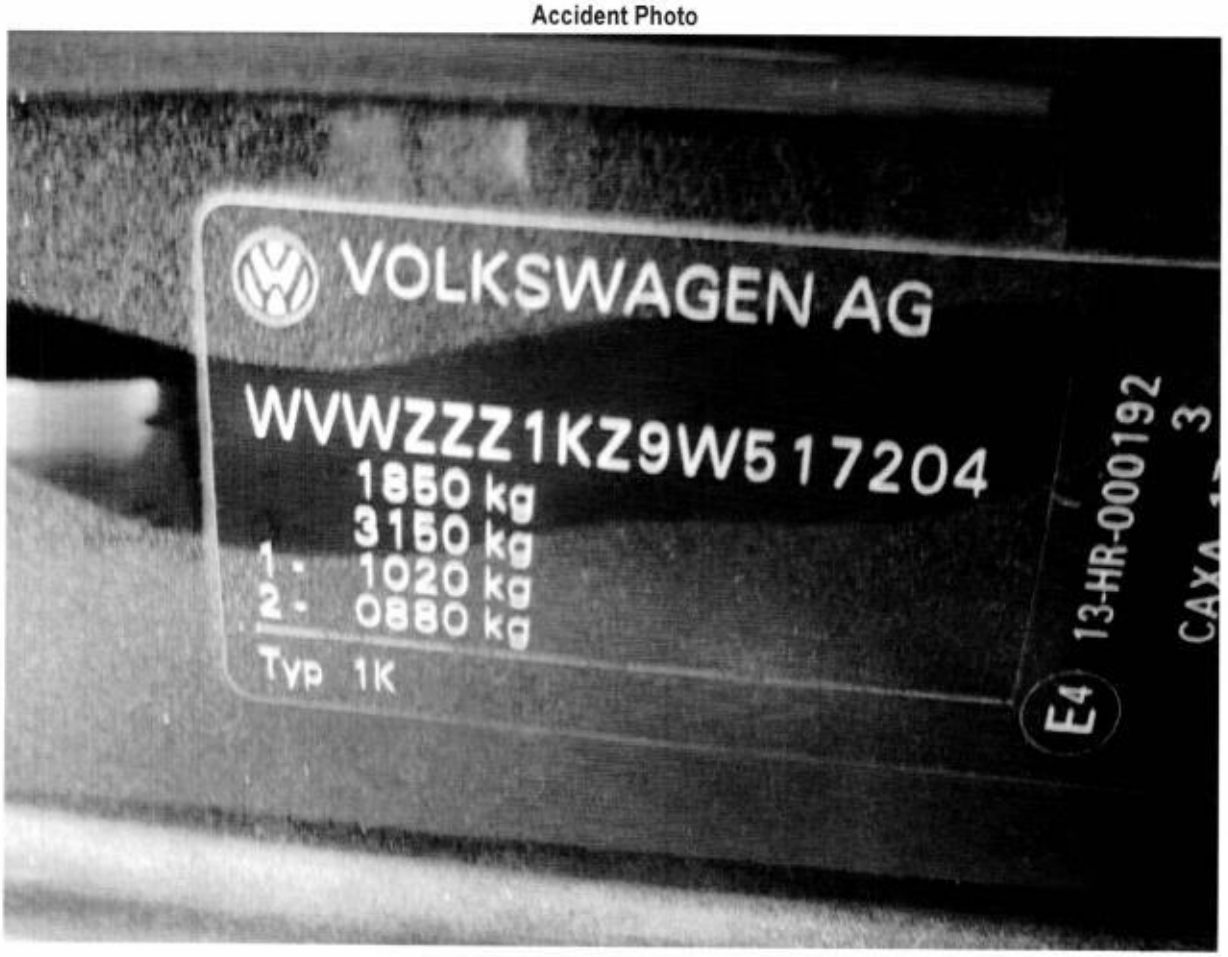
The vehicle sustained impact / damages caught fire at interior compartment. Cause of fire due to electrical nature to the wiring behind the front dashboard and parts claimed are consistent to the accident.
