INITIAL INSPECTION REPORT OF VEHICLE NO. SHD 1038U

ESTIMATE REPAIR BILL FOR KIA OPTIMA REGN NO: SHD 1038 U

Ref : CS/FCI19008692/K1vd3n2

ADJUSTMENT ON REPAIR COST FOR VEHICLE NO. SHD 1038U

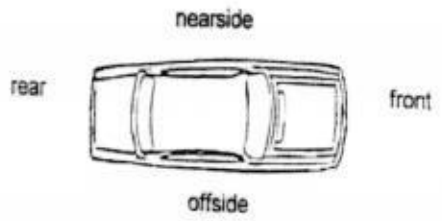
Description of Damage:
The vehicle sustained damages at the n/s body

Comments/Present Status:
Damages Consistent
