Veh No: SLU6912B Yr Regn: 13/4/11

Make: Volkswagen Scirocco R c.c 1984

PRE-REPAIR INSPECTION REQUEST – SLU6912B vs SJT786S (OI) on D.O.A.: 05/12/2019

VEHICLE DAMAGE INSPECTION REPORT

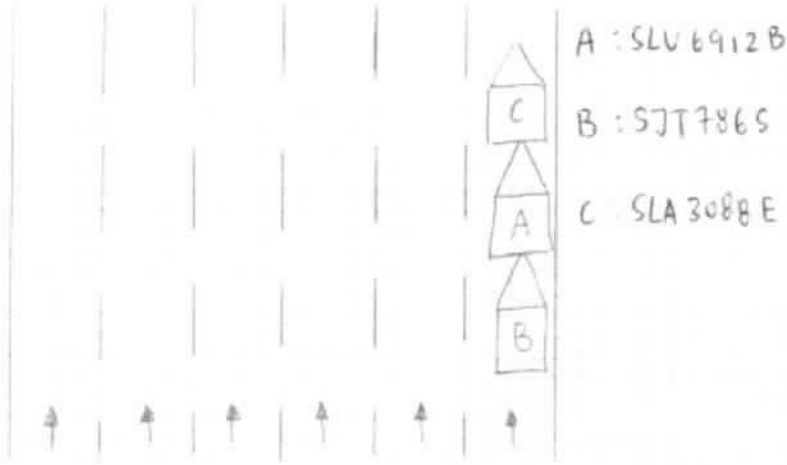
SKETCH PLAN

On the above stated date and time, my vehicle was stationary when suddenly vehicle B came from the rear and collided on to my vehicle rear portion. Due to the impact my vehicle got pushed forward and touched vehicle C.
