Report No: 0793-18-TCA

ACCIDENT VEHICLE SURVEY REPORT

SLL 9689Z

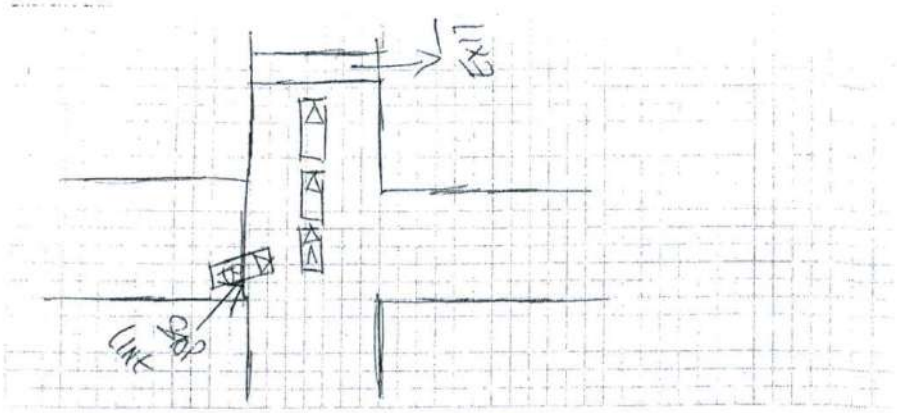
Sketch Plan #2 Pg. 1

my VEHICLE WAS QUEUING UP TO EXIT TAMPINES MALL, VEHICLE B FROM LEFT CAN'T WAIT AND HIT ONTO my VEHICLE LEFT SIDE.

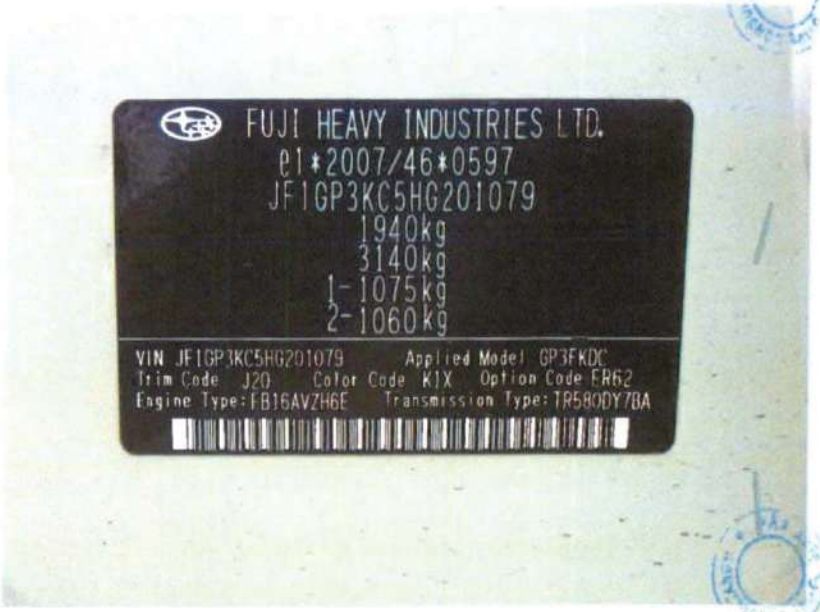
Impact on the rear LH portion.
Please see details as described in the Annex for parts and labour.

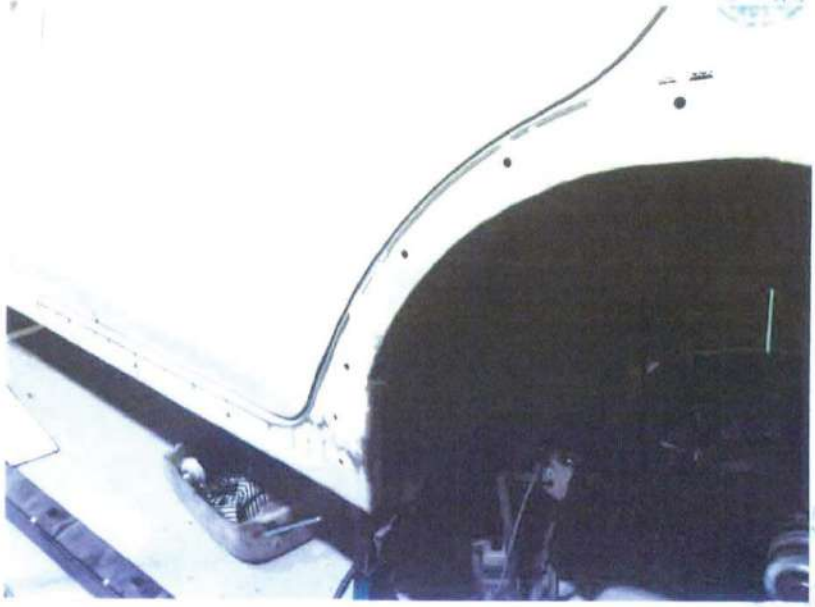
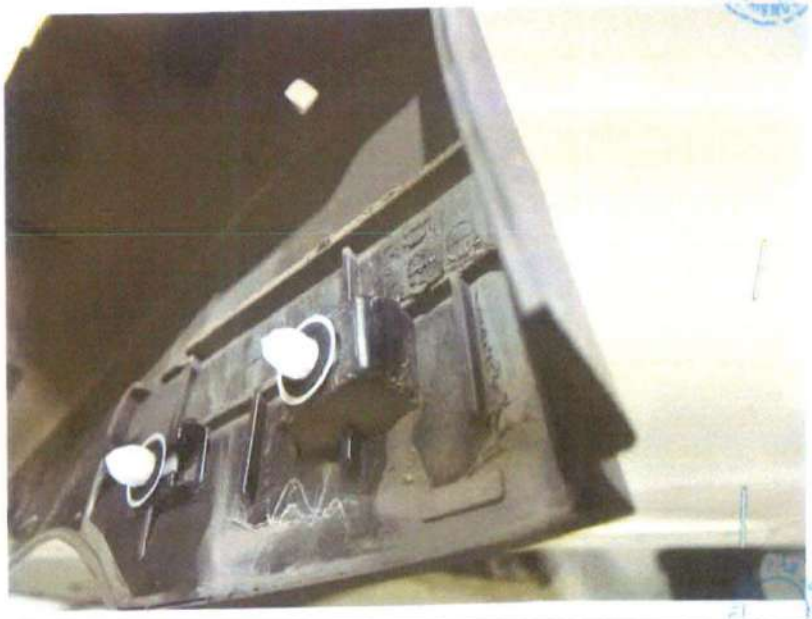
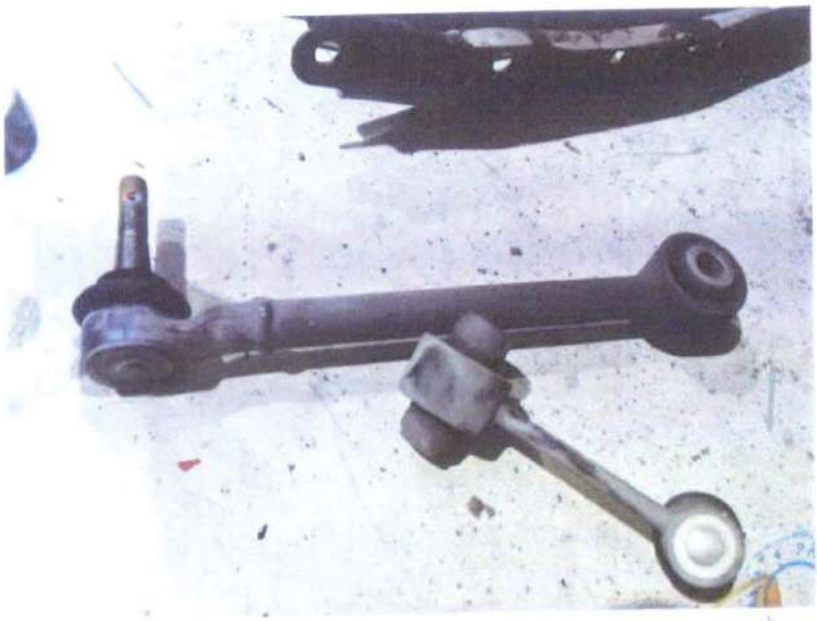
SLL 9689Z

We had carried out re-inspection during works in progress and post repair inspection on the above vehicle. Attached in Annex B are the re-inspection photos, showing the work in progress and our re-inspection to the hidden part that were damaged.
