NS/INC20011447/Eqf3

ASSIGNMENT

Claims No. MT/1107221-002

Veh No: SHB 6616O Yr Regn: 19/12/19

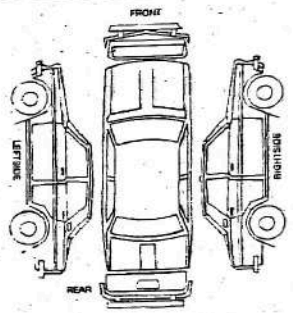
#: Cracked X: Dented
/: Scatched O: Missing

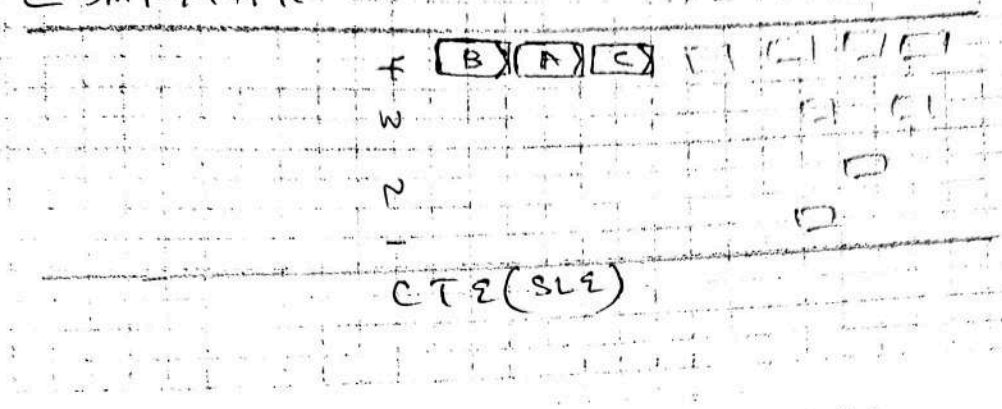
Sketch Plan Pg. 1

A - SHB 6616D
B - GBH 5832S
C - SMT 7474K

Somewhere near the end of the tunnel before the Moulmein exit, the front vehicles suddenly brake and stopped. I applied brake too and collided with the front car, C, and split second later, was hit by a van, B, from the rear.
