ASSIGNMENT

To Inspect Vehicle No: SLF 5265X

at Workshop m/s RICO 60 AUTO

Claims No. SNM21D201305/C02

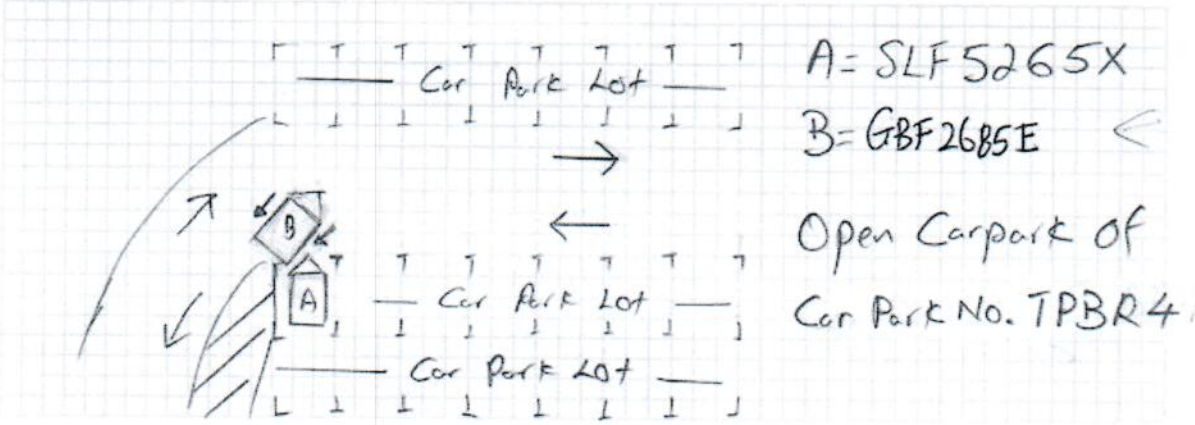
Sketch Plan

Suddenly, I felt an impact. When I looked up, I saw it was vehicle (B) that collided onto the front left hand side portion of my vehicle (A) while reversing.
