ASSIGNMENT

To Inspect Vehicle No: SLN 4768B

Veh No: SLN 4768B Yr Regn: 5/5/2017

Make: Mercedes Benz CLA 180 c.c 1595

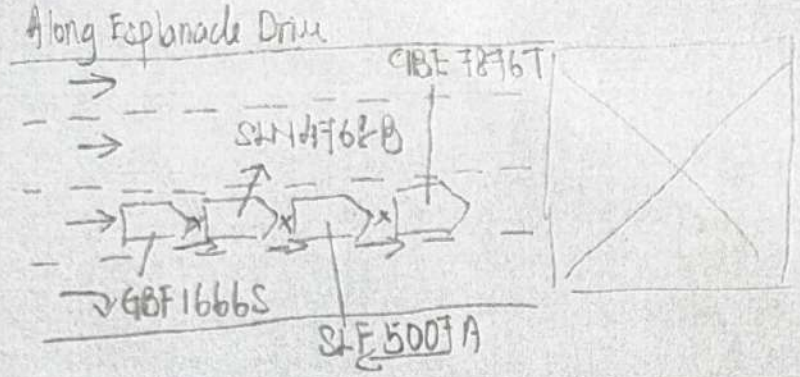
SKETCH PLAN

Car accident 24 April 21 (chain collision 4 cars).

It was a 4 lane road (3 straight , 1 right turn). My car was on 3rd lane from left. I Stopped fully at traffic light. After about 3 Seconds , I felt my car being banged from behind and jerked forward. a pick up GBF 1666S couldn't stop in time and had rear ended my car which cause My car to collide into the front car SLF 5007A (GRAB). The GRAB car then collided into the van (GBE 7876T) in front. At the time of accident , ms tan hui Min was seated in the passenger seat next to me. Both of us suffered slight Injury :
Me - right shin bruise/ swollen , left calf bruised , right elbow abrasion.
Tan hui Min - right back sore
We have seen a doctor after the accident. (DTAP clinics 11 unity street , #02-06. Robertson walk. Dr Jonathan Ti)
