ASSIGNMENT

Veh No: SCW 8675T Yr Regn: 04, 99

Make: Honda Civic VTi c.c 1493

ESTIMATE REPAIR BILL ON SCW8675T HONDA CIVIC AUTO

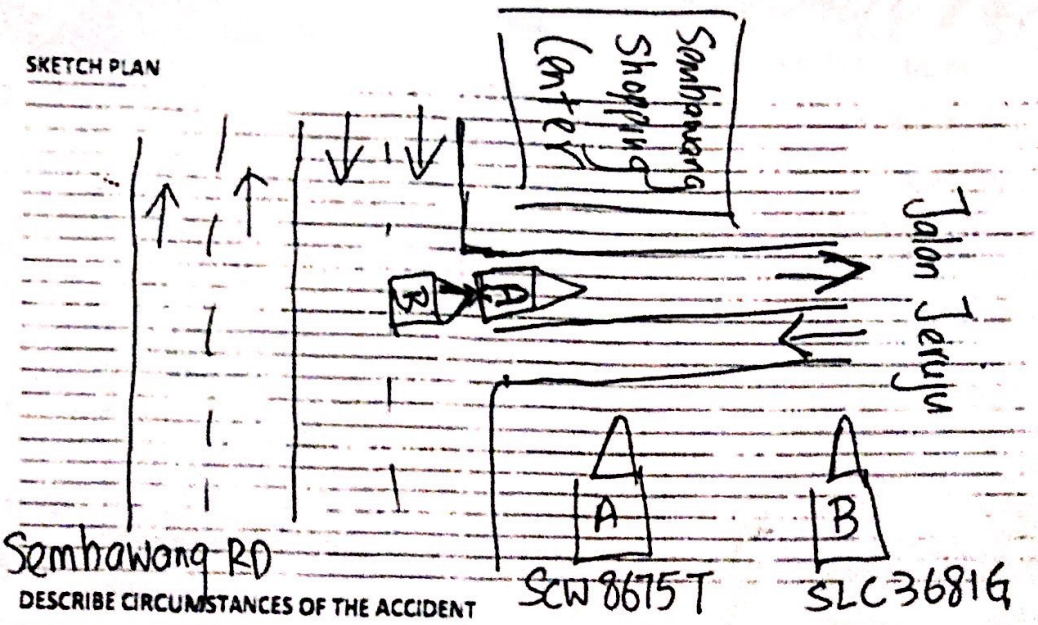
SKETCH PLAN

On Saturday around 6pm, I turned from Sembawang Road into Jalan Jeruju, I slowed down due to Pedestrian crossing the road. Suddenly, car B banged onto the rear of my car (car A) with loud bang. My travelling speed is ard 20Km/hr.
