ACCIDENT INVOLVING SMA 4439H / SMK 2100U ON 21.4.2022 ALONG TAMPINES AVE 5 TOWARDS PIE

VEHICLE APPRAISAL REPORT

Registration No.	: **SMA 4439H**	Chassis Frame No.	: ZYX10-2118735
Make / Model	: Toyota C-HR Hybrid 1.8S CVT	Engine No. (Logcard)	: 2ZR8431654
Year of Manufacture/Reg	: 2018	Odometer Reading	: 218,337 KM
Colour	: Red		
Class / Type	: SUV

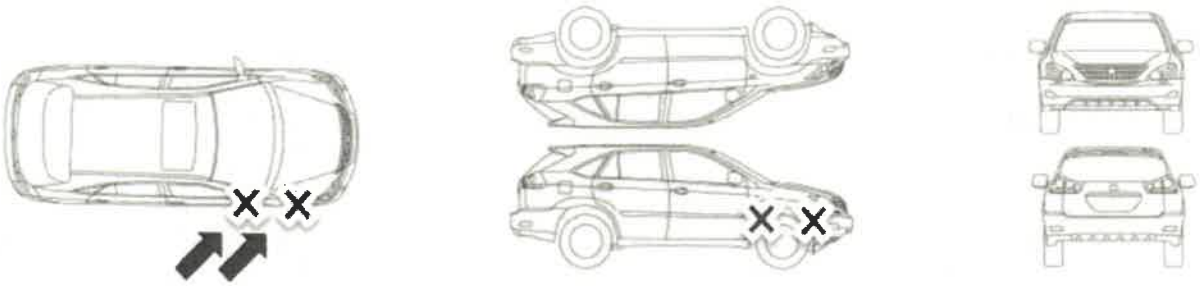
Damages sustained were consistent with the subject vehicle being involved in a collision with another vehicle and the impact was delivered **Diagonally to the RH Side from rear to front; right to left;** portion of the vehicle.

The general area of damages is at the **RH Side portion** .
(Please refer to the parts list and photographs as attached for more information)

The estimated repair costs submitted by Messrs **Oohray Rental Pte Ltd** is $ 4,072.80 .
We have adjusted the cost to $ 3,022.10 and the repairer has agreed to undertake the repairs at a
Contract Lump Sum of $ 2,400.00 to a acceptable quality and standards.
However, we have not given authorization and instruction to the repairer to proceed with the repairs.

The repairs should be completed within a reasonable period of **3** working days.
