ASSIGNMENT

To Inspect Vehicle No: SKW 4952A

Veh No: SKW4952A Yr Regn: 30/10/15

SINGAPORE ACCIDENT STATEMENT

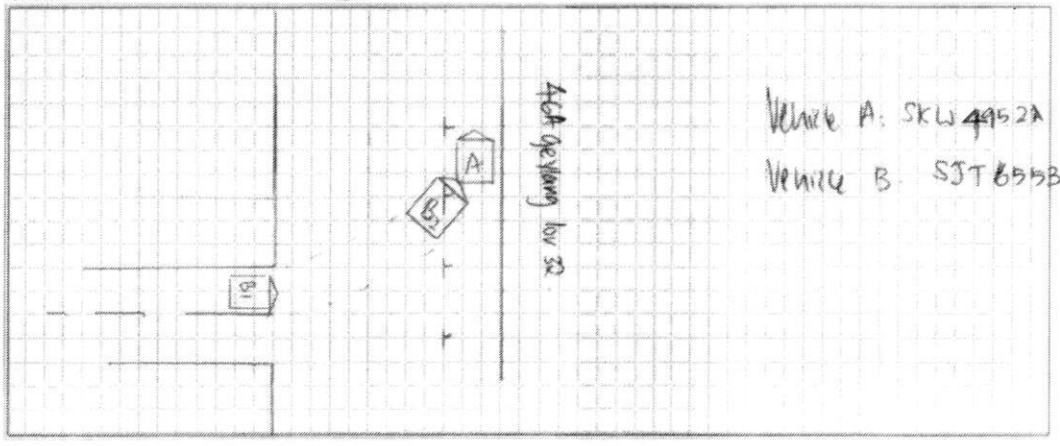
Sketch Plan

On the stated date and time, my vehicle was parked parallel stationary at the carpark lot of 46A geylang lor 32, as I just live nearby, I did heard a loud bang and was informed by my landlord that vehicle B has collided onto my stationary vehicle's rear left portion.
