Your Ref: 23/24/24/VC05/029893
Our Ref : CS/LPC24100120/K

14 October 2024

**TECHNICAL INVESTIGATION REPORT OF INSURED VEHICLE YQ 1422Z
INVOLVED IN AN ACCIDENT ON 10 SEPTEMBER 2024**

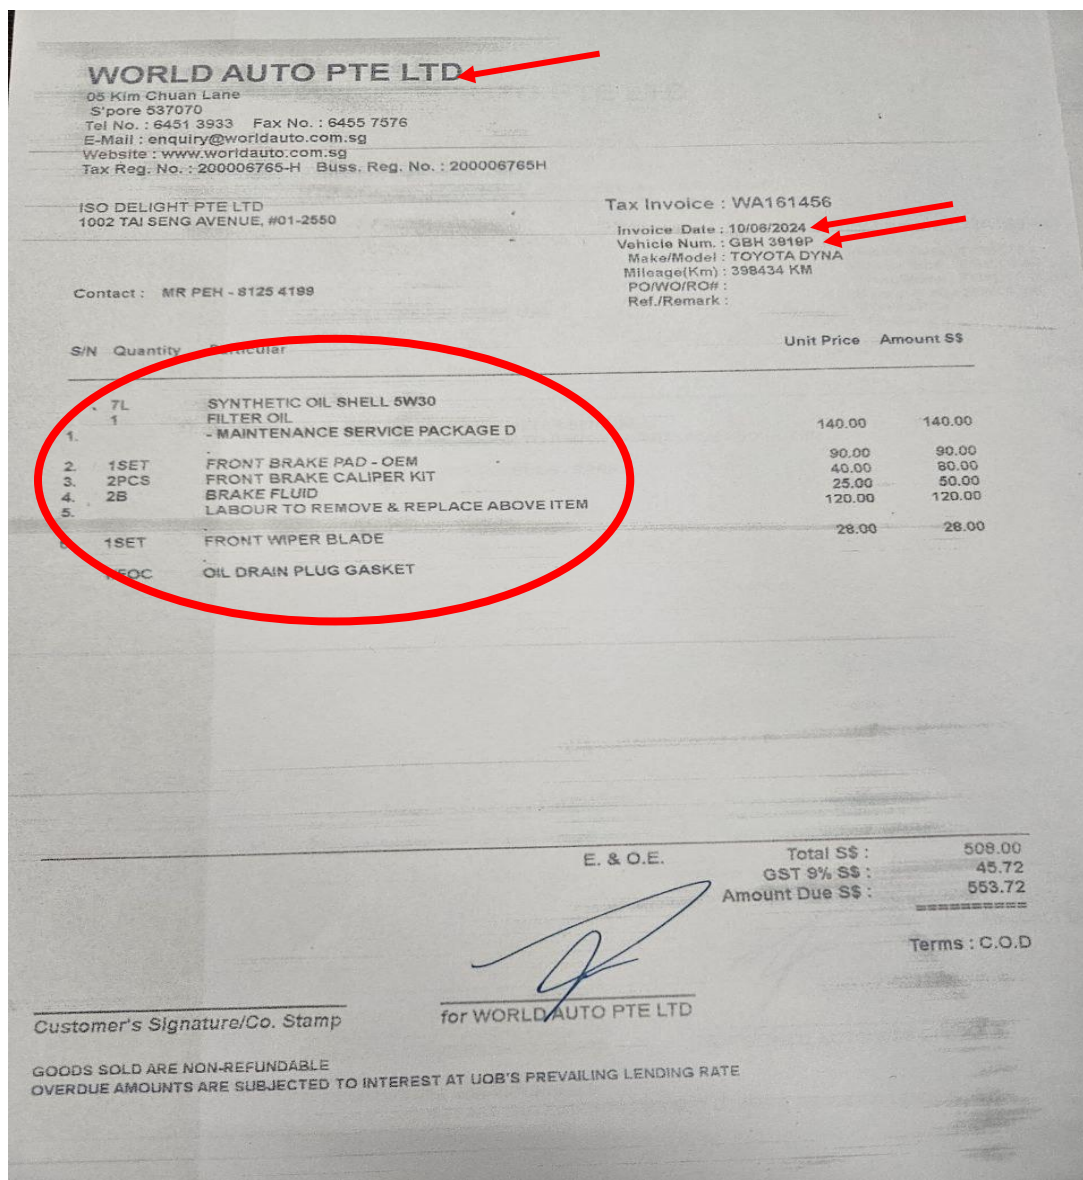
11. Pertaining to the maintenance aspect, Mr Daryl Peh who is the fleet manager for ISO Delight Pte Ltd mentioned that the Insured Vehicle was sent in to conduct a periodical maintenance by World Auto Pte Ltd on the 10 August 2024. See invoice 1 below.

Invoice 1 shows the latest servicing invoice where the last known periodical service was conducted on the Insured Vehicle at World Auto Pte Ltd on the 10 August 2024 (red arrows). The servicing package had included changing of engine oil, oil filter, oil drain plug gasket, front brake pads, replacement of brake fluid and replacement of front wiper blades (circled).
