**TECHNICAL INVESTIGATION REPORT OF INSURED VEHICLE SKZ 8123J
INVOLVED IN AN ACCIDENT ON 14 DECEMBER 2024**

Registration Number : SKZ 8123J
Make & Model : TOYOTA ALPHARD 2.5G CVT ABS D/AIRBAG 2WD 5DR
Year of Registration : APRIL 2016
Chassis Number : AGH300032567
Speedo Reading : N/A

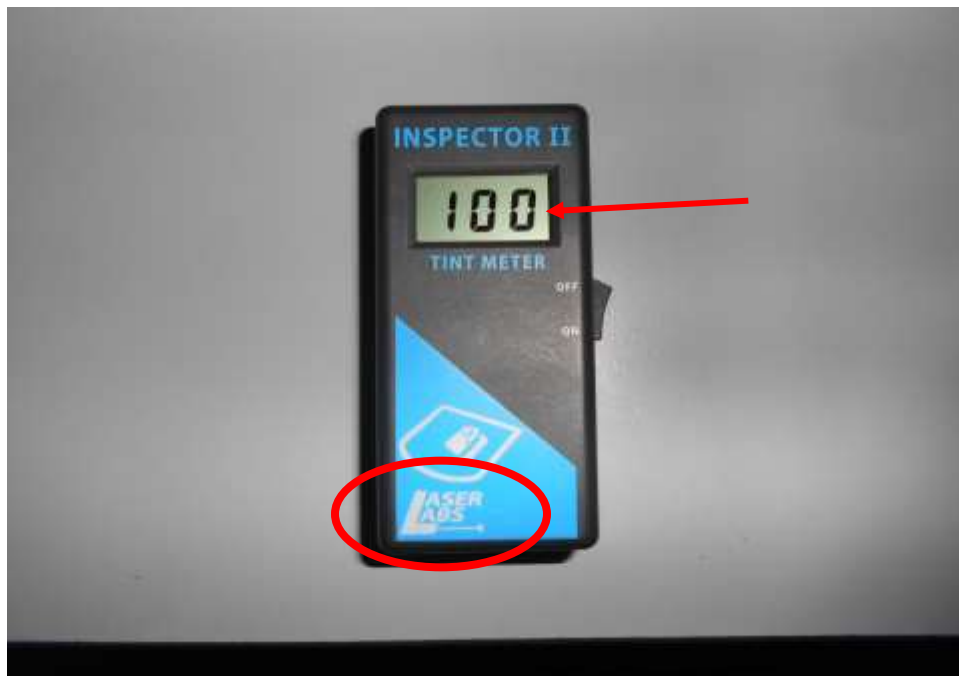
Photo 5 shows the Tint Meter used to measure the Visible Light Transmission (VLT) on the Insured Vehicle's windscreen and windows which has been recalibrated (red arrow) before the testing of the Visible Light Transmission (VLT) of the window and windscreen tints. The brand of the Tint Meter was 'Laser ABS'
