**Preliminary Advice**

| Vehicle No | : SGG161Z | Accident Date | : 27/07/2016 |
| Make | : VOLKSWAGEN JETTA | Policy No. | : A27158598QMY |

The vehicle sustained impact / damages front o/s portion and parts claimed are consistent to the accident.

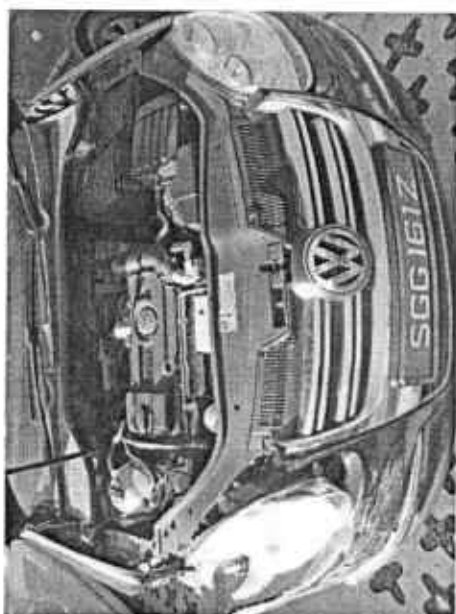
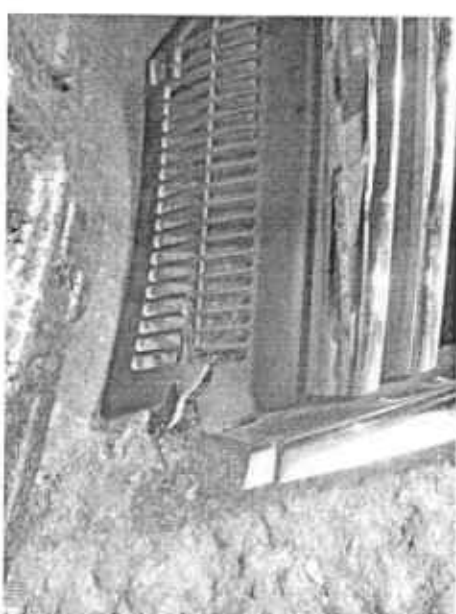
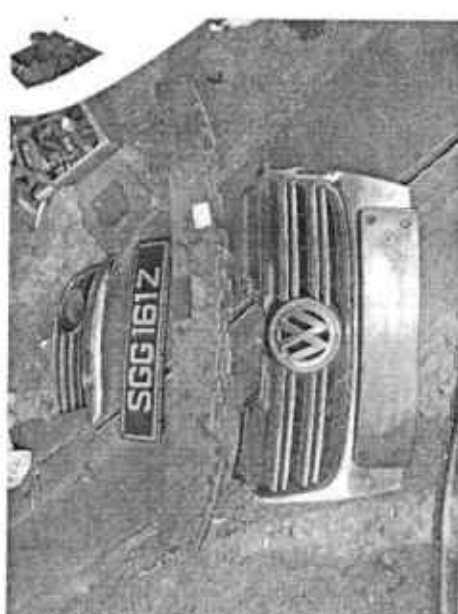
- Based on the photographs taken, the front grille base was cracked, front grille chrome frame and front grille chrome stripe was with deformation due to the impact. As for the front logo & old grille base clips it is necessary to be replaced when the front grille is being replaced.
- Labour was given \$1000 to replace front bumper, front bumper <sup>and</sup> front RH fender, and to repair the front RH fender inner panel and front RH door which was affected due to the accident.

Front grille base crack.

| No. | Qty | Part No. | Particulars | Condition | Repairer's | Amount |
|---|---|---|---|---|---|---|
| 16 | 1 | | *FRT GRILLE BASE (WCP) | Cracked | 169.50 F | *169.50 F |
