Your Ref: CMTD1703331  
Our Ref : CI/SMO17019484/D

**Sompo Insurance Singapore Pte Ltd**

**TECHNICAL INVESTIGATION REPORT OF ENGINE DAMAGE TO THE INSURED VEHICLE SKS 7683C**

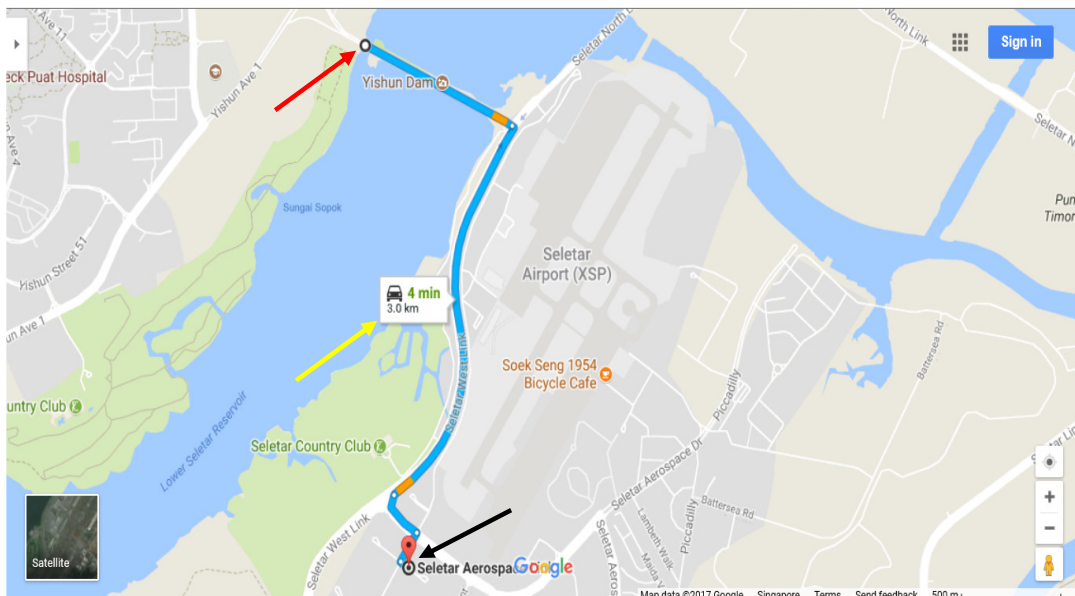
9. In view of the vaguely reported incident location of along Yishun Avenue 1, I had on 10 October 2017, spoken to the driver of the Insured Vehicle. I was informed that, to the best of her recollection, a more approximate incident location would be along Yishun Avenue 1, just before Yishun Dam.
10. From the document relating to the towing work that was carried out by Eng Bee Recovery Pte Ltd, it was recorded that the Insured Vehicle was towed from the junction of Seletar Aerospace and Seletar Aerospace Link. Basing on Google Map, the approximate distance from the reported location where the Insured Vehicle had gone over the stones to the reported location where it was towed was approximately 3km. See screenshot extracted from Google Map below.

Screenshot extracted from Google Map shows the shortest distance from Yishun Avenue 1, just before Yishun Dam (red arrow) to Seletar Aerospace Link (black arrow). Co-relating this distance with this particular case, the Insured Vehicle had travelled a distance of at least 3km (yellow arrow) after it had gone over the stones before being eventually brought to a stop after a warning message had appeared on the console screen of the Insured Vehicle.

11. The damage to the engine of the Insured Vehicle could have thus been avoided if it was not driven for this 3km. Such damage can therefore be considered to be a consequential damage and not a direct damage as a result of the Insured Vehicle going over the stones.
