Your Ref: CMTD1703331  
Our Ref : CI/SMO17019484/D

**Sompo Insurance Singapore Pte Ltd**  
50 Raffles Place #05-01/06  
Singapore Land Tower  
Singapore 048623  
(Motor Claims Department)

### **TECHNICAL INVESTIGATION REPORT OF ENGINE DAMAGE TO THE INSURED VEHICLE SKS 7683C**

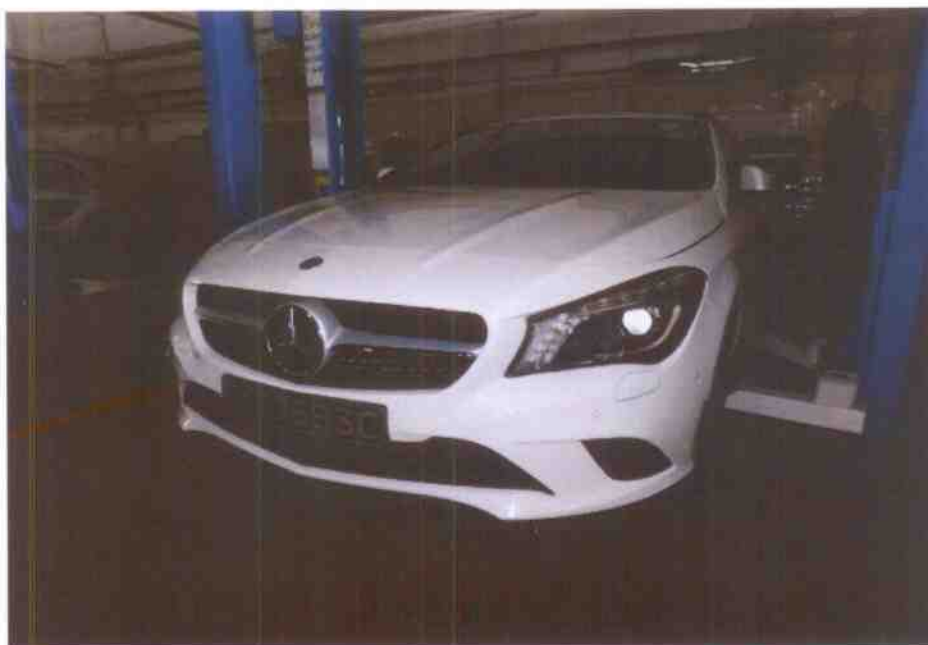
4. It was noted from the photographs provided to me that the engine oil sump, front engine undercover and centre engine undercover of the Insured Vehicle were damaged as a result of the incident.

5. The photographs had depicted both the front engine undercover and centre engine undercover torn, and engine oil sump broken. The damage profile of these 3 parts correspond to the Insured Vehicle going over an object. See photo 1 – 4 below.

**Photo 1** shows a general view of the Insured Vehicle as seen from the photographs that were provided to me.

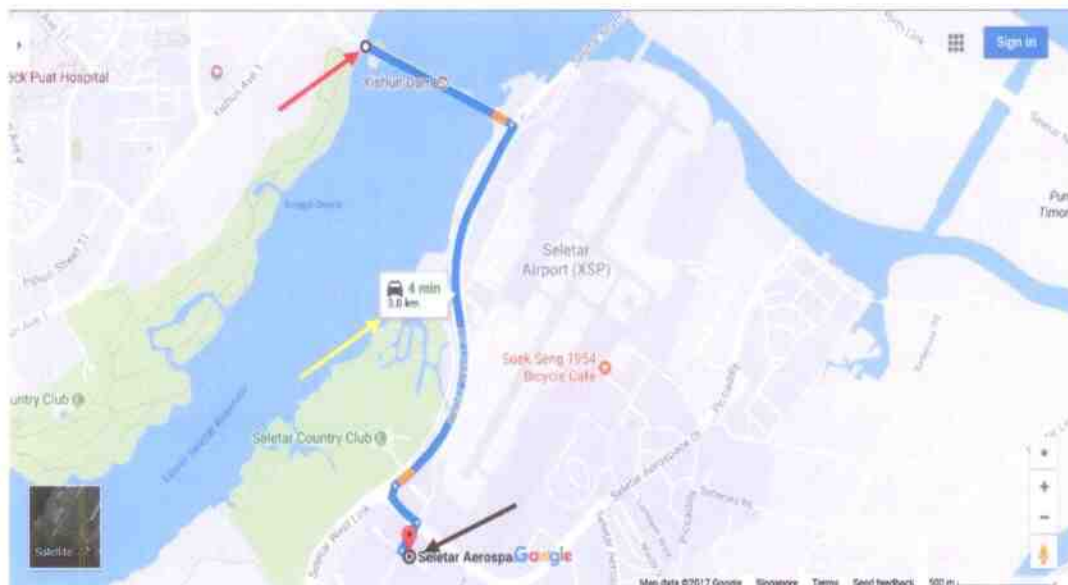
Screenshot extracted from Google Map shows the shortest distance from Yishun Avenue 1, just before Yishun Dam (red arrow) to Seletar Aerospace Link (black arrow). Co-relating this distance with this particular case, the Insured Vehicle had travelled a distance of at least 3km (yellow arrow) after it had gone over the stones before being eventually brought to a stop after a warning message had appeared on the console screen of the Insured Vehicle.

11. The damage to the engine of the Insured Vehicle could have thus been avoided if it was not driven for this 3km. Such damage can therefore be considered to be a consequential damage and not a direct damage as a result of the Insured Vehicle going over the stones.
