Your Ref: TP/IP/51353/2017
Our Ref : CI/TPD17021563/Z

20th November 2017

Fatal Accident Investigation Team

MECHANICAL INSPECTION REPORT OF MOTOR LORRY GBF 1281T

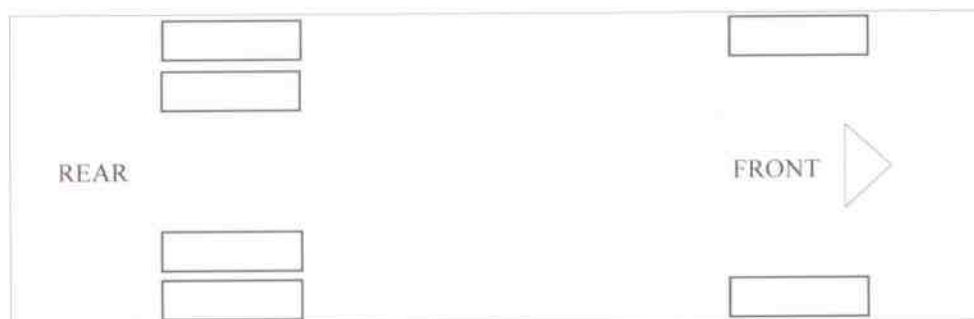
6. The 2 front tyres and 4 rear tyres of the Motor Lorry were observed to be in serviceable condition and sufficiently inflated for vehicular operation. We did not find any tear, cut or burst mark(s) on the outer and the inner sidewalls as well as across the tread of the 6 tyres. The tyre brand, tyre size and remaining tread depth of the 6 tyres of the Motor Lorry were recorded as follows:-

Bridgestone RD-613 145 R13 (5mm)

Maxtrek SU-810 195 R15 6mm)

Bridgestone RD-613 145 R13 (2mm)

Bridgestone R202 175/75 R15 (9mm)
