Your Ref: TP/IP/45529/2017  
Our Ref : CI/TPD17021579/Zn

**Fatal Accident Investigation Team**

**MECHANICAL INSPECTION REPORT OF MOTOR TAXI SHD 1875U**

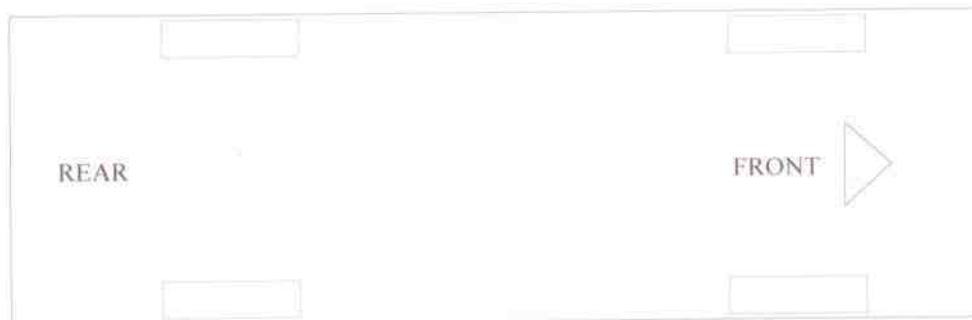
6. The condition of the Motor Taxi's 4 tyres was observed to be in serviceable condition. We did not find any tear, cut or burst mark(s) on the outer and the inner sidewalls as well as across the tread of the 4 tyres. The 4 tyres were also observed to be sufficiently inflated for vehicular operation. The tyre brand, tyre size and remaining tread depth of the 4 tyres were recorded as follows:-

Maxxis Radial UA-603 205/65ZR16 (4mm)

Maxxis Radial UA-603 205/65ZR16 (5mm)
