Your Ref: TP/IP/60517/2017  
Our Ref : CI/TPD17022590/Z

**Fatal Accident Investigation Team**

**MECHANICAL INSPECTION REPORT OF MOTOR VAN GW 5055E**

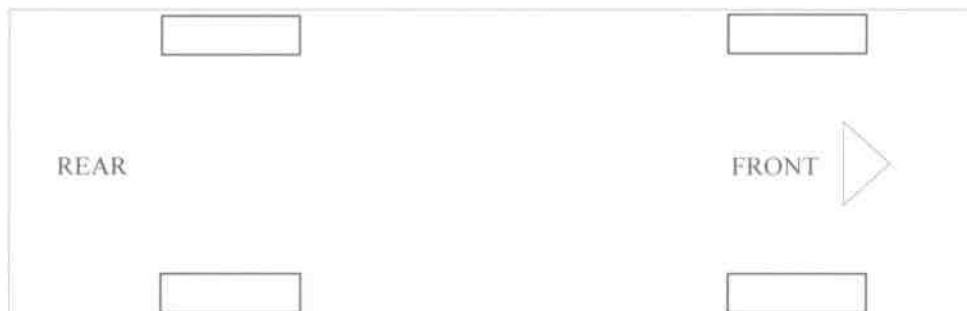
6. The 2 front tyres and 2 rear tyres of the Motor Van were observed to be in serviceable condition and sufficiently inflated for vehicular operation. We did not find any tear, cut or burst mark(s) on the outer and the inner sidewalls as well as across the tread of the 4 tyres. The tyre brand, tyre size and remaining tread depth of the 4 tyres of the Motor Van were recorded as follows:-

Bridgestone Duravis R624  
185R14 (2mm)

Yokohama Delivery Star 818  
185R14 (6mm)

Yokohama Delivery Star 818  
185R14 (1.6mm)

Yokohama Delivery Star 818  
185R14 (5mm)
