Your Ref : 73740  
Our Ref : CI/DAI17022799/N

20 November 2017

## **TECHNICAL INVESTIGATION REPORT OF FIRE INCIDENT INVOLVING THE INSURED MOTORCYCLE FT 4200L ON 13 NOVEMBER 2017**

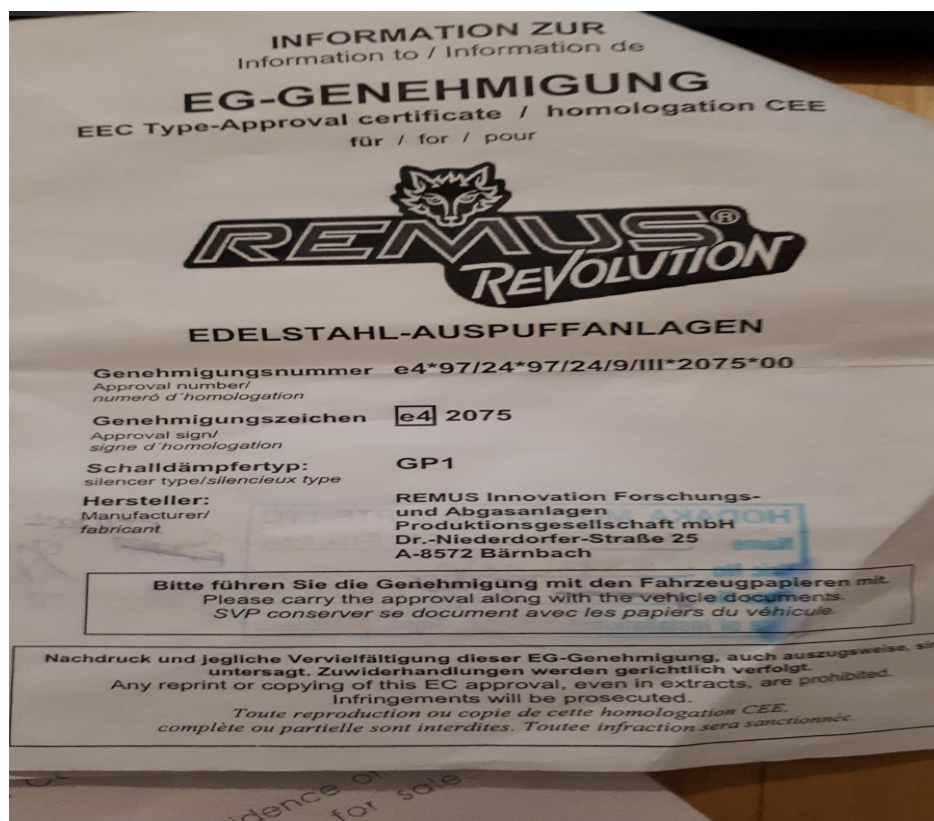
15. We asked Mr Simon regarding the engine crash bars, side pannier racks, and non- standard rear exhaust muffler that were fitted on the Insured Motorcycle. He mentioned that all these components came with the Insured Motorcycle when he purchased it. As for the after-market rear exhaust muffler, it was already registered to the Insured Motorcycle by the previous owner. We were able to obtain the exhaust authentication certificate as well as the inspection acknowledgement letter issued by the LTA to prove that the after-market rear exhaust muffler had passed inspection on 5 October 2012. See photos 15 & 16 below.

**Photo 15** shows the REMUS rear exhaust muffler authentication certificate for the Insured Motorcycle.
