Your Ref: TP/IP/51353/2017  
Our Ref :CI/TPD17023257/Z

**Fatal Accident Investigation Team**

**INSPECTION REPORT OF BICYCLE (GREEN) - TRAFFIC POLICE POUND  
REPORT NO. PR3995/17**

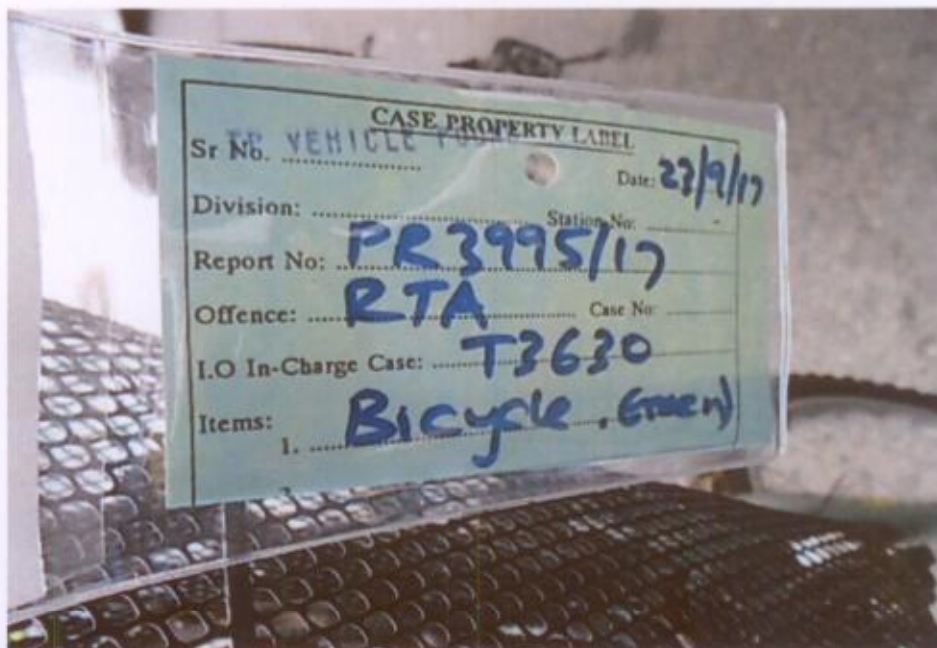
Photo 1 shows the identification of the Bicycle with reference to Traffic Police Pound Report No. PR3995/17.

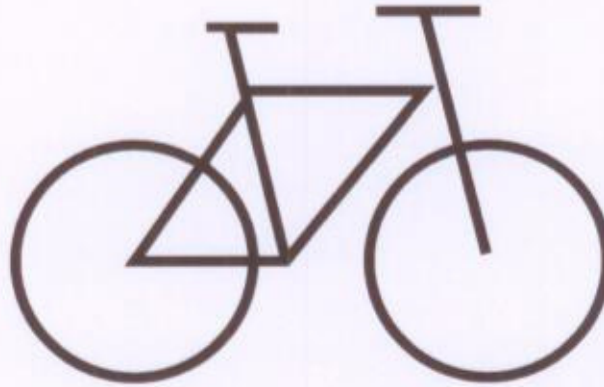
5. The condition of the Bicycle's front & rear tyres was observed not to be in serviceable condition. The tread pattern of the 2 tyres was observed only visible on the sides of both tyres, the middle section of the 2 tyres was observed to be bald.
6. Further examination on the rear tyre revealed that the inner core of the tyre was found to be exposed at the middle section of the tyre. Having said that, we did not observe any tear, burst mark(s) and/or punctured hole(s) on the sidewalls as well as across the tread of the 2 tyres.
7. The front tyre was observed to be deflated at time of our inspection whereas the rear tyre was sufficiently inflated for vehicular operation. The tyre brand, tyre size and remaining tread depth of the 2 tyres were recorded as follows:-

Wandaking 53-559 26 X 1.95 (0mm on the middle section )
