INSPECTION REPORT OF MOTORCYCLE FBE 3545A

1. We refer to your request dated 24th November 2017 to conduct a physical inspection of a motorcycle bearing registration number FBE 3545A (herein referred to as "**Motorcycle**"), which was involved in a fatal road traffic accident.
2. The purpose of this inspection is to primarily determine if there was any possible mechanical failure to the Motorcycle that may have contributed to the accident.
3. Following the request, we had carried out a physical inspection of the Motorcycle on 07th December 2017 at the premises of Traffic Police vehicle pound, 517 Airport Road Singapore 539942. We now set out below our observations and comments with respect to this inspection.

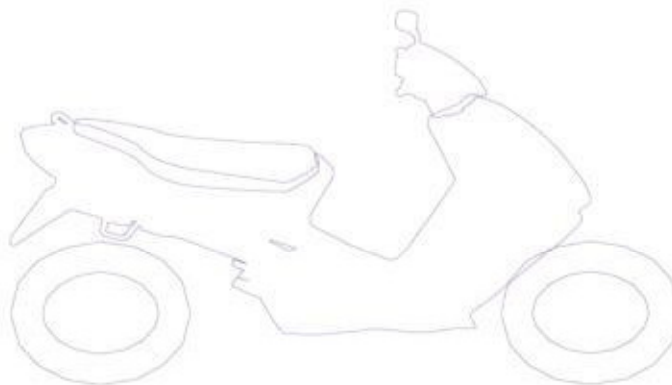
6. The condition of the Motorcycle's 2 tyres was observed to be in serviceable condition. The tread pattern of the 2 tyres was clearly visible. We did not observe any tear, burst mark(s) and/or punctured hole(s) on the sidewalls as well as across the tread of the 2 tyres. The 2 tyres were both observed to be sufficiently inflated for vehicular operation. The tyre brand, tyre size and remaining tread depth of the 2 tyres were recorded as follows:-

Metzeler 160/60 - R17
(3mm)

Metzeler 110/70 - R17
(2mm)
