Your Ref : M1703953/FG
Our Ref : CI/TMI17014634/N-1

**AUTOMOBILE TECHNICAL INVESTIGATION REPORT OF ACCIDENT
INVOLVING SHA 4501U AND GBB 2494K ON 26 JULY 2017**

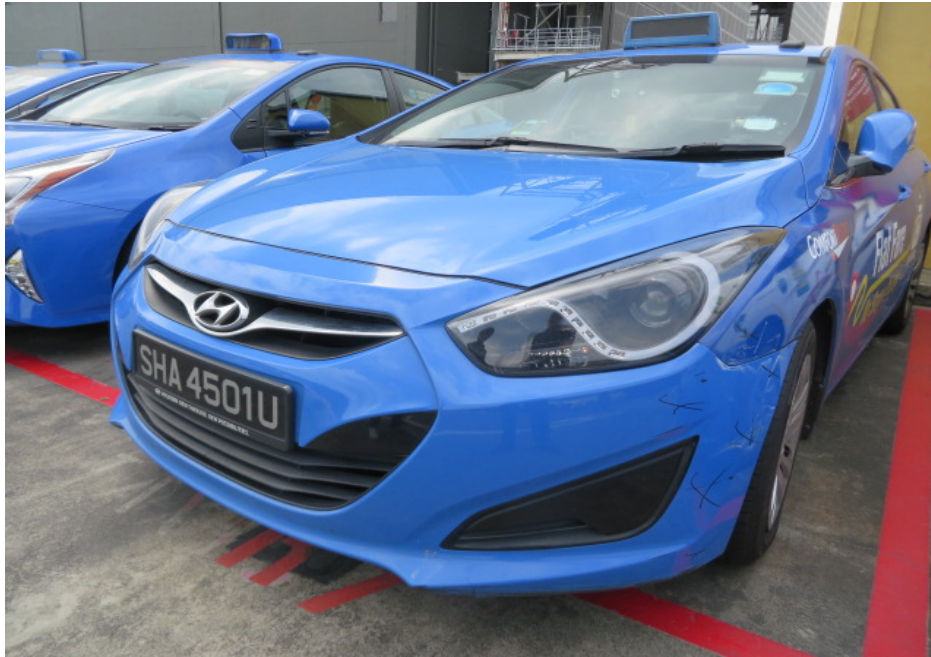
Photo 1 shows a front view of the Taxi at the time of the Pre- Repair Survey conducted by LKK Auto Consultants Pte. Ltd. which was taken about 2 days after the accident.

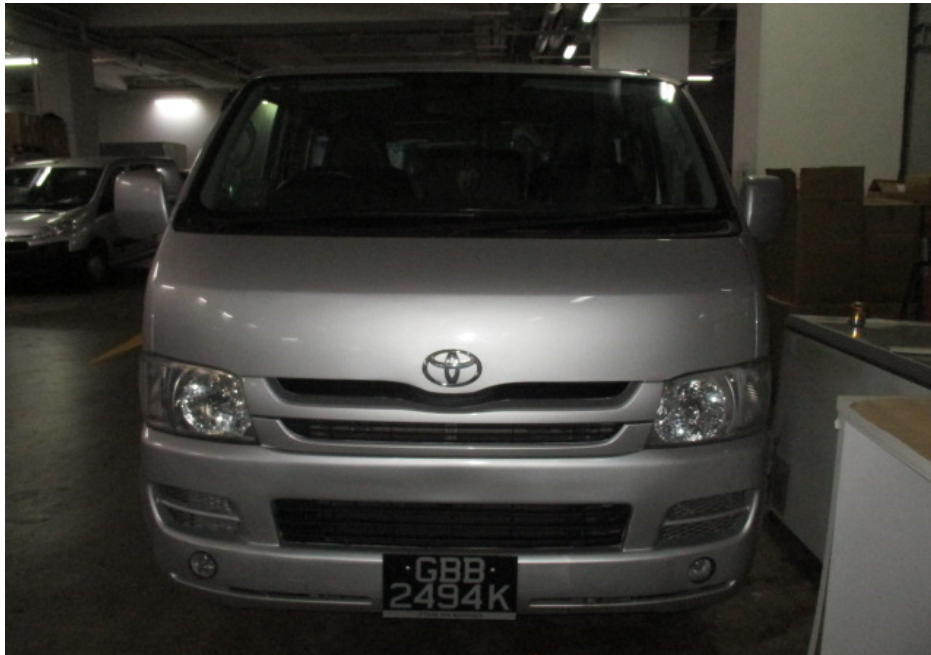
Photo 6 shows the general view of the front portion of the Van at the time of our inspection.

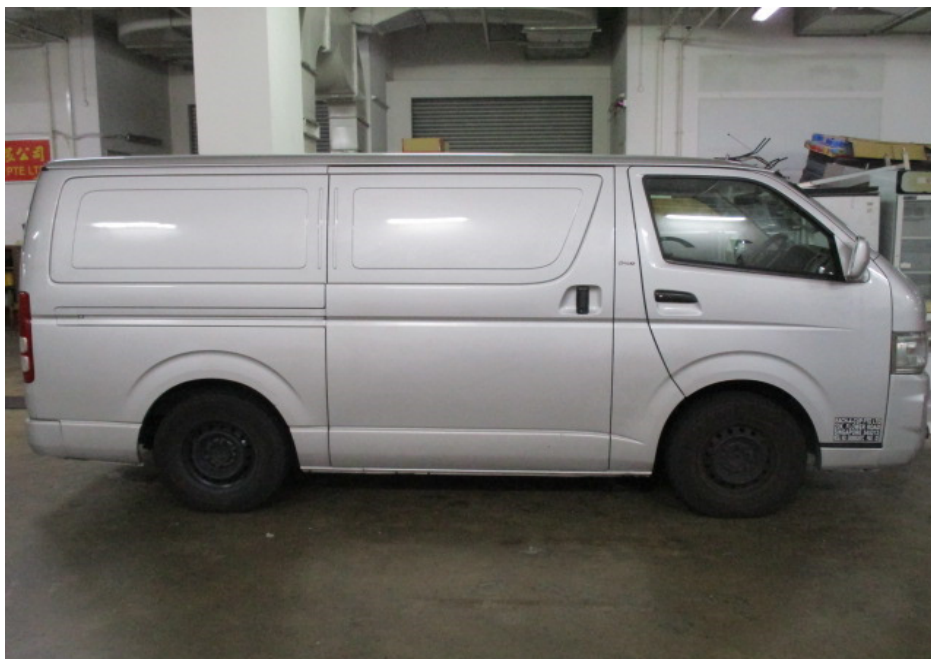
Photo 7 shows the general view of the right side of the Van at the time of our inspection.

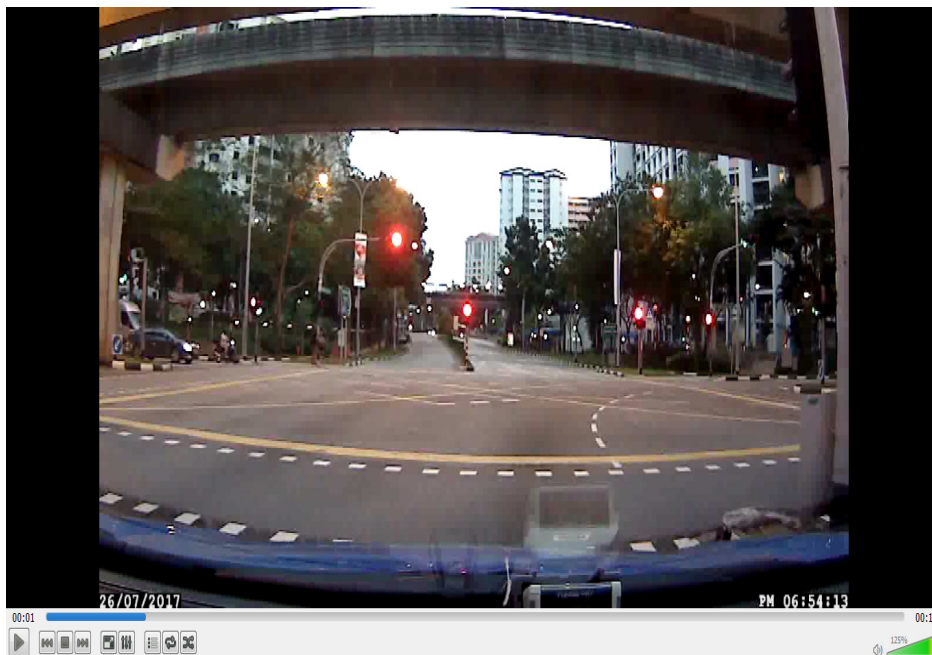
Screenshot 1 of the 1st video recording from the video recording device that was mounted onto the front windscreen of the Taxi shows the Taxi waiting to turn right into Rivervale Drive at the traffic junction of Sengkang East Way on the 1st lane at the 1 second mark.

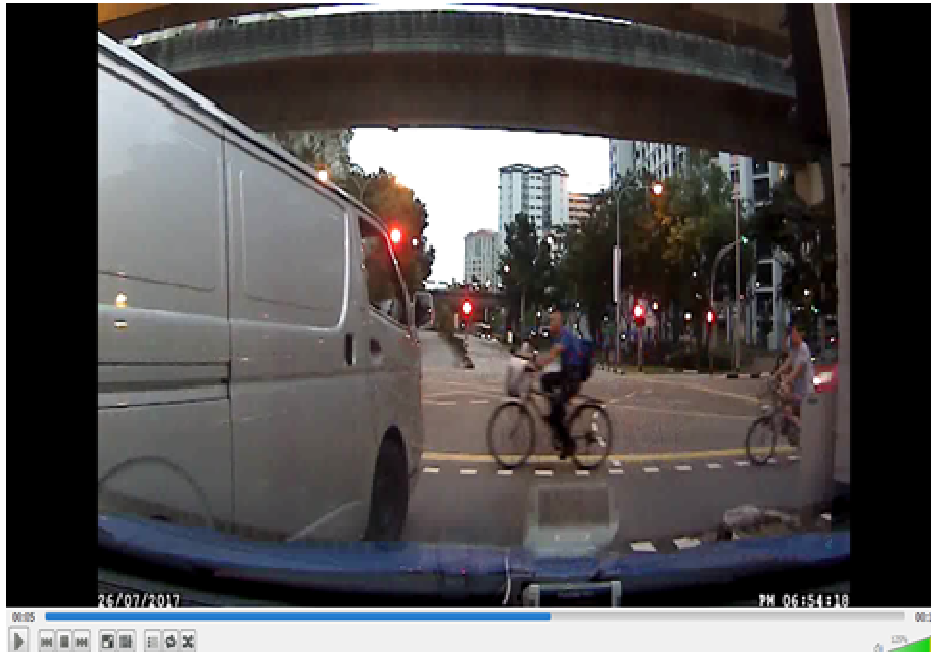
Screenshot 2 of the 1st video recording from the video recording device that was mounted onto the front windscreen of the Taxi shows the Van approaching the traffic junction and the driver positioning the Van towards the right, close to the Taxi from the 2 second mark till the end of the duration of the video.

15. For this case, based on the nature of damages of grazing nature to the left front portion of the Taxi and the rear right portion of the Van as well as close examination of the video recordings provided to us, it would appear that the point of contact between the Involved Motor Vehicles would be the left front portion of the Taxi and the rear right portion of the Van as the Van was trying to overtake the Taxi which was on the 1st lane, to turn right at the traffic junction.
