Your Ref: TP/IP/65709/2017
Our Ref : CI/TPD17024643/Z

29th December 2017

MECHANICAL INSPECTION REPORT OF MOTOR CAR SJU 8481M

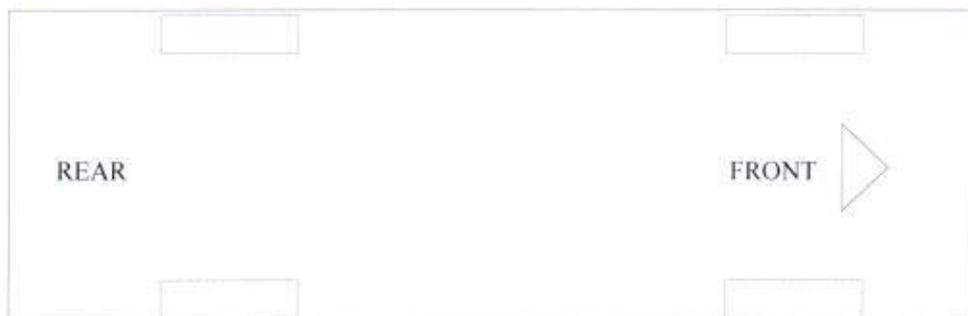
6. The condition of the Motor Car's 4 tyres was observed to be in serviceable condition. We did not find any tear, cut or burst mark(s) on the outer and the inner sidewalls as well as across the tread of the 4 tyres. The 4 tyres were also observed to be sufficiently inflated for vehicular operation. The tyre brand, tyre size and remaining tread depth of the 4 tyres were recorded as follows:-

Neuton NT511 195/65R15 (7mm)

Neuton NT511 195/65R15 (6mm)
