MECHANICAL INSPECTION REPORT OF TOW TRUCK XD 8880T

1. We refer to your request on 13th December 2017 to conduct a physical inspection of a tow truck bearing registration number XD 8880T (herein referred to as "**Tow Truck**"), which was involved in a road traffic accident on 13th November 2017.
2. The objective of this inspection is to determine if there was any possible mechanical failure to the Tow Truck that may have contributed to the accident.
3. Following the request, we had carried out a physical inspection of the Garbage Truck on 23rd January 2018 at the premises of Traffic Police vehicle pound, 517 Airport Road Singapore 539942. We now set out below our observations and comments with respect to this inspection.

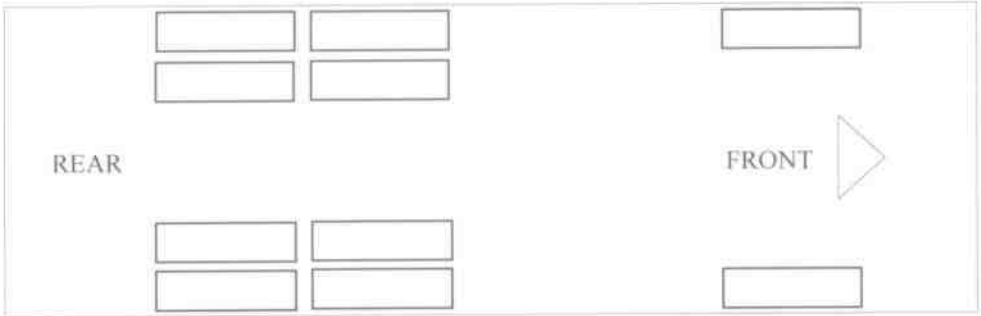
7. The 10 tyres fitted on the Tow Truck were found to be in serviceable condition despite 01 tyre from the front left was found to be with damages. The front left tyre on the tread pattern surface was found to be chipped off. However, further investigation revealed there was no tear, cut or burst mark(s) on the outer and the inner sidewalls as well as across the tread of the 10 tyres. The 10 tyres were sufficiently inflated for vehicular operation.
8. We did not find any tear, cut or burst mark(s) on the outer and the inner sidewalls as well as across the tread of the tyres. The tyre brand, tyre size and remaining tread depth of the Tow Truck's 10 tyres were recorded as follows:-

Firenza SSM 10 315/80 R22.5 (10mm)	Firenza SSD 08 315/80 R22.5 (10mm)	Agate HF121 315/80 R22.5 (10mm) (Chipped off)

Firenza SSM 10 315/80 R22.5 (8mm)	Agate HF638 315/80 R22.5 (5mm)	Agate HF121 315/80 R22.5 (8mm)
