Your Ref: 1396297935SG-001
Our Ref :CI/AIG18001166/Z

19th January 2018

**TECHNICAL INVESTIGATION REPORT OF FIRE INCIDENT INVOLVING THE
INSURED VEHICLE SJZ 8084A ON 30th DECEMBER 2017**

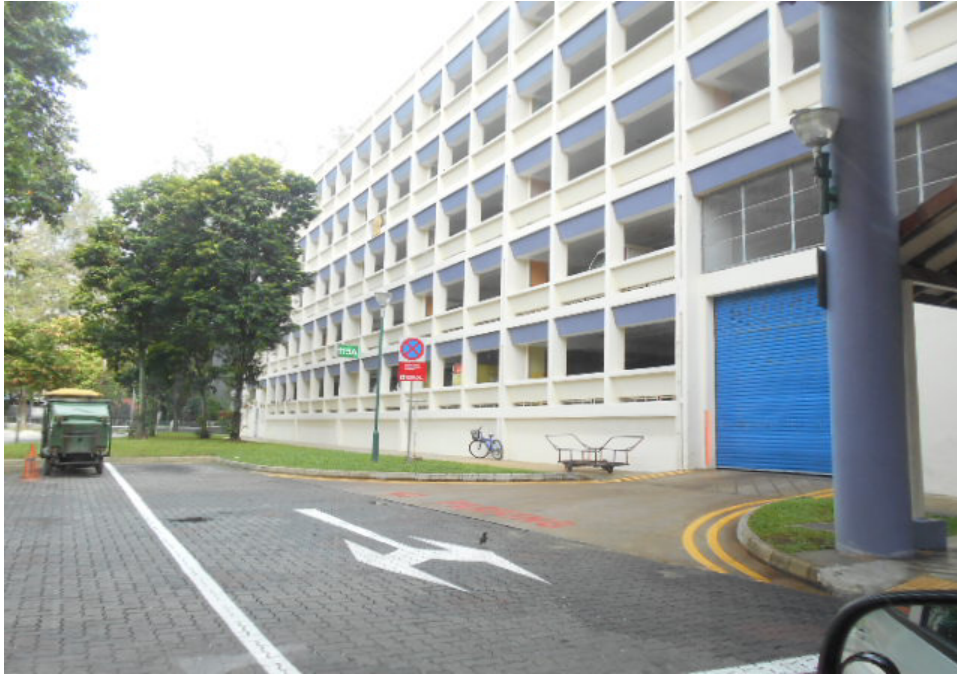
Photo 9 shows the general view of the multi-storey carpark where the Insured Vehicle was parked at the time of incident. This was inside the premises of blk 115A Ho Ching Road. The Insured Vehicle was parked at the 1st floor of this carpark at the material time of incident.

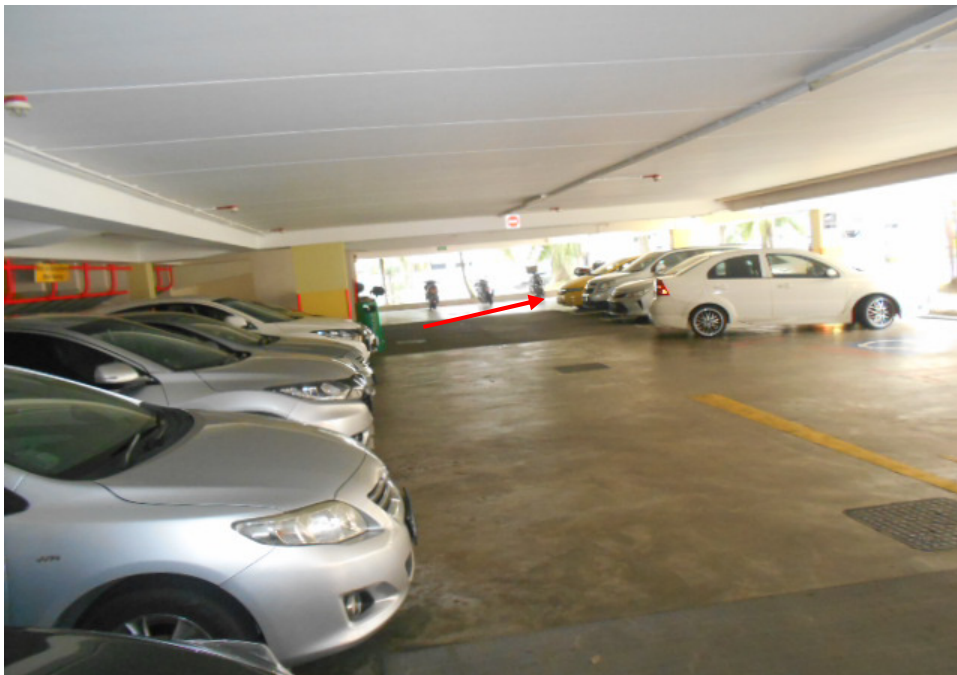
Photo 10 shows the general view of where the Insured Vehicle was parked (arrowed) at the time of incident. This was inside parking lot 3, which is on the left side of the carpark driveway, at the 1st floor of the multi-storey carpark.

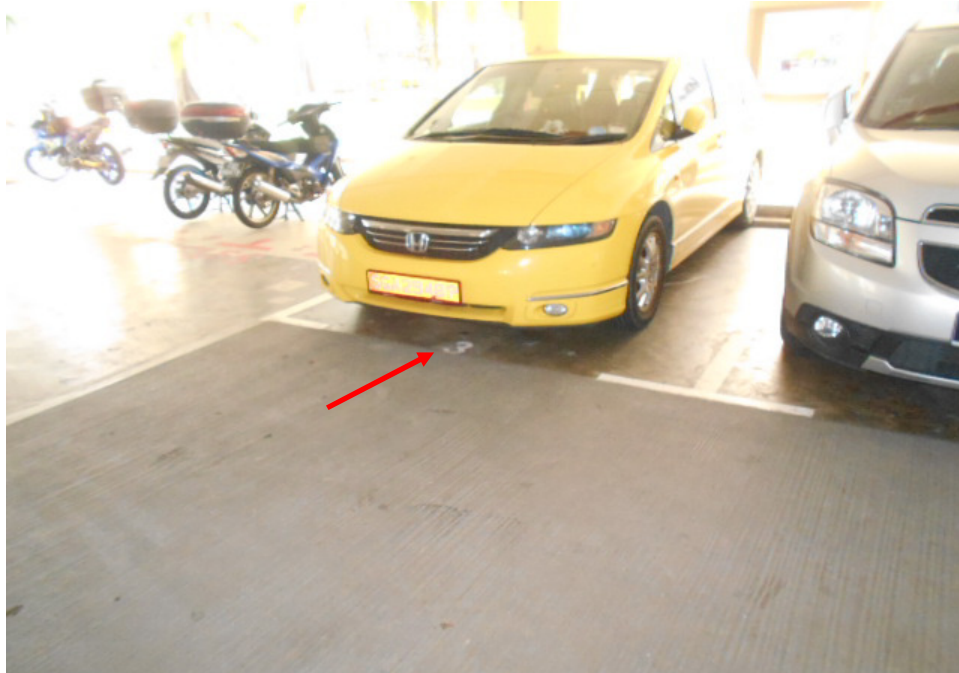
Photo 11 shows the general view of where the Insured Vehicle was parked (arrowed) at the time of incident. This was inside parking lot 3, which is the first of 3 parking lots in between the motorcycle lot and the handicapped lot.
