Your Ref: TP/IP/66307/2017
Our Ref : CI/TPD18001554/Z

03rd January 2018

MECHANICAL INSPECTION REPORT OF MOTOR CAR SLJ 8352L

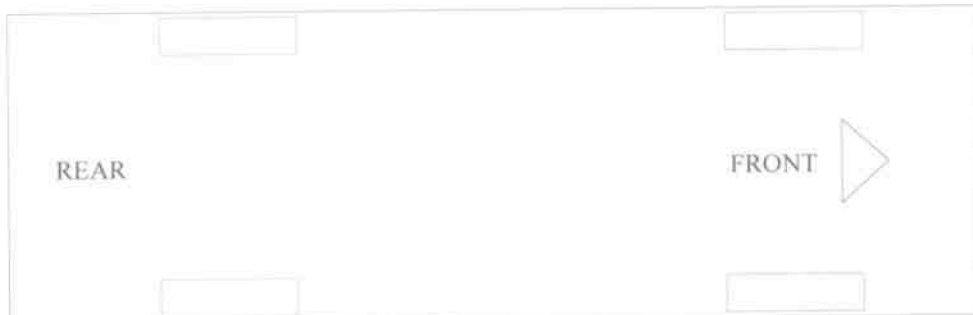
Classe Premiere CP672
195/60R14 (5mm)

Acenda ACE-100
195/60R14 (3mm) (Deflated)

Classe Premiere CP672
195/60R14 (6mm)

Acenda ACE-100
195/60R14 (5mm) (Deflated)
