Your Ref: 1801164929SG
Our Ref : CI/AIG18001638/N

TECHNICAL INVESTIGATION REPORT OF ENGINE DAMAGE TO THE INSURED VEHICLE SLB 9121Y

Registration Number.	: SLB 9121Y
Make & Model	: MERCEDES BENZ A200 FL STYLE (R17 HLG)
Year of Registration	: April 2016
Chassis Number	: WDD1760432J450276
Speedo Reading	: 40,259km

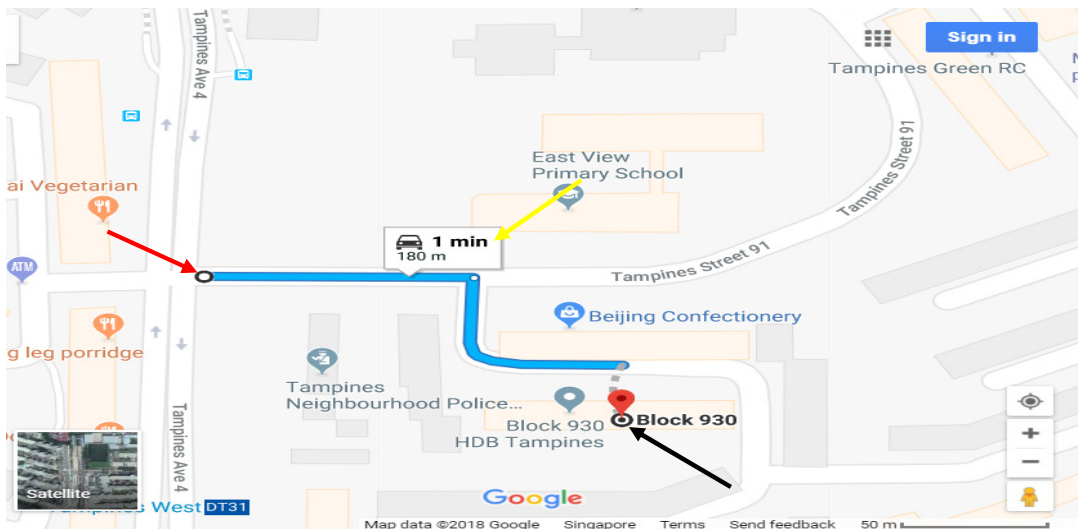
14. From the document relating to the towing work that was carried out by Eng Bee Recovery Pte Ltd, it was recorded that the Insured Vehicle was towed from the carpark of Block 930 Tampines Street 91. Basing on Google Map, the approximate distance from the reported location where the Insured Vehicle had gone over an object to Block 930 Tampines Street 91 where it was towed was approximately 180m. See screenshot extracted from Google Map below.

Screenshot extracted from Google Map shows the shortest distance where the right turn was made from Tampines Avenue 4 (red arrow) to the carpark of Block 930 Tampines Street 91, (black arrow) which was approximately 180m (yellow arrow). Co-relating this distance with this particular case, the Insured Vehicle had travelled a distance of at least 180m, after it had gone over the object, before it was parked and eventually towed to C & C after the loud rumbling noise was heard from the engine when the Insured Vehicle was started up the following day.
