Your Ref: 1801164929SG
Our Ref : CI/AIG18001638/N

18 January 2018

**TECHNICAL INVESTIGATION REPORT OF ENGINE DAMAGE TO THE
INSURED VEHICLE SLB 9121Y**

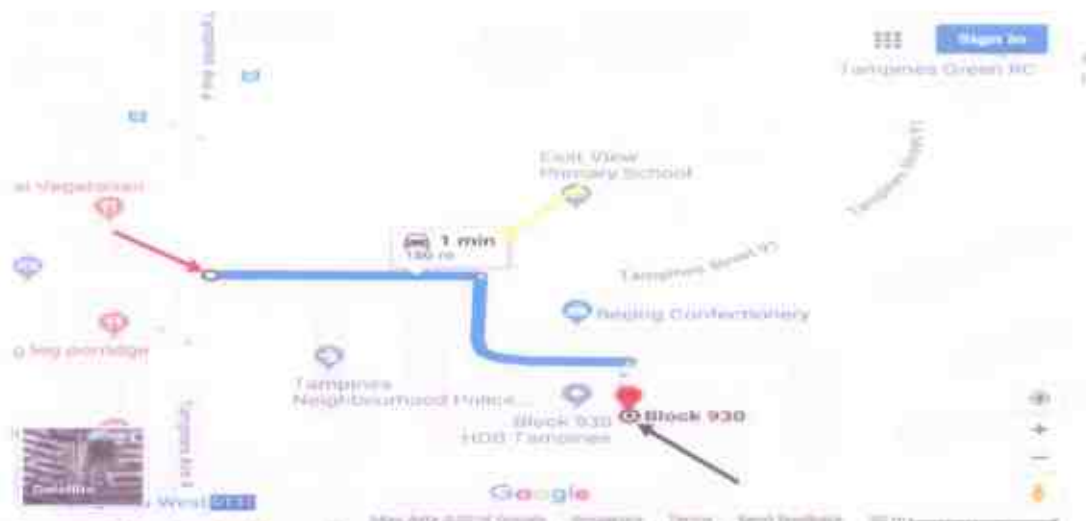
14. From the document relating to the towing work that was carried out by Eng Bee Recovery Pte Ltd, it was recorded that the Insured Vehicle was towed from the carpark of Block 930 Tampines Street 91. Basing on Google Map, the approximate distance from the reported location where the Insured Vehicle had gone over an object to Block 930 Tampines Street 91 where it was towed was approximately 180m. See screenshot extracted from Google Map below.

Screenshot extracted from Google Map shows the shortest distance where the right turn was made from Tampines Avenue 4 (red arrow) to the carpark of Block 930 Tampines Street 91, (black arrow) which was approximately 180m (yellow arrow). Co-relating this distance with this particular case, the Insured Vehicle had travelled a distance of at least 180m, after it had gone over the object, before it was parked and eventually towed to C & C after the loud rumbling noise was heard from the engine when the Insured Vehicle was started up the following day.
