Your Ref: TP/IP/65389/2017
Our Ref : CI/TPD18001916/D

01 February 2018

MECHANICAL INSPECTION REPORT OF MOTOR TAXI SHD 9684B

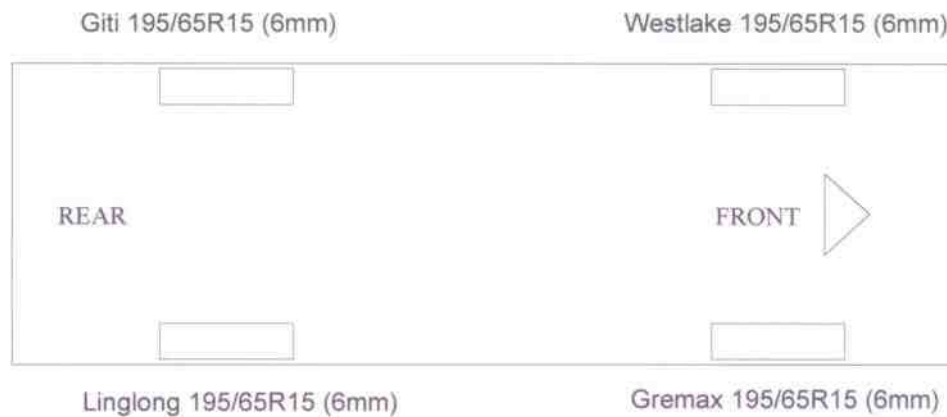
6. The condition of the Motor Taxi's 4 tyres was observed to be in serviceable condition. The 4 tyres were also sufficiently inflated for vehicular operation. I did not find any tear, cut or burst mark(s) on the outer and the inner sidewalls as well as across the tread of the 4 tyres. The tyre brand, tyre size and remaining tread depth of the 4 tyres were recorded as follows:-
