MECHANICAL INSPECTION REPORT OF MOTOR CAR SLB 1038H

1. We refer to your request on 09th January 2018 to conduct a physical inspection of a motor car bearing registration number SLB 1038H (herein referred to as "**Motor Car**"), which was involved in a fatal road traffic accident on 16th December 2017.
2. The purpose of this inspection is to primarily determine if there was any possible mechanical failure to the Motor Car that may have contributed to the accident.
3. Following the request, we carried out a physical inspection of the Motor Car on 01st February 2018 at the premises of Traffic Police vehicle pound, 517 Airport Road Singapore 539942. We now set out below our observations and comments with respect to this inspection.

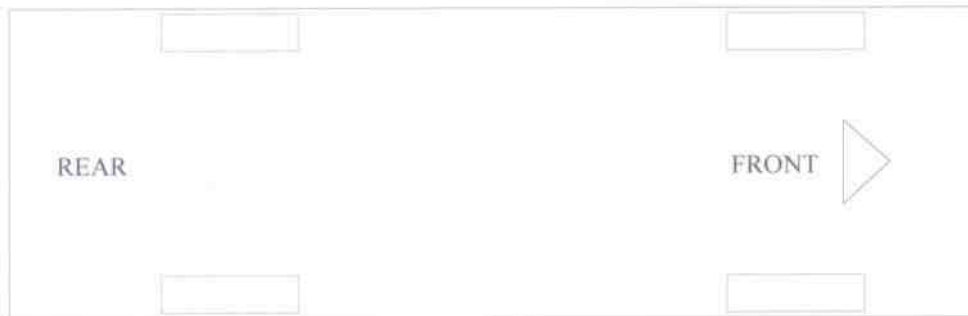
8. The rear right tyre was observed to be deflated likely due to the accident's impact. The front left & front right tyres were observed to be severely damaged likely due to the accidents impact. The conditions of the Motor Car's 4 tyres were observed to be in serviceable condition despite the severe damages & deflation that we found at time of inspection. The tread patterns were obvious visually. The remaining tread depth of the front left tyre was approximately 3mm, the front right tyre was approximately 3mm & the rear right tyre was approximately 3mm.

9. The rear left tyre was observed to be in serviceable condition. We did not find any tear, cut or burst mark(s) on the outer and the inner sidewalls as well as across the tread of the tyre. It was also observed to be sufficiently inflated for vehicular operation. The remaining tread depth of the rear left tyre was approximately 3mm.

Toyo Proxes C1S 205/55R16 (3mm)
(Inflated - Sidewall torn)

Toyo Proxes C1S 205/55R16 (3mm)
(Damaged – Torn)

Toyo Proxes C1S 205/55R16 (3mm)
(Deflated)
